RECAPP Facility Evaluation Report

St. Justin Catholic Elementary School

B3308A
Edmonton

Evaluation Company: Koliger Schmidt
Evaluation Date: December 1 2004
Evaluator Name: Mr. Mario Macchione

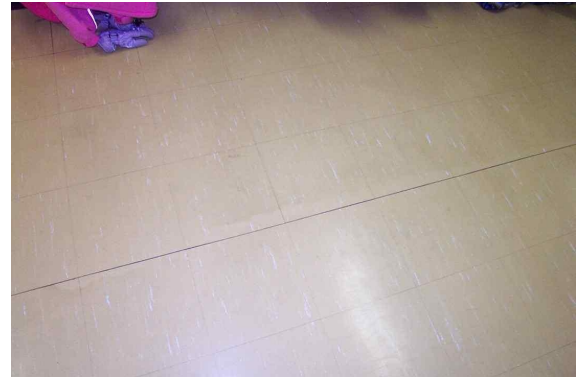
Event: Investigate slab movement.**Concern:**

Concrete slab on grade in 1973 building is cracking at numerous locations throughout the building and telegraphing through floor finishes. Major area of concern is the floor in hallway leading to 1995 addition because it is heaving in the middle.

Require structural study to determine cause and solution to slab movement. Other areas on this school site are having sinkage problems (ex. portables on eastside).

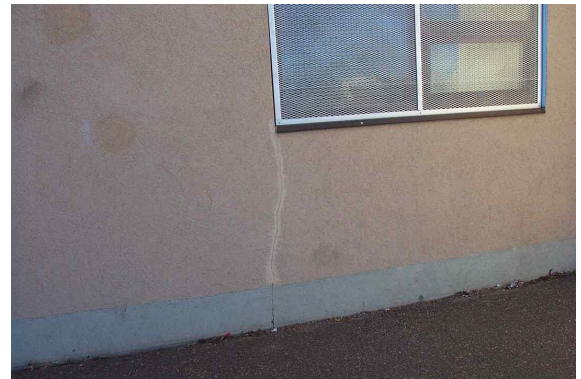
Event: Replace stucco finish**Concern:**

Stucco throughout 1973, 1995 and mechanical mezzanine has cracks, staining and areas of large unevenness.

Replace stucco finish. (approx 800 m²)

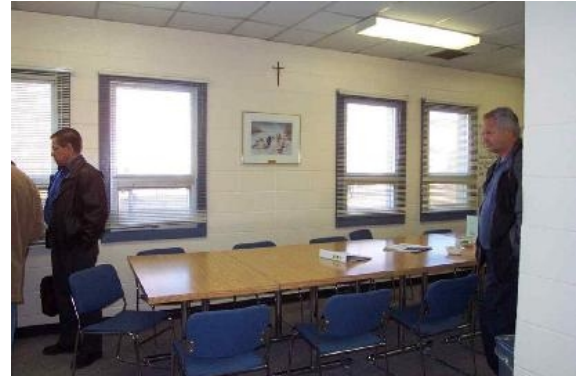
Event: Replace office and staff area window hardware.

The windows in the office and staff area have sliding casement adjusters that latch to lock. These arms are sometimes unlatched by pushing on the exterior of the window and popping them out of their locked position and by pulling can open window. Has become a security problem.

Replace window hardware with a more secure system. (11 windows)

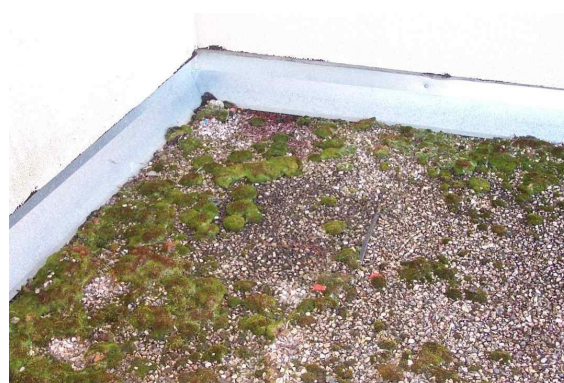
Event: 1973 building- Replace roof

1973 building was reroofed in 1986 and has area where moss is growing on roof.

Replace 1973 building roofs with a new 2 ply SBS system (Including mech mezzanine roof, total approx 1400m²).

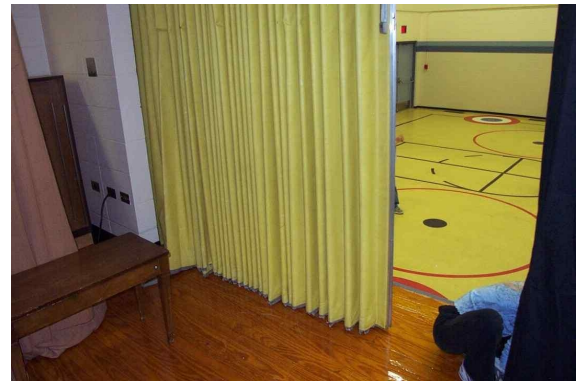
Event: Replace folding partition.**Concern:**

Damaged and coming off ceiling track. Could come loose and fall.

Replace curtain.

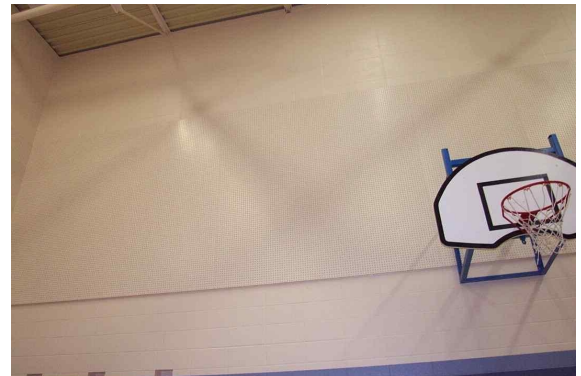
Event: Replace acoustical wall treatment

Replace wall treatment with new acoustical panelling. (approx. 153 m²)

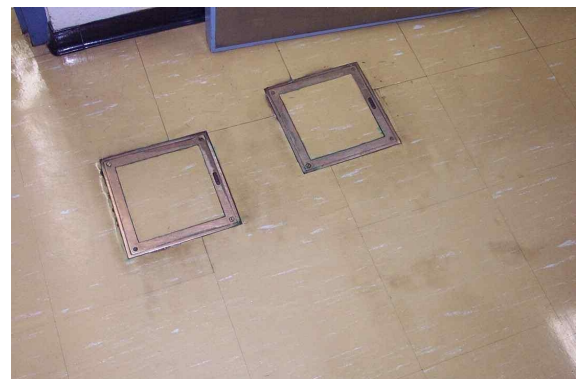
Event: Replace VCT tile in 1973 building

1973 buildings- Staff male and female, hallway, ANC kindergarden room, classroom 101, 102, 103, 104 and the boys and girls washrooms by the westside exit. Areas are discolored mismatched, stained and in some areas joints are seperating.

Replace VCT tile in these areas after structural study has been performed and problem of movement solved. (approx 590m²)

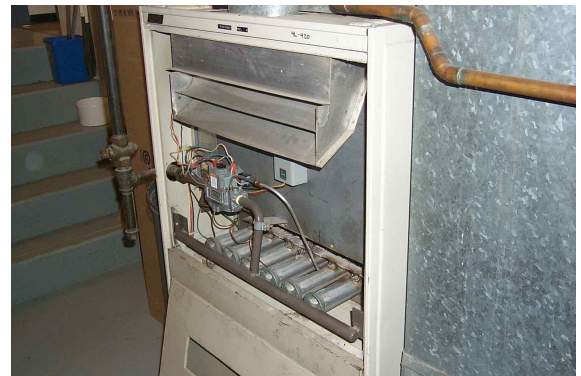
Event: Replace furnaces in original building.

The existing furnaces are inefficient, showing rust, and parts are difficult to find. Insufficient fresh air to building occupants.

Replace furnaces in original building with air handling units.

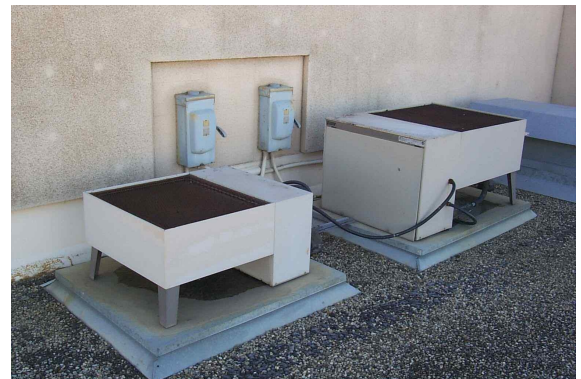
Event: Replace furnace and multizone condensers.

Replace furnace and classroom condensers.

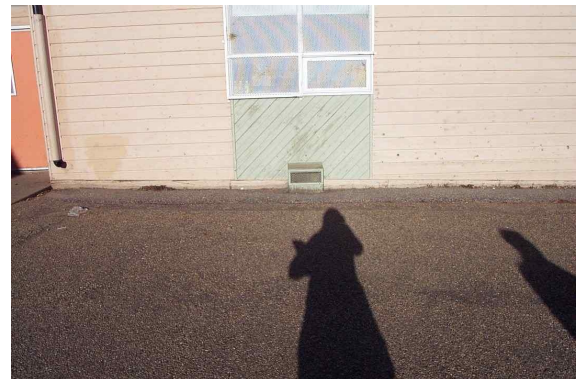
The exterior siding needs to be repainted due to peeling, chipping and major worn down areas of paint.

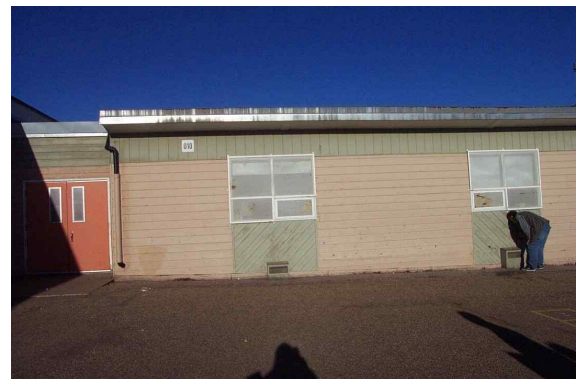
Event: Repair portable.

This portable was built in 1958 and has extensive repairs. Structurally this portable is sinking in the middle and pulling from additional portable pod.

Remove and asses ground for sinking problems correct foundation problems.

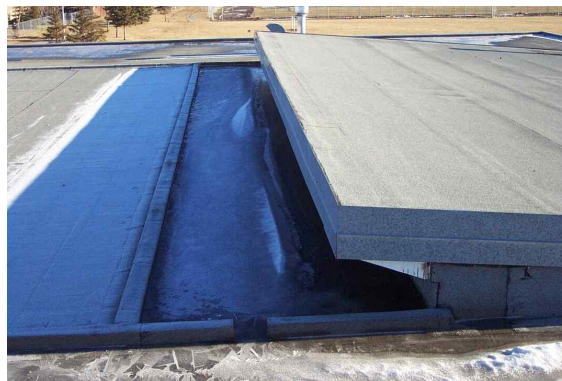
Event: Repair roof.

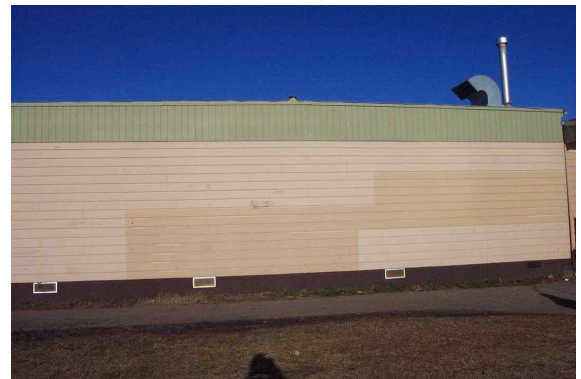
Exterior paint is chipped and mismatched from existing maintenace repair.

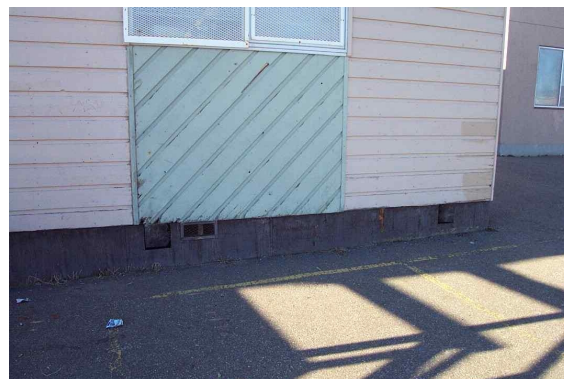
Exterior paint is chipped and mismatched from existing maintenace repair.

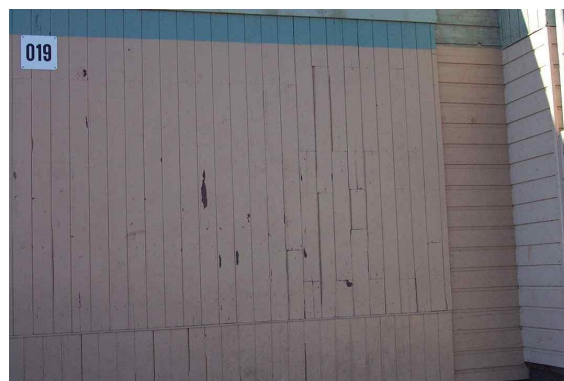
Exterior paint is chipped, worn and mismatched from existing maintenace repair.

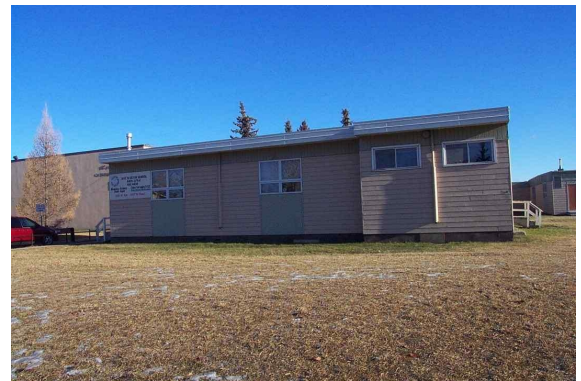
Exterior paint is chipped and worn down.

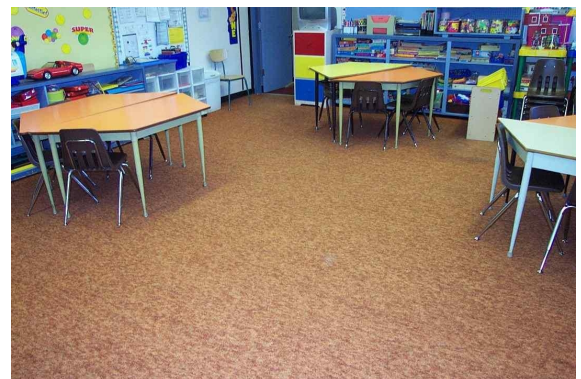
Event: Replace carpet.

Carpet is old, worn down and stained.

Replace carpet.

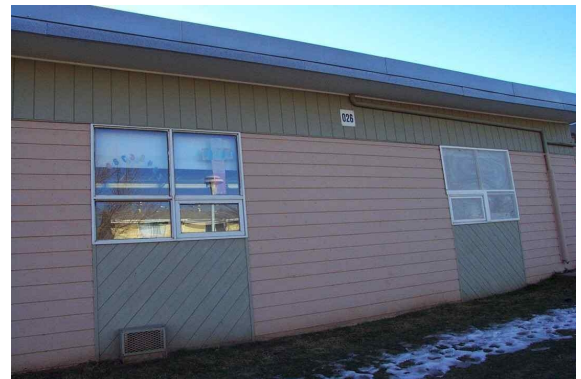
Window is missing security grille and could be a target for breakins.

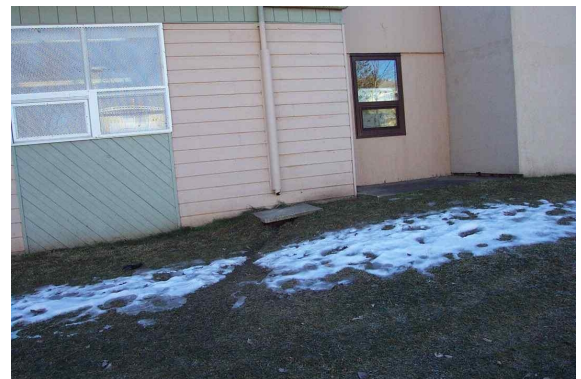
Event: Repaint exterior wood siding.

Exterior paint is chipped, worn and mismatched from existing maintenace repair.

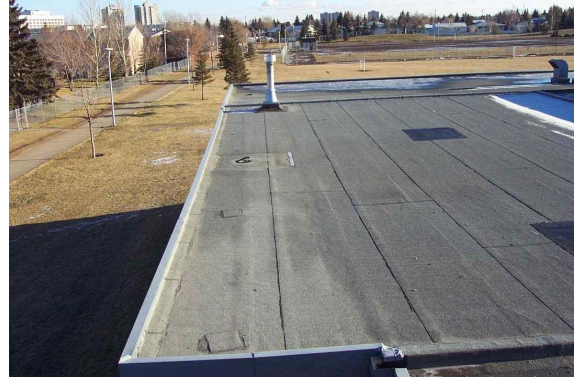
Event: Replace roof.

Roof has been patched and some leaks are starting to happen occur again.

Replace roof with 2 ply SBS system. Include corridor pod link (attached to southside) (approx 106m² in total) Coordinate with replacement of portable #10.

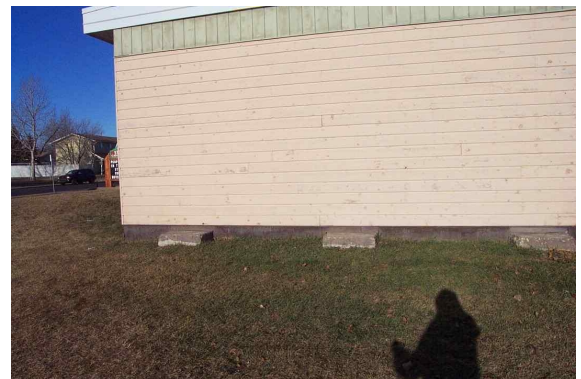
Event: Repaint exterior wood siding, door and stairs.

Exterior paint is chipped, worn and mismatched from existing maintenace repair.

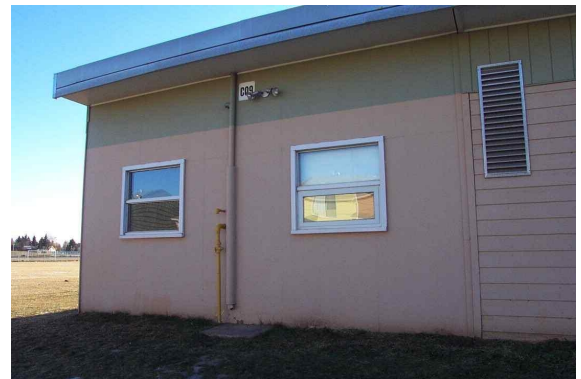
Windows and door windows are missing security grilles and could be a target for breakins.

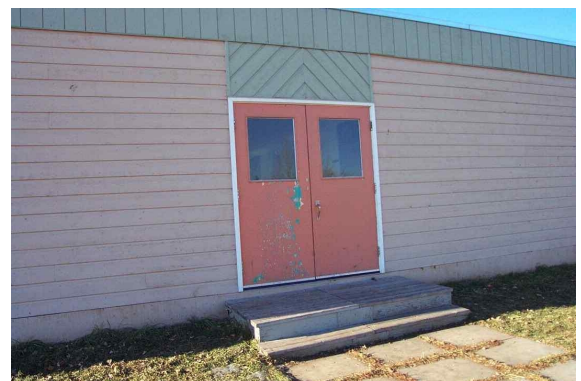
Event: Repaint exterior wood siding, doors and stairs. Repair water damaged wood and replace wood corner guard.

Repaint exterior wood siding, doors and stairs. Repair water damaged wood and wood corner. Install concrete splash pad.

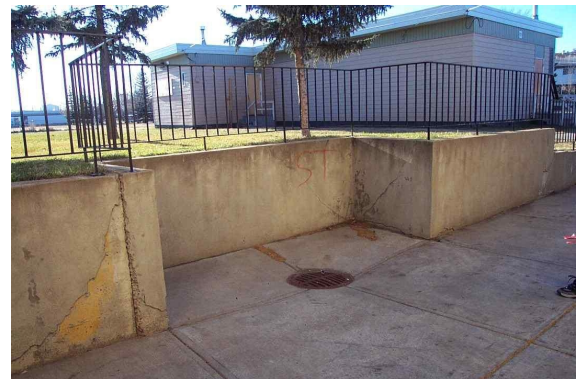
Event: Replace concrete retaining wall.

Retaining wall is cracked in many areas and concrete is deteriorating.

Replace wall on southside of gym, repairs have been made before and the cracking is still happening. Replace concrete wall but reuse existing rebar. (approx. 20m²)
