# RECAPP Facility Evaluation Report

Living Waters Cath Reg Div #42

**St. Mary Of The Lake School**

B4040A  
Slave Lake

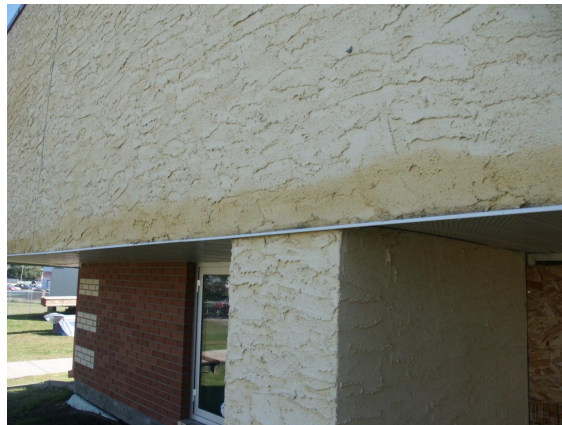
**Event:** Clean stucco.

Stucco badly stained with what appears to be mould or dirt in areas. Water, ice and snow seem to be overflowing eavestroughs and parapets.

Remedy cause of stain prior to cleaning stucco,

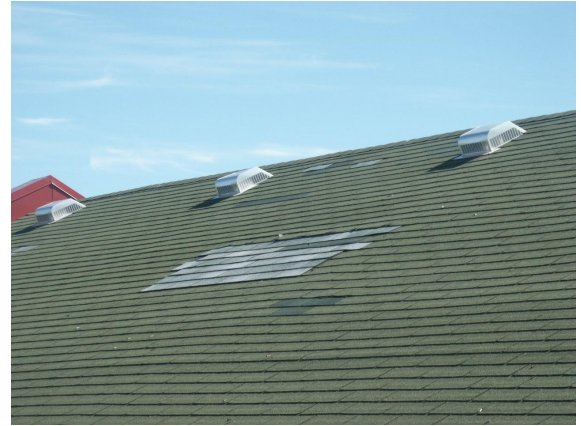
**Event:** Replace asphalt shingles.

Shingles have been problematic. A number of repairs required due to vandalism.

Replace asphalt shingles with roofing materials less prone to vandalism such as SBS roofing or standing seam metal (2,260.0 sq m).

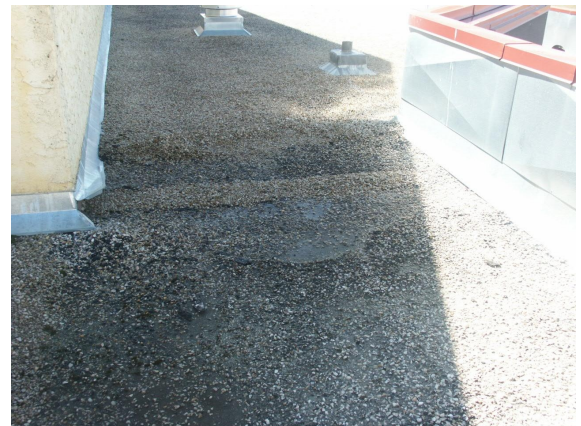
**Event:** Replace BUR membrane

Roof leaks have been a chronic problem. Roof is currently leaking.

Replace BUR membrane with 2 ply SBS and introduce additional insulation to slope to drain (810.0 sq m).

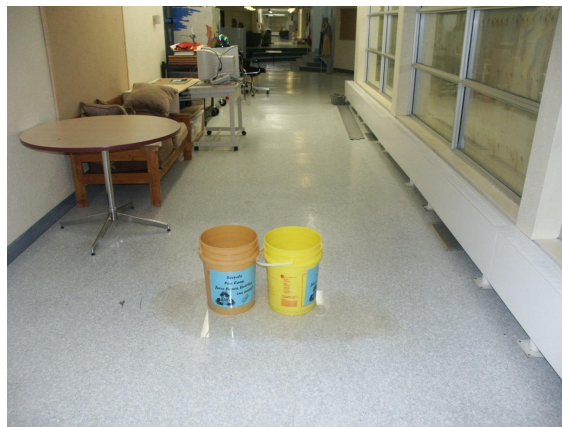
**Event:** Replace SBS membrane.

2003 roofing report by Wade Engineering lists costly defects and recommends replacement. Roof leaks have been a chronic problem; noticable ponding. Roof currently leaks.

Replace EPDM membrane with SBS membrane and add sloped insulation for improved drainage (1,080 sq m).

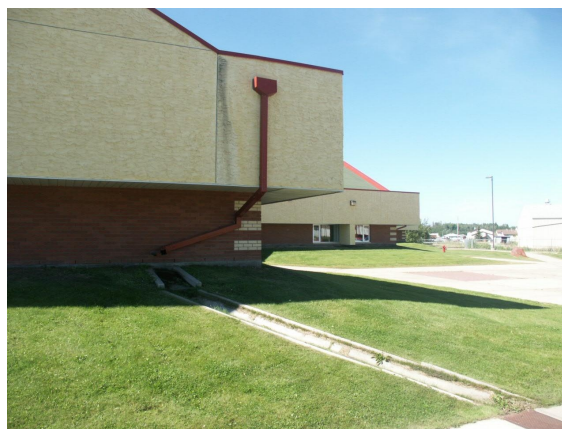
**Event:** Replace eavestroughs and downspouts.

Eavestroughs are leaking and damaging finishes; downspouts are missing or damaged.

Replace eavestroughs, downspouts and concrete splashpads. consider introducing interior drains.

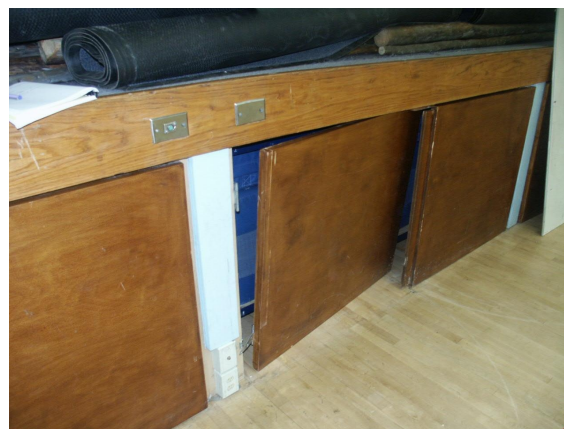
**Event:** Repair doors to storage under stage.

Doors are in poor repair; hanging off hinges.

Repair doors to understage storage.

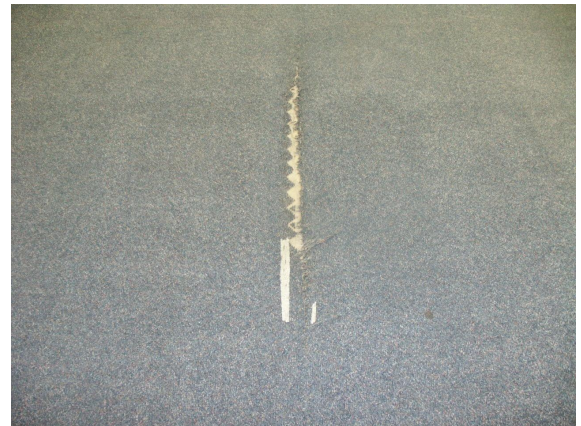
**Event: Replace carpet**

Carpet is worn and stained in a number of areas

Replace carpet in selected areas with caropet or sheet vinyl (1,350.0 sq m).

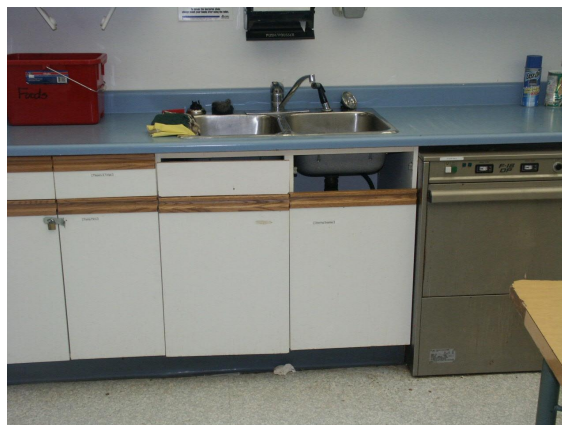
**Event:** Replace kitchen casework.

Casework is in poor condition.

Replace kitchen casework.
