Upgrading/ Modernization (identify whether minor or major)	1990						-Minor Modernization upgrade Science Rm. -Minor Modernization upgrade snack/servery area to assure cleanliness. -Minor Modernization H.C. access to General Office, back & front entries. -Minor Modernization supply & install security safe.
	1995						
	1998						
	1999						
Portable Struct. (identify whether attached/perman. or free-standing/ relocatable)							
List of Reports/ Supplementary Information	See Section 8 for complete list.

Evaluation Components	Summary Assessment	Estim. Cost
1	Site Conditions	Generally good, some attention required to concrete sidewalks and play areas.	\$16,000
2	Building Exterior	Mixture of additions in generally good condition. Windows in need of replacement in 1965 section.	\$136,500
3	Building Interior	Mixture of materials - lacks any kind of cohesion. Ample evidence it is need of an complete interior repaint. Ceilings are marginal in a number of areas and will require replacement when ventilation system is installed.	\$297,000
4	Mechanical Systems	Provide new ventilation systems for hallways except 1968 and 1972, complete with humidification; clean existing ductwork distributio

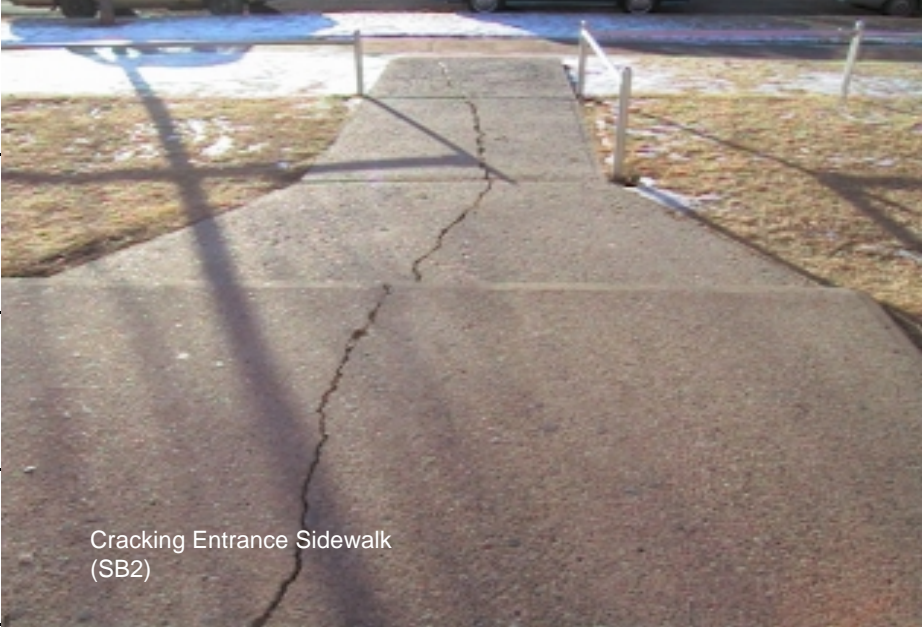
(SB2)	Exterior Walkways are in need of repair.	
(SB3)	Driveway at South West Entrance has damaged slab probably from heavy vehicle traffic

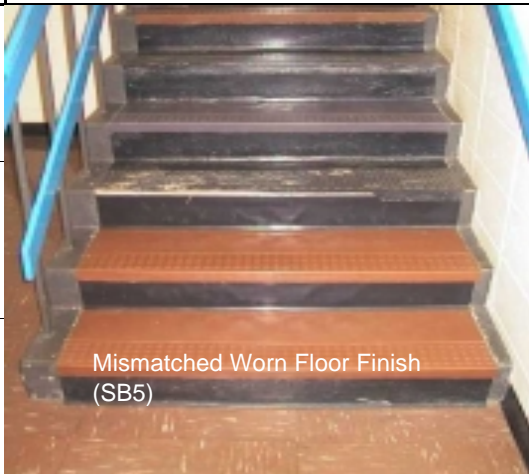
<p>Mismatched Worn Floor Finish (SB5)</p>

3.2	Materials and Finishes		<u>Bldg. Section</u>	<u>Description/Condition</u>	\$297,000
3.2.1	Floor materials and finishes.	3	1952 1953 1954 1965 1972	VCT or Sheet Flooring - Probably original floor finish, marginally acceptable, near end of life VCT or Sheet Flooring or Hardwood Floor (Gym) -Hardwood good, VCT and sheet marginal Sheet Flooring or carpet - Probably original floor finish, marginally acceptable, near end of life VCT or Carpet. (confirm gym). minor deficiencies generally good	\$20,000

<p>Typical Interior Door Frame Requiring Repainting (SB6)</p>
	<p>(SB5) Floor materials in some high traffic areas require replacement</p> <p>(SB6) Doors and Frames are prime area illustrating need of repainting.</p>

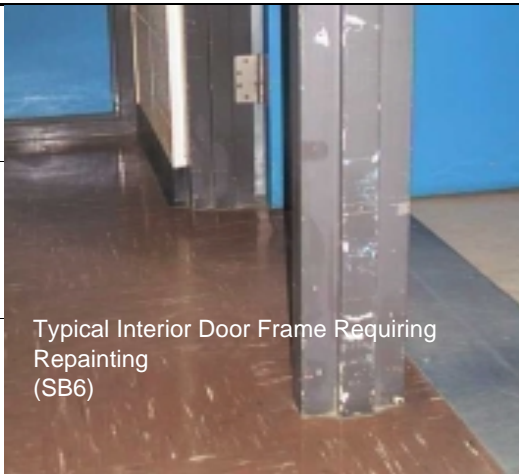
Section 3	Building Interior - Overall Conditions	Rating	Comments/Concerns		Estim. Cost
3.2.4	Interior doors and hardware.	3	All	Doors and hardware showing age but serviceable shows signs of need of repaint. Cost is assumed to be part of complete repaint identified in 3.2.2	Refer to 3.2.2

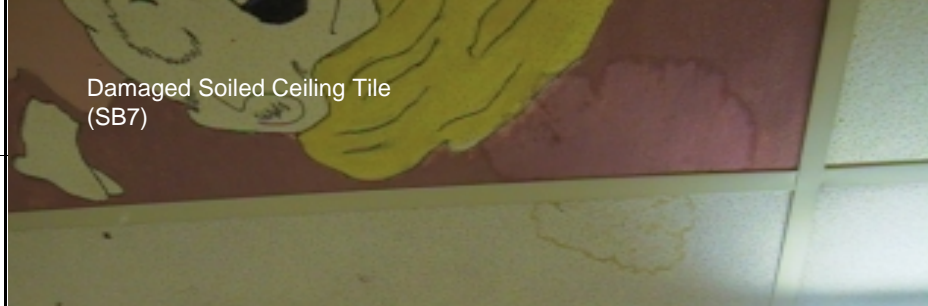
<p>Damaged Soiled Ceiling Tile (SB7)</p>

3.2.3	Ceiling materials and finishes.	3	1952 1953 1954 1965 1972	Plaster Ceilings generally good condition - Install. Vent. sys. requires clngs Plaster Ceilings/adhered acoustic tile in gym - Install. Vent. sys. requires clngs. Plaster Ceilings generally good condition - Install. Vent. sys. requires ceilings. T-Bar or adhered ceiling tile or GWB, showing age allow for 50% replacement Generally T-Bar, Water Damage I.A. area, showing age allow 50% replacement	\$135,000

(SB7)	Ceiling Tiles are damaged and soiled in a number of areas.
