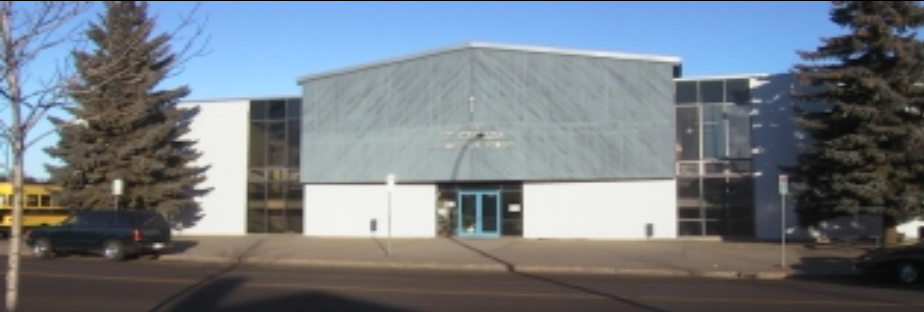
Main Entrance - Exterior (SC1)

Main Entrance

1.2.4	Fire vehicle access.	F.I.	Same as 1.2.1. Rear of school has parked cars blocking direct access.	
1.2.5	Signage.	3	Very poor signage and building identification at rear of school.	\$5,000
Other

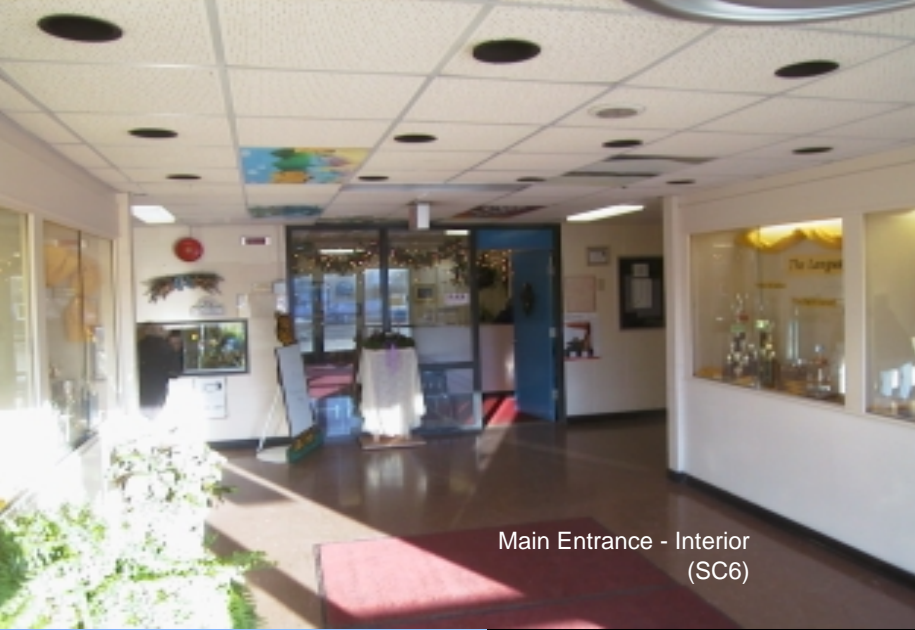
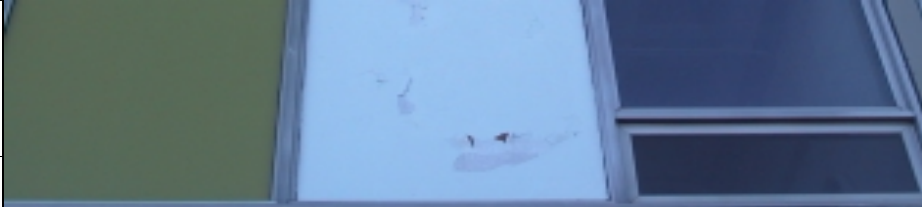
Exterior Wall Finishes	A combination of painted brick, stucco, glazed spandrel panels and wood siding are all in poor condition. Painted brick is cracking and dirty, stucco panels are cracked and show signs of age (SC2, SC5), spandrel panels have been replaced with plywood (SC3) at some locations and the wood siding at the front of the school needs painting. New stucco and replacement of spandrel panels recommended.

Section 2	Building Exterior	Rating	Comments/Concerns		Estim. Cost
2.3	Exterior Walls/Building Envelope		Bldg. Section	Description/Condition	\$100,000
2.3.1	Exterior wall finishes (i.e., signs of deterioration, cracks, brick spalling, effluorescence, water stains).	3	66/67	A combination of painted brick, stucco, glazed spandrel panels and wood siding are all in poor condition. Painted brick is cracking and dirty, stucco panels are cracked and show signs of age, spandrel panels have been replaced with plywood at some locations and the wood siding at the front of the school needs painting. New stucco and replacement of spandrel panels recommended.	\$100,000

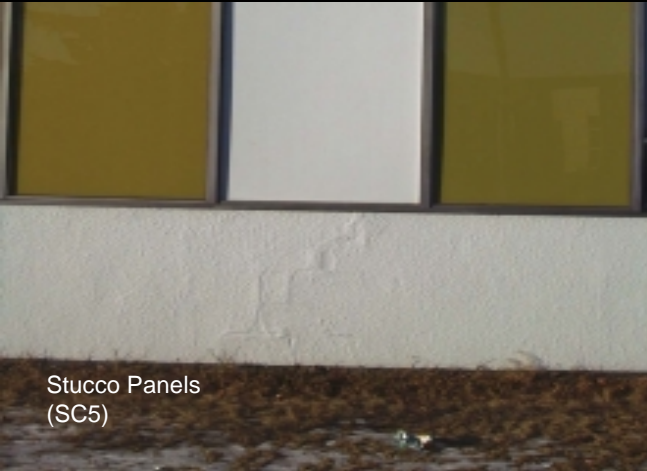
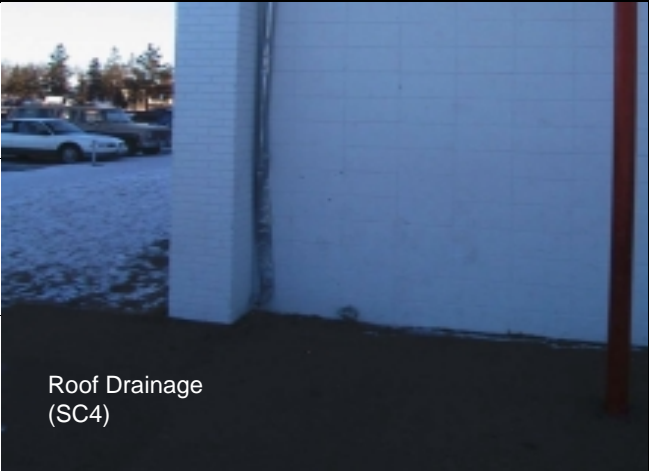
Stucco Panels (SC5)	Roof Drainage (SC4)
Roof Accessories	Downspouts are not connected to storm sewer, draining too close to building.

2.2.2	Roof accessories (i.e., ladders, stairs, hatches, masts, exhaust hoods, chimneys, gutters, downspouts, splashpads).	FI		Downspouts are not connected to storm sewer, draining too close to building.
