<b>Upgrading/ Modernization</b> (identify whether minor or major)	1984  1992  1998		14.9			-Minor Modernization to Science Prep. Rm. #128. -Minor Modernization renovate main floor Staff Washroom & Work Room. -Minor Modernization correct the over heating problem in C.R. #108 & #208.
<b>Portable Struct.</b> (identify whether attached/perman. or free-standing/ relocatable)						
<b>List of Reports/ Supplementary Information</b>	See Section 8 for complete list.

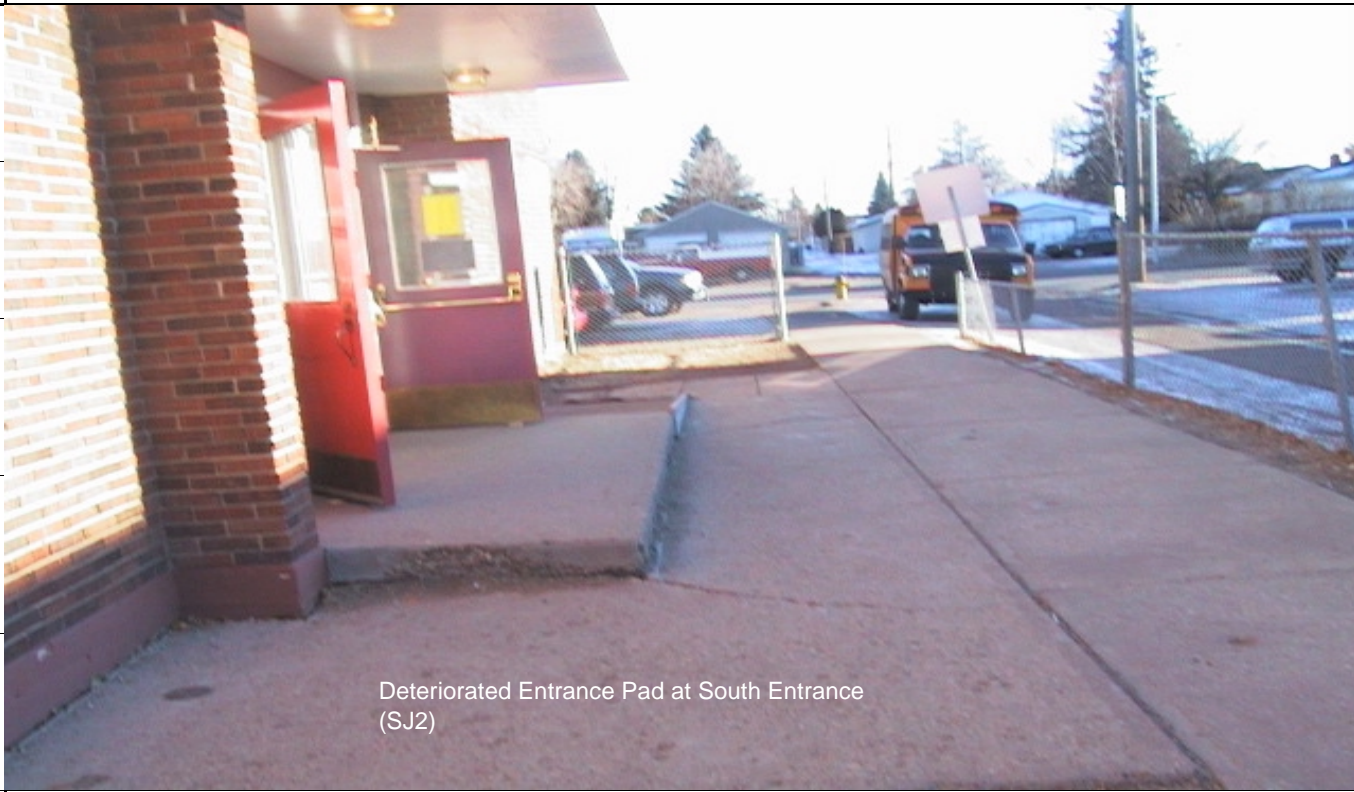
1.3.5	Surfacing and drainage of sidewalks (note type of material).	4	Winter conditions make assessment difficult. Pad at South east entrance in poor shape. Replace.	\$2,500

<p data-bbox="947 899 1430 959">Deteriorated Entrance Pad at South Entrance (SJ2)</p>
(SJ2)	Exterior Walkways are in need of repair in some areas.

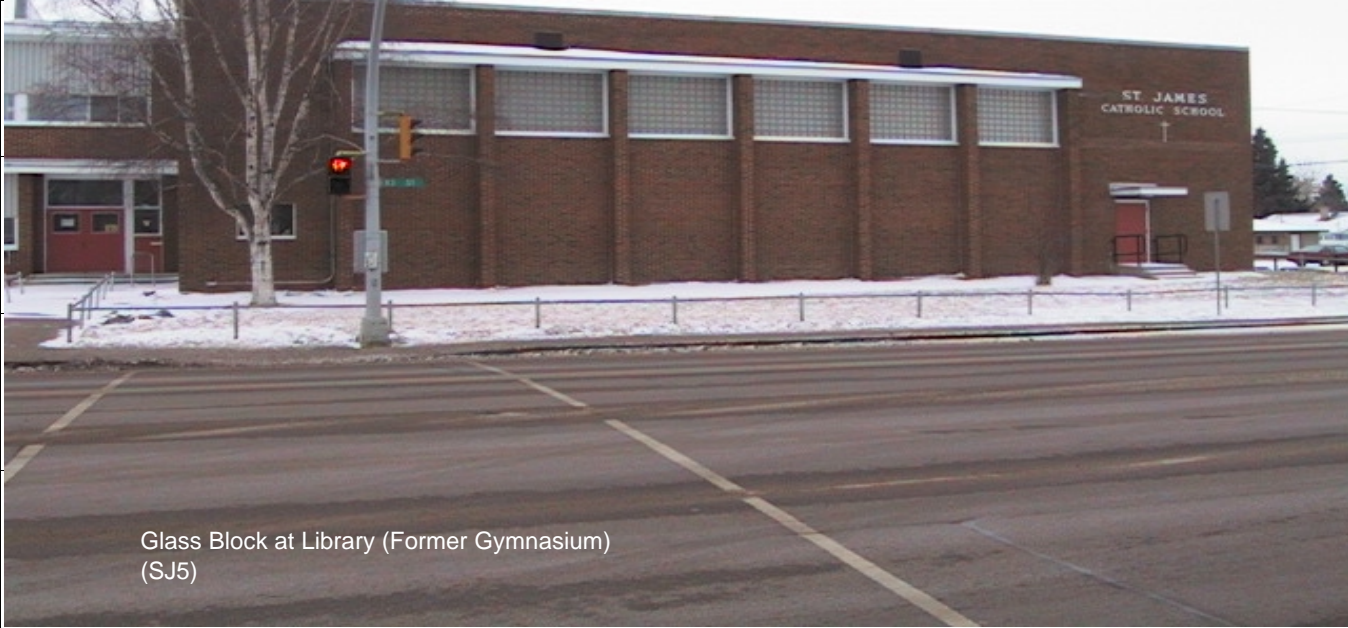
2.3.2	Fascias, soffits, parapets (i.e., signs of looseness, stains, rust, peeling paint).	4		All sections seem acceptable from perimeter inspection.	
2.3.3	Building envelope (i.e., evidence of air infiltration/exfiltration through the exterior wall or ice build up on wall, eaves, canopy).	3		Glass block 1956 addition shows signs of movement and looks as though could be source of potential infiltration.	\$7,500

(SJ5)	<p>Glass Block at Library (Former Gymnasium) (SJ5)</p> <p>Original Glass Block in former gymnasium has mortar joints which look as though they may be a source of air/water infiltration.</p>

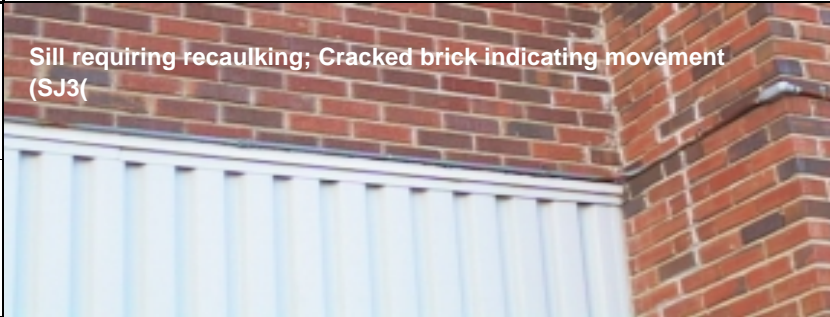
2.3.1	Exterior wall finishes (i.e., signs of deterioration, cracks, brick spalling, effluorescence, water stains).	3	1953 1956 1959 1973	Frame brick; pre-finished metal Frame brick; pre-finished metal Frame brick; pre-finished metal Masonry brick/block (PTD). Evidence of need for sill re-caulking 1953-1956	\$5,000

<p>Sill requiring recaulking; Cracked brick indicating movement (SJ3)</p>

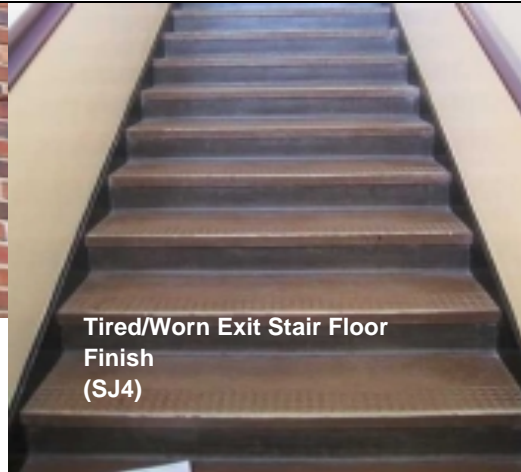
<p>Tired/Worn Exit Stair Floor Finish (SJ4)</p>
(SJ3)	Pre-Cast sills have loose caulking in a number of areas.	
(SJ4)	Stair Finish in central area stair is worn and in need of replacement.
