School Facility Evaluation Project
Part IV - Additional Notes and Comments

School Name:	St. Jerome				School Code:	36
	Location:	3310 - 107 avenue Edmonton, Alberta T5W 0C7				Facility Code:	1979
	Region:	Central				Superintendent:	Dr. Dale W. Ripley
	Jurisdiction:	Edmonton RCSSD No. 40				Contact Person:	Mr. Garnet McKee
						Telephone:	(780) 453-4500 (Garnet)
	Grades:	K-VI				School Capacity:	Total 200
	Building Section	Year of Compl.	No. of Floors	Gross Bldg Area (Sq.M.)	Type of Construction (i.e., structure, roof, cladding)	Description of Mechanical Systems (incl. major upgrades)	Comments/Notes
	Original Building	1970	1	1845.3	Masonry/B.U.R	Hot water heating to classroom ventilators along perimeter; separate ventilation system for interior classrooms & gymnasium	
	Additions/ Expansions						
						Evaluator's Name:	Bill Vance
						& Company:	Henderson Inglis Partridge

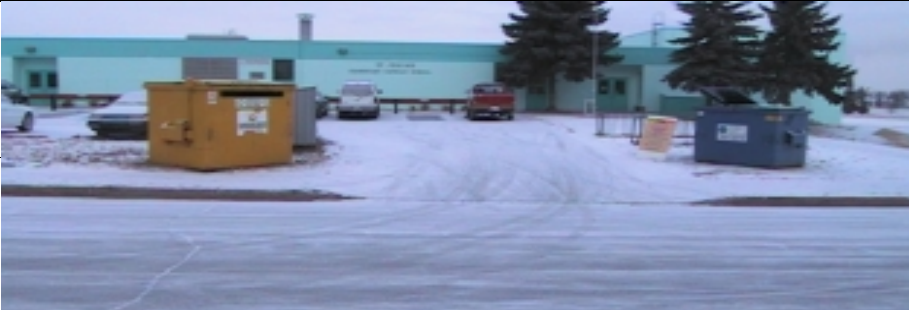
1.3.6	Curb cuts and ramps for barrier free access.	2	No curb cuts at off-site crosswalk	\$1,000
Other		4	Garbage bins have been located at entrance to parking, effectively the front door of the school presumably to allow trucks to pick-up garbage without damaging asphalt in parking area (this problem has been identified at other schools). No costs have been allocated to this aesthetic problem.	
	Overall Site Conditions & Estimated Costs			\$3,500

(SJE2)	<p>Garbage Bins at Main School Entrance (SJE2)</p> <p>Garbage Bins make for an unattractive entrance.</p>	
(SJE3) (SJE4)	<p>Exterior stucco band cracking in a number of locations.</p>

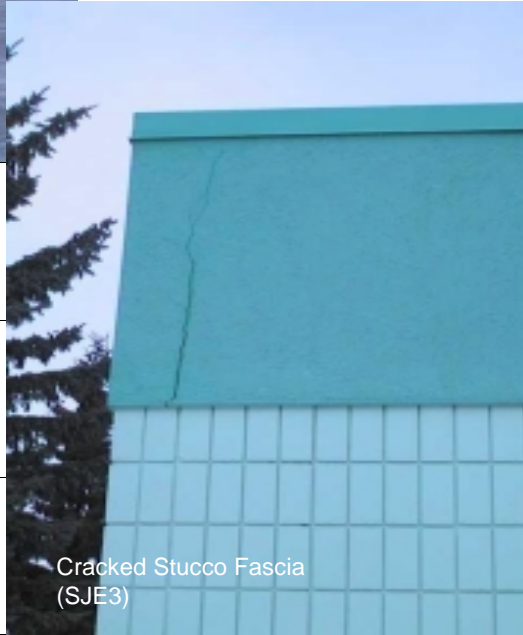
2.3.2	Fascias, soffits, parapets (i.e., signs of looseness, stains, rust, peeling paint).	3		Cracking stucco fascia and signs of peeling paint. Staff indicated that school exterior is scheduled for painting spring of 2000. Painting cost included in 2.3.1 above	Refer to 2.3.1

<p>Cracked Stucco Fascia (SJE3)</p>

Section 2	Building Exterior	Rating	Comments/Concerns		Estim. Cost
2.3	Exterior Walls/Building Envelope		Bldg. Section	Description/Condition	\$26,500
2.3.1	Exterior wall finishes (i.e., signs of deterioration, cracks, brick spalling, effluorescence, water stains).	3		Signs of peeling paint and cracking in Stucco Fascia some areas. Staff indicated that school exterior is scheduled for painting spring of 2000. Cracking stucco in SouthWest corner. Cracking stucco by North West entrance. Cracking Peeling Paint North wall under windows. Removal of Uni-Vent as part of mechanical systems upgrades will require wall infill/patching.	\$26,500

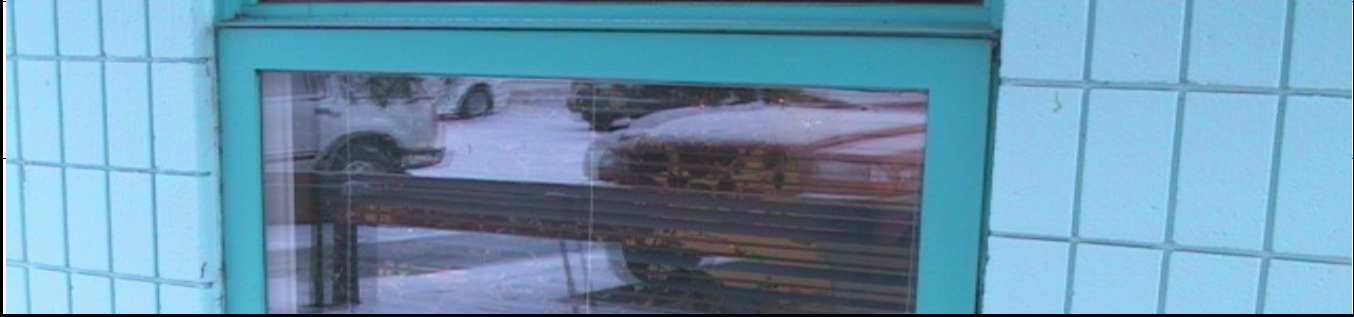
2.4.3	Exit door hardware (i.e., safety and/or code concerns).	4	Generally good condition.	
2.4.4	Windows (i.e., signs of deterioration, rusting metal, glass cracks, peeling paint, damaged seals, sealed unit failure).	3	Loose seals noted at a number of locations. Windows are original with the exception of a window in the general office which was added to monitor school visitors. Although there were not significant signs of deficiencies windows are 29 years old and show age. Replacement should be budgeted in near future. Budget should allow for increasing exterior window area as poor daylighting is	\$25,000
			an issue sighted by staff.

(SJE5)(SJE6)	Loose window seals evident at a number of locations.

Evaluation Component/ Sub-Component	Additional Notes and Comments
	  <p>Poor Condition Exterior Window (SJE6)</p>

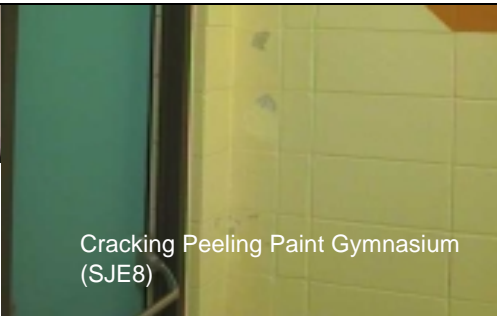
2.3.3	Building envelope (i.e., evidence of air infiltration/exfiltration through the exterior wall or ice build up on wall, eaves, canopy).	F.I.		Peeling Paint is a problem in the Gymnasium in the upper third of the walls and in the north East and South East corners. It is possible that this may be due to moisture penetration through the block or perhaps due to inadequate insulation within this wall system.

Evaluation Component/ Sub-Component	Additional Notes and Comments	
	Cracking Peeling Paint Gymnasium (SJE7)

Cracking Peeling Paint Gymnasium (SJE8)
(SJE7)(SJE8)(SJE9)	Problem with exterior wall at gym resulting in cracking and peeling paint in a number of areas.	
	Painting/Repair Typical Interior Door (SJE10)

2.3.4	Interface of roof drainage and ground drainage systems.	4			
2.3.5	Inside faces of exterior walls (i.e., signs of cracks, water stains, dust spots).	F.I.		Peeling Paint is a problem in the Gymnasium in the upper third of the walls and in the north East and South East corners. It is possible that this may be due to moisture penetration through the block or perhaps due to inadequate insulation within this wall system. costs for repainting of the school is identified in 3.2.2	Refer to 3.2.2
Other

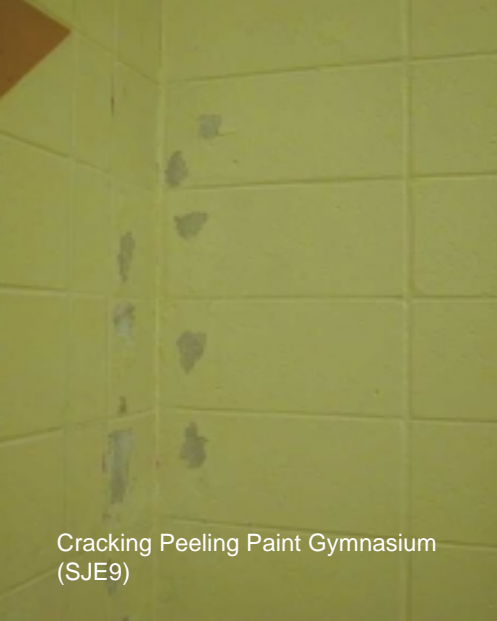
Cracking Peeling Paint Gymnasium (SJE9)

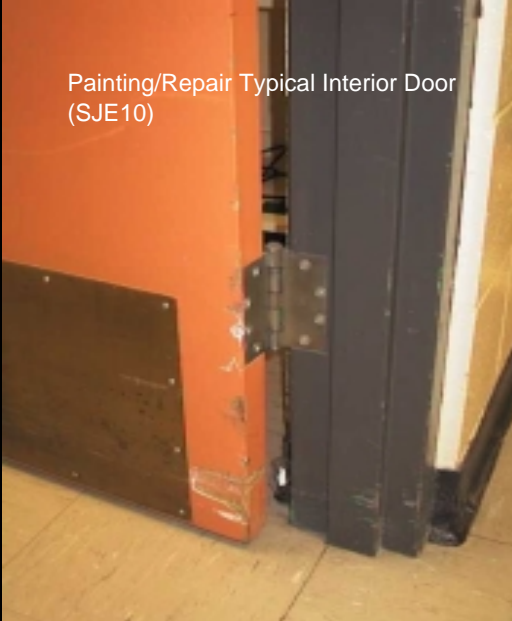
Section 3	Building Interior - Overall Conditions	Rating	Comments/Concerns		Estim. Cost
3.2.4	Interior doors and hardware.	4		Generally good condition. Paint chips evident due to school being at end of paint cycle.

Evaluation Component/ Sub-Component	Additional Notes and Comments
(SJE10)	Repainting required in a number of areas.
List of Reports/ Supplementary Information	<p> Educational Facilities Master Plan 2007 Edmonton Catholic Schools March 1998 Inventory of Core School Buildings – Edmonton Catholic School District Summary From Alberta Education School Buildings Service Areas in m2 Roofing Projects Revised July 22, 1999 1997 B.Q.R.P. 1998 B.Q.R.P. 1996 B.Q.R.P. 1995 B.Q.R.P. 1993 B.Q.R.P. Heating, Ventilation and Air Conditioning Systems Portable Classroom Locations – Edmonton Catholic Schools Edmonton Catholic Schools Fire Alarm Systems Consultants for School Facilities Edmonton Catholic Schools – Legal Description December 01, 1998 Inventory of School Buildings – Edmonton Catholic Schools November 05, 1999 Edmonton Catholic Schools – Gymnasium Inventory Edmonton Catholic Schools – 1999/2000 Summary of Minor Modernization Projects From 1990 through to 1999 Major Modernizations and Additions Summary of Alternately Funded Renovation Projects Standard Assessment and Utilization Report 0018 Edmonton RCS REG DIV #40 </p> <p>Data Sheets</p> <p>St. Jerome School February 1980</p> <p>Mini-Plans</p> <p>St. Jerome School March 1970 – Last Rev. Dec.1997</p>

3.2.2	Wall materials and finishes.	3		Wall materials are generally in good condition but paint shows signs of being at end of cycle. Interior is scheduled to be painted in 2001.	\$22,500
