School Facility Evaluation Project
Part IV - Additional Notes and Comments

School Name:	St. Rose				School Code:	227
	Location:	8815 - 145 street Edmonton, Alberta T5R 0T7				Facility Code:	2031
	Region:	Central				Superintendent:	Dr. Dale W. Ripley
	Jurisdiction:	Edmonton RCSSD No. 40				Contact Person:	Mr. Garnet McKee
						Telephone:	(780) 453-4500 (Garnet)
	Grades:	VII - IX				School Capacity:	Total 450
	Building Section	Year of Compl.	No. of Floors	Gross Bldg Area (Sq.M.)	Type of Construction (i.e., structure, roof, cladding)	Description of Mechanical Systems (incl. major upgrades)	Comments/Notes
	Original Building	1962	2	2010.9	Concrete/Masonry/B.U.R./Stucco/Ceramic Tile	Classroom ventilators using perimeter hot water.	Severe limitations on outside air for ventilation.
	Additions/ Expansions	1965	2	2591.9	Concrete/Masonry/B.U.R./Stucco/Ceramic Tile		
						Evaluator's Name:	Bill Vance
						& Company:	Henderson Inglis Partridge

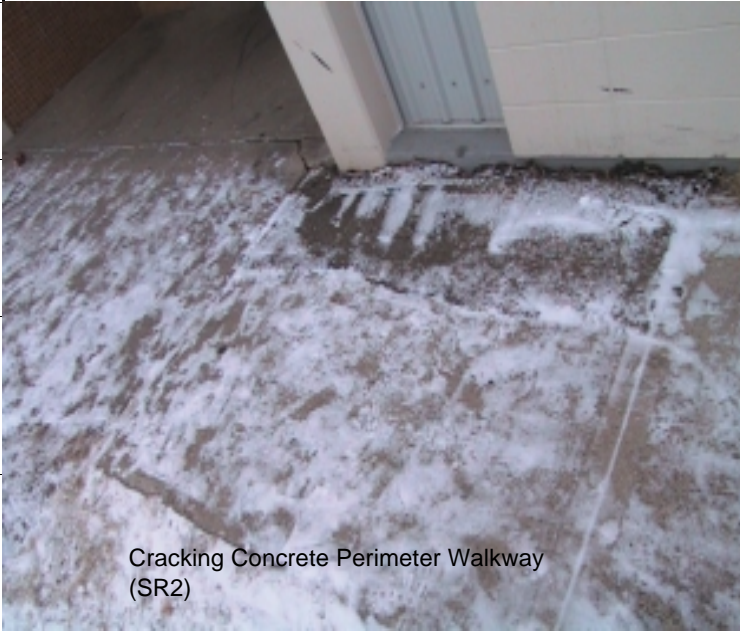
Cracking Concrete Perimeter Walkway (SR2)			Cracking Slab at North West Entrance (SR3)
(SR2)(SR3)	Exterior walkways are in need of repair in some areas.

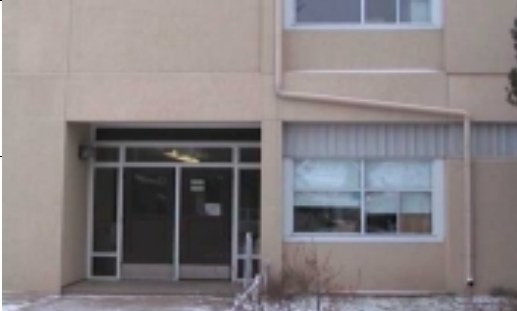
2.2.2	Roof accessories (i.e., ladders, stairs, hatches, masts, exhaust hoods, chimneys, gutters, downspouts, splashpads).	3		Generally seems O.K. Problem cited with freezing air intake in extreme winter conditions. Scupper drain arrangement west elevation and freezing creates problem at north west entrance.	\$20,000

2.3.4	Interface of roof drainage and ground drainage systems.	3		Ice build-up. Scupper roof drain north west entrance 1962. Costs have been identified in Section 2.2.2	Refer to 2.2.2

<p>Exterior Drain Which Causes Hazardous Condition at North West Entrance (SR4)</p> <p>Typical Window with Failing Seals/Accessories</p>
(SR4)	<p>Drainage problem at North West Entrance creates icy and hazardous sidewalks.</p>
(SR5)	<p>Some windows have been replaced but the original windows remaining require repairs but parts unavailability makes this difficult.</p>

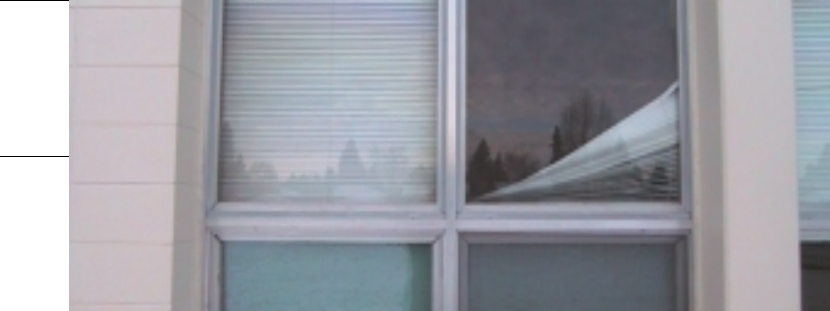
2.4.3	Exit door hardware (i.e., safety and/or code concerns).	4	All	Generally O.K.	
2.4.4	Windows (i.e., signs of deterioration, rusting metal, glass cracks, peeling paint, damaged seals, sealed unit failure).	3	1962	Replaced west and north elevation - north elevation windows reduced in size- pre-finish metal infill.	\$57,000
			1965	Replaced west and north elevation. Evidence of seal failures east elevation. Remaining windows at end of serviceable life - replace.

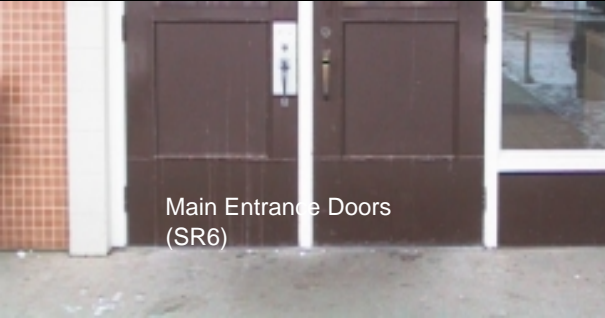
2.4.1	Doors (i.e., signs of deterioration, rusting metal, glass cracks, peeling paint, damaged seals, sealed unit failure).	3	1962	Main entrance doors appear dated, out of place in terms of condition relative to new exterior stucco.	\$2,500
			1965	Generally O.K.

(SR6)	Main Entrance doors are in need of replacement	
(SR7)	Ceramic tile on south side of school is in need of repair.

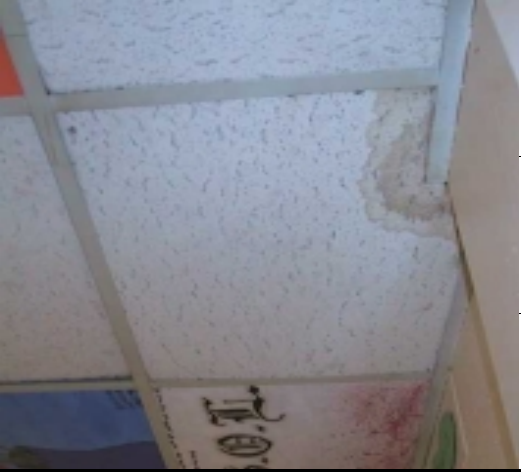
<p>Stained Ceiling Tiles (SR8)</p>

3.2.3	Ceiling materials and finishes.	3	1962	T-Bar corridors, adhered acoustic ceiling tile. T-Bar at end of life. Many areas water stains/chips, some loosened tiles. Damage combined with replacement due to installation of ventilation system we have budgeted for 35% replacement of Non-Gym area.	\$45,000
			1965	T-Bar, adhered acoustic ceiling tile (confirm). T-Bar at end of life, many areas water stains/chips, some loose adhered tiles. 35% replacement.

<p>Soiled Ceiling Tile (SR9)</p>
(SR8)(SR9)	Ceiling Tiles in many areas are damaged or soiled.

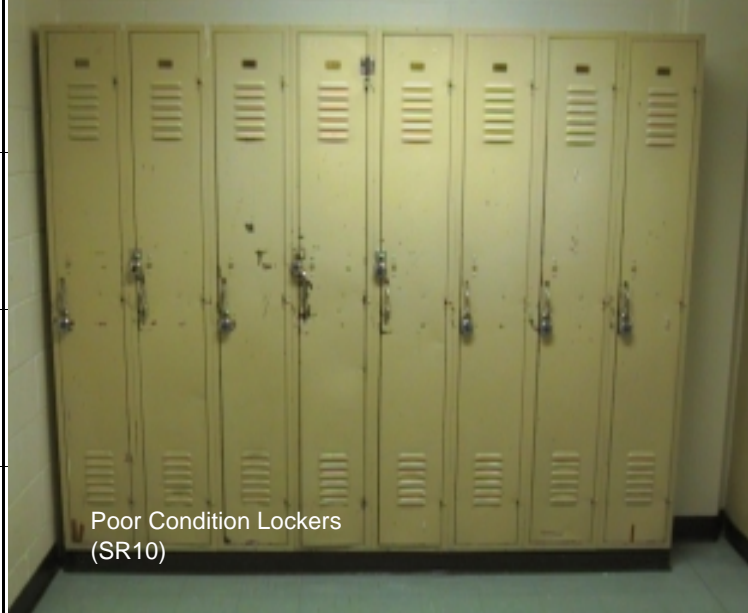
<p>Poor Condition Lockers (SR10)</p>

3.2.6	Fixed/wall mounted equipment (i.e., writing boards, tackboards, display boards, signs).	4	All		
3.2.7	Any other fixed/mounted specialty items (i.e., CTS equipment, gymnasium equipment).	3		Lockers in poor condition - replace in phases. Budgeted for 100 lockers Appear to be approximately 365 on site in corridors.	\$15,000

Evaluation Component/ Sub-Component	Additional Notes and Comments	
(SR10)(SR11)	Many lockers are in very poor condition, requiring high levels of maintenance and have a negative affect on the corridor appearance.

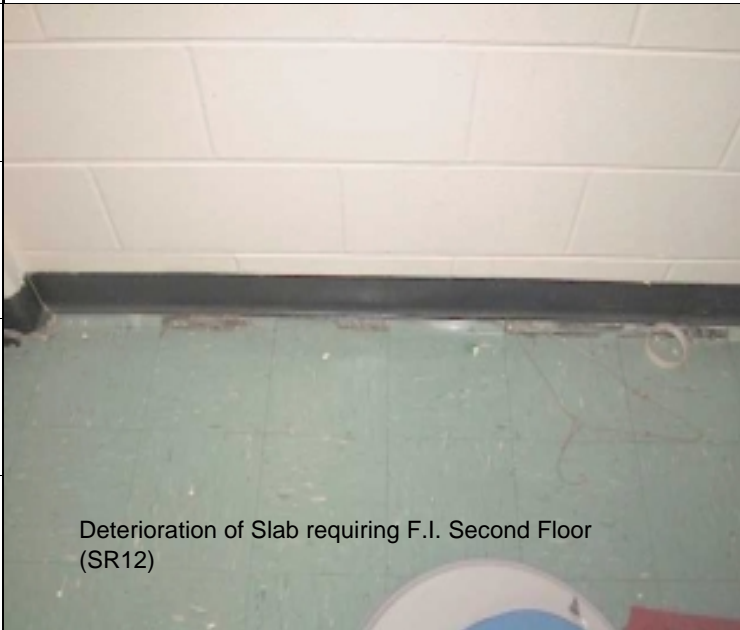
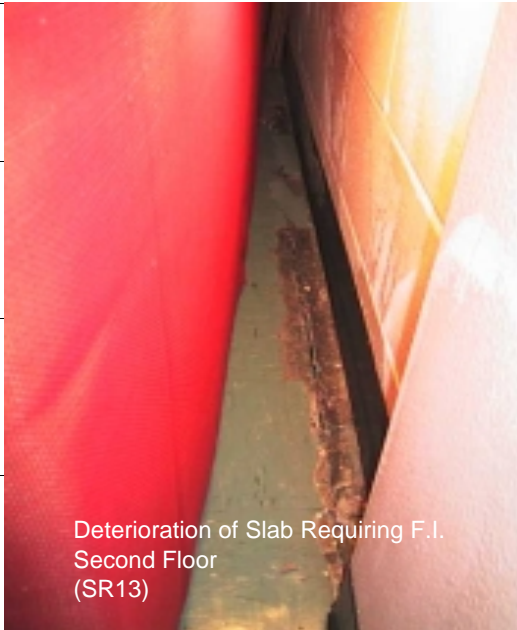
Deterioration of Slab requiring F.I. Second Floor (SR12)	
(SR12)(SR13)	Second Floor slab at South East shows signs of movement. F.I. Is required.
