RECAPP Facility Evaluation Report

Greater North Central Francophone Education Region#2

Ecole Ste. Jeanne D'Arc School

B9722A
Edmonton

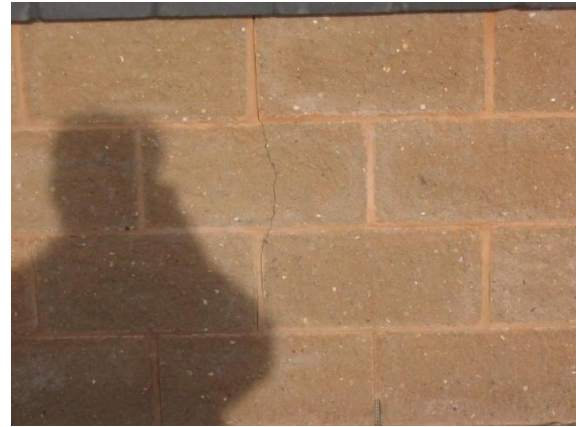
A1030.02 Structural Slabs on Grade

New 2002 addition - Settlement cracking on the exterior wall between the Prematernelle and the Maternelle

Event: Cracking observed on the exterior wall between the Prematernelle and the Maternelle.

Settlement cracking was observed on the exterior wall between the Prematernelle and the Maternelle. The floor slab has settled and the interior block wall has step cracks.

A study is recommended to determine the extent of damage to the building structure.
