RECAPP Facility Evaluation Report

Sturgeon Composite High School

B3816A

Evaluation Company: Wilson Architects Ltd.
Evaluation Date: May 6 2006
Evaluator Name: J. R. Irlam

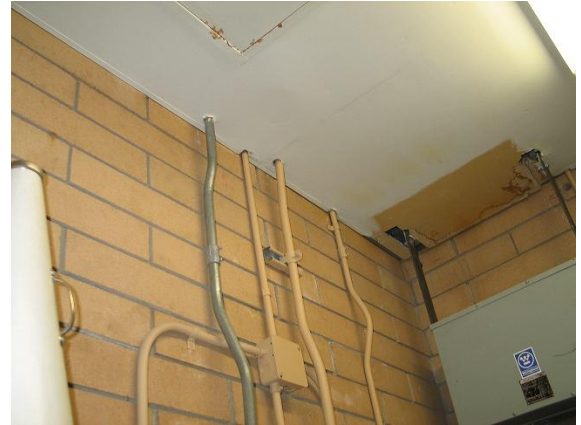
There are some rooms where fire stopping is missing which does not comply with Code particularly where data and other communications systems have been installed subsequent to the original construction in the emergency generator room and janitor's room for example.

The school building will continue to be non-compliant with the Code.

Installation of fire stopping in the janitor's room and emergency generator room is recommended.

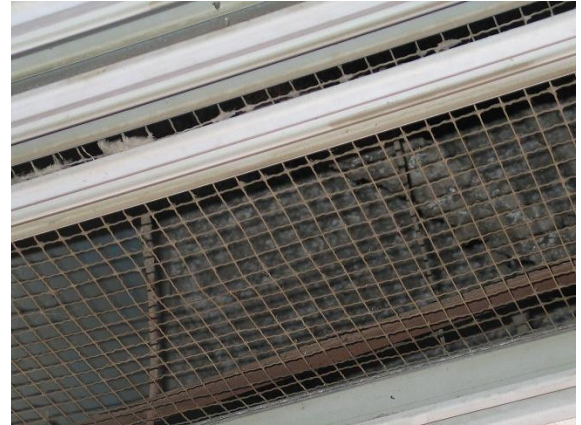
Event: Replace exterior grilles

There are several louvers with blades missing. Failure to replace the blades may lead to damage to the filters and associated machinery.

Damage to air handling equipment may result if louvers are not replaced.

Replacement of the louvers is recommended to prevent internal damage to air handling equipment.

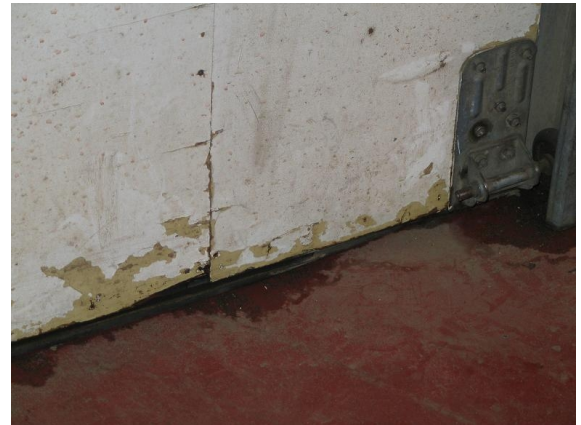
Event: Replace over head doors

The wood panels in the overhead doors are damaged at the base and sides where the runners are attached and require replacement. The doors are difficult to operate.

The doors will continue to deteriorate and their operation will become increasingly difficult.

The replacement of the overhead doors is recommended.

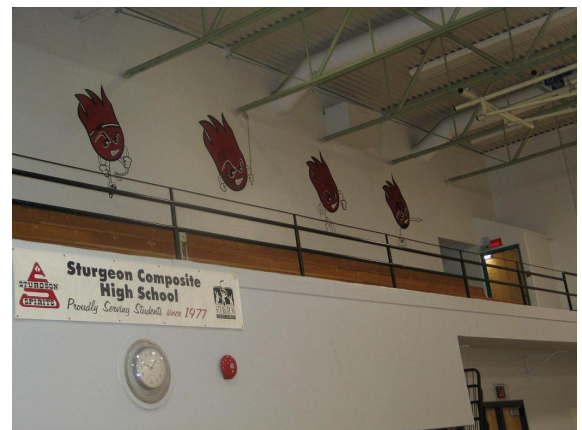
The gallery will continue to be in breach of the Code.

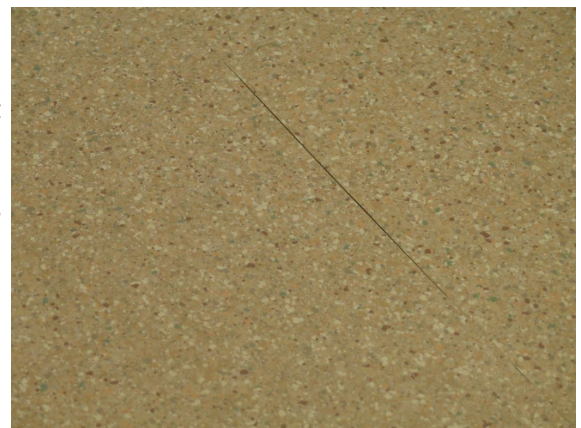
Event: Replace resilient flooring

There is damaged and deteriorated resilient flooring throughout the school.

The resilient flooring will continue to deteriorate further.

Replacement of the damaged or deteriorated resilient flooring is recommended.

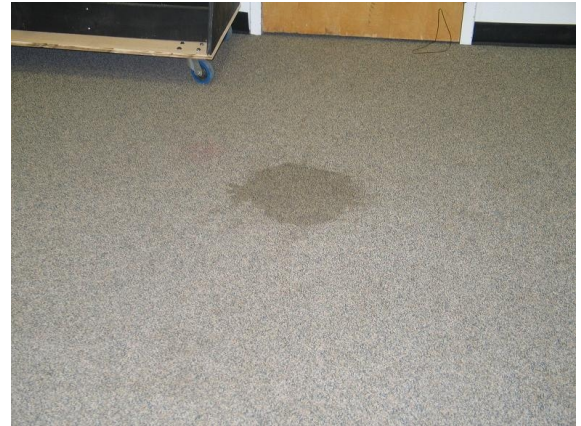
Event: Replace carpet

There is carpet throughout the school which has deteriorated, is damaged and requires replacement.

The carpet will continue to deteriorate.

Replacement of worn or damaged carpet is recommended.

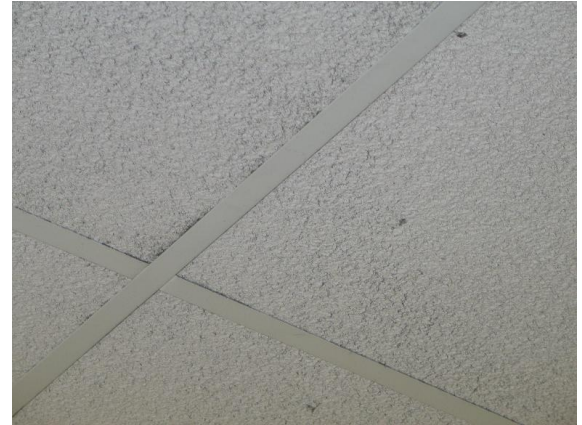
Event: Replace ceiling tiles

There are areas of damaged T-bar ceiling tiles throughout the school which require replacement.

Deferral of this recommendation will result in the continued unsightliness of the ceiling finishes and further deterioration.

It is recommended that the damaged ceiling tiles be replaced.

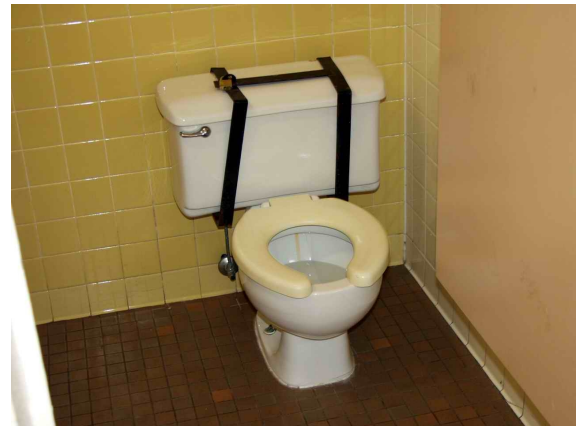
Event: Replace Water Closets

Water closets are old 5 gpf and in poor condition. The seating configuration does not meet code. The toilet tank covers have steel straps and locks to prevent vandalism.

The WCs will continue to deteriorate.

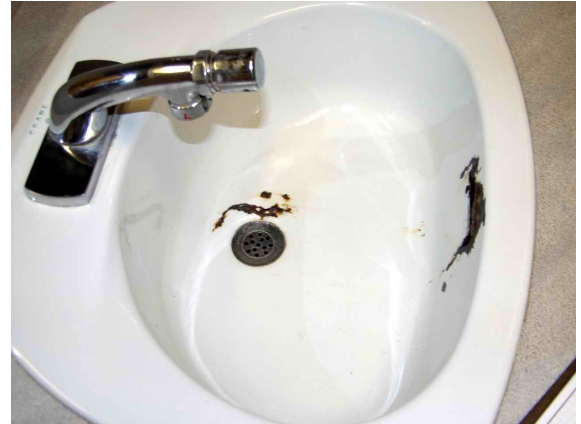
Event: Replace Lavatories

Many chipped and rusting lavatories.

The lavatories will deteriorate further.

Provide new stainless steel vanity mounted lavatories with hands free meting faucets.

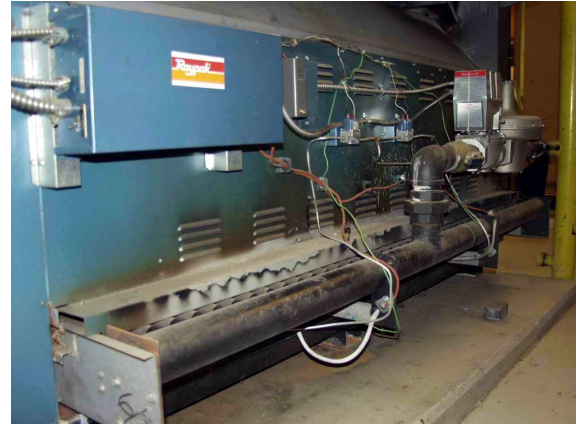
Event: Replace Heating Boilers

Boilers are in poor condition and show signs of overheating, flame roll-out , and poor combustion. Refractory and insulation repairs were made in 2005 but boilers are operating poorly and are inefficient.

The boilers will deteriorate further.

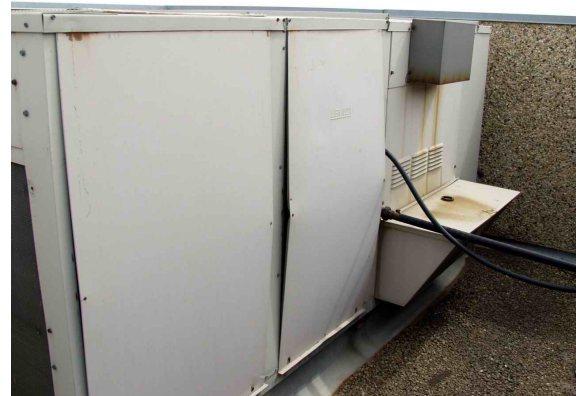
Event: Replace rooftop unit.

Unit is in very poor condition. Its location and access makes servicing of the unit hazardous. Repairs and maintenance appears to have been sporadic.

The unit will continue to deteriorate.

Replace roof top unit with a roof mounted air handing unit mounted on the main roof and ducted into the pyramid structure.
