# **RECAPP Facility Evaluation Report**

## **Calgary School District #19**

### **Viscount Bennett School**

**Evaluation Company:** Quinn Young  
**Evaluation Date:** December 1 2004  
**Evaluator Name:** Mr. Sheldon Quinn

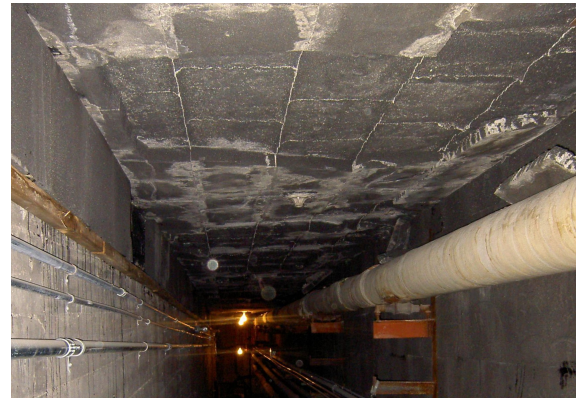
#### Event: Replace service tunnel insulation

Remove remaining board insulation and replace with new durable material

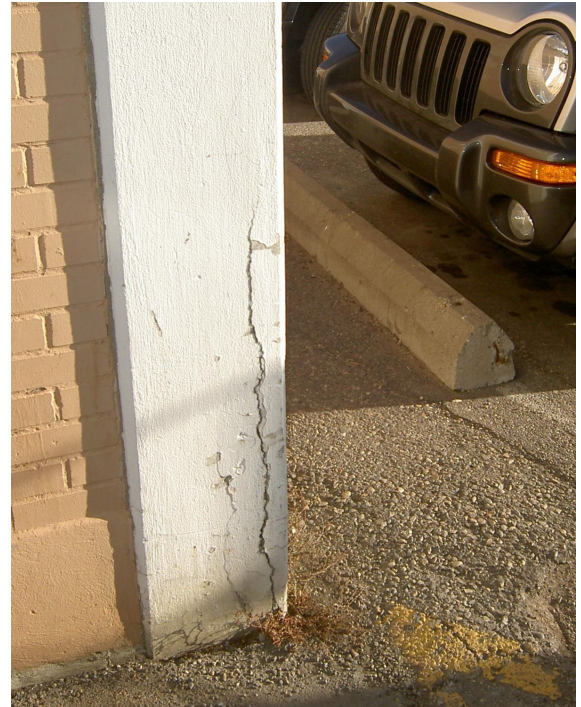
#### Event: Examine cracked concrete columns and beams

Examine concrete structures for degree of or possibility of failure

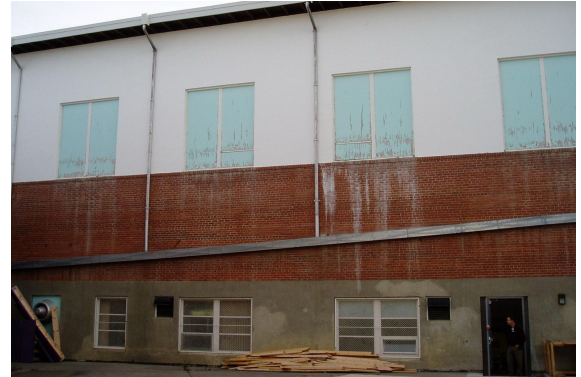
1954: Brick surfaces are aging, staining and deteriorating throughout.

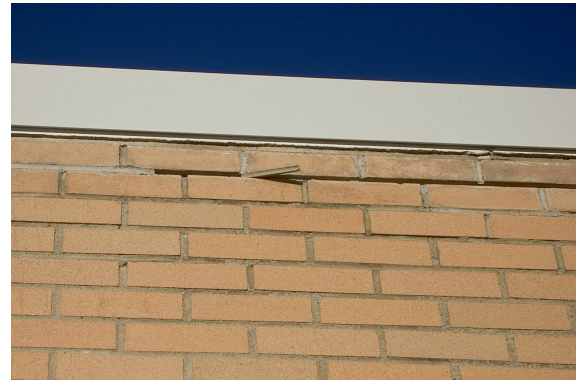
Brick joint mortar is loose in numerous locations. There are cracks in brick walls and many bricks are falling out.

Clean out and re-point failing brick joints. Remove loose brick, clean surfaces and re-lay brick.

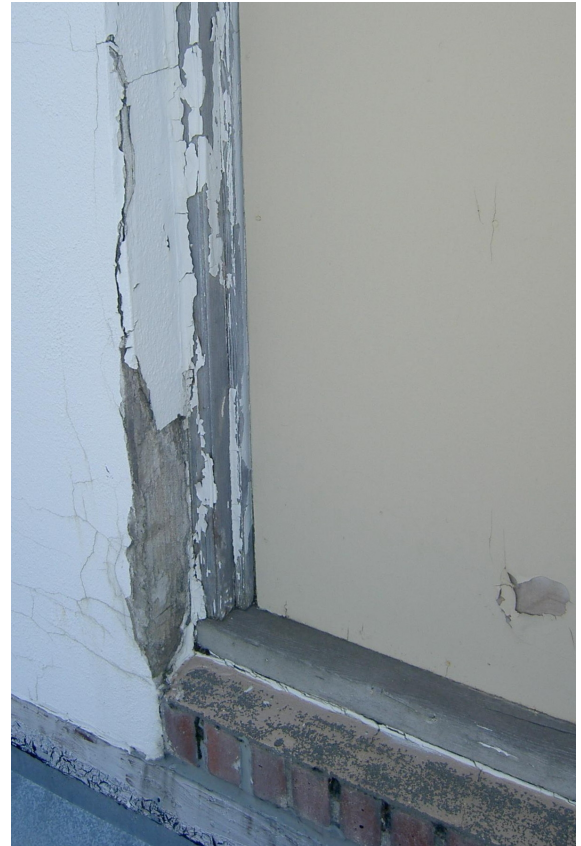
Stucco and parging wall finish is cracked in several locations

Repair cement stucco and parging

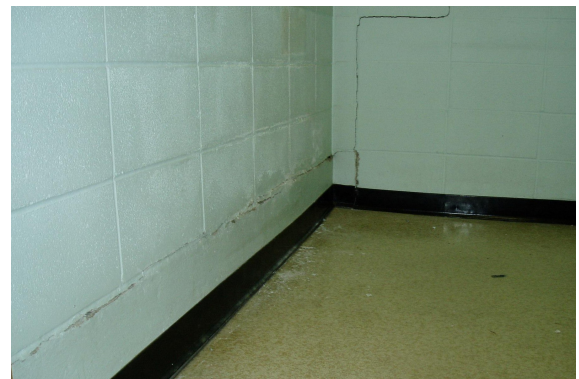
Wall cracks in high wall at music room practice areas

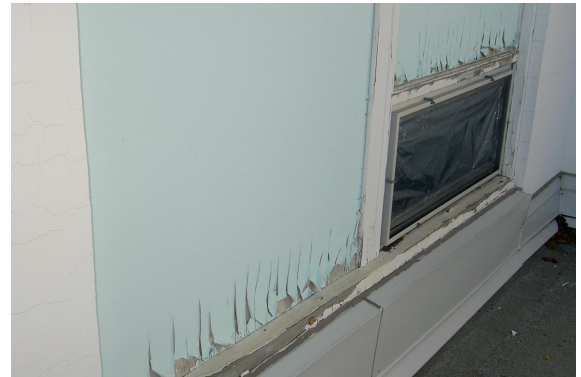
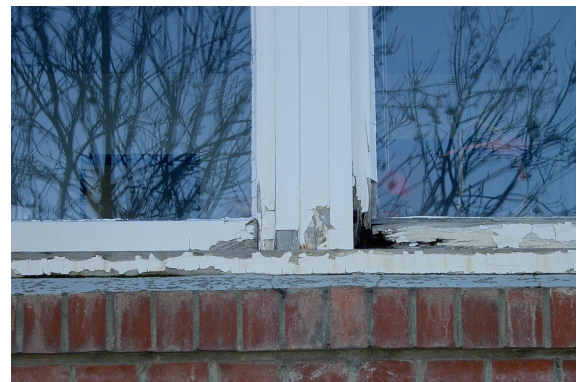
Wood window units on the north side of the building have completely rotted out and will soon fail totally.

Replace wood windows with aluminum units. Esitimated cost of replacing is \$80,000. See B2020.01.01.05

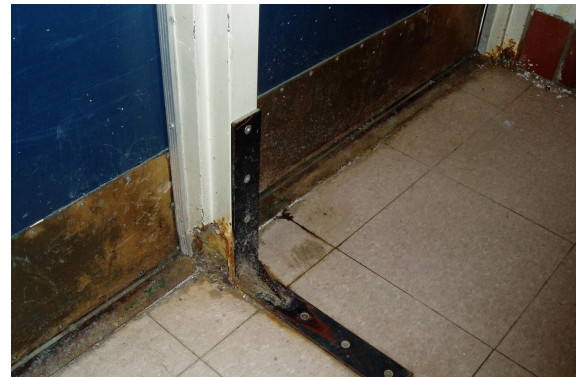
Steel door frames are rusted and the anchors have failed. Some wood doors are heavily used and are damaged.

Replace wood doors and frames, hardware and steel door frames with insulated hollow metal doors, upgraded hardware and pressed steel frames for 8 units.

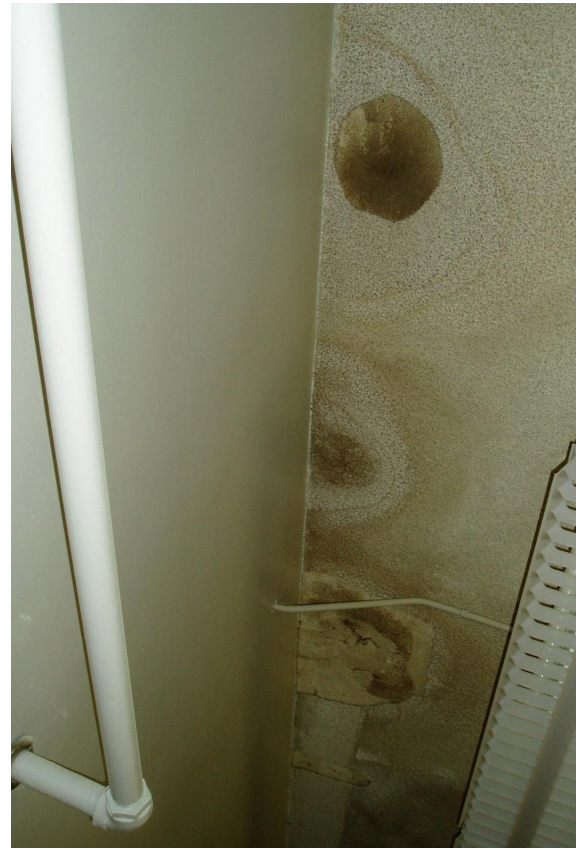
1957: BUR is rippled and bubbled in numerous locations throughout and there are several locations of roof leaks as evidenced by staining on the interior textured (contaminated) ceiling finish. Cap flashings are painted and are peeling.

1965: At link to 1957 addition, the painted metal flashing doesn't cover the top (cap) of the precast panels and leakage to interior has occurred.

Replace roof with a 2 ply modified roof and install new prefinished metal flashings

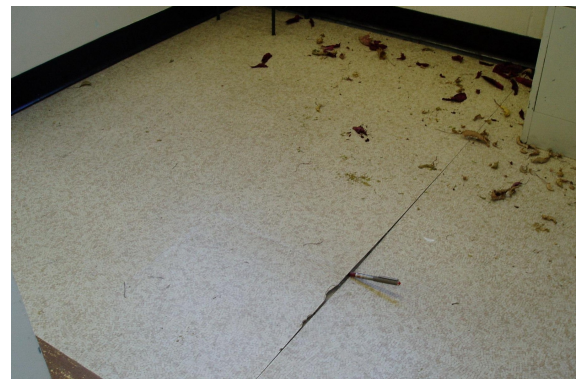
Sheet flooring in music room is delaminating and is damaged at mezzanine.

Replace flooring with new sheet goods.

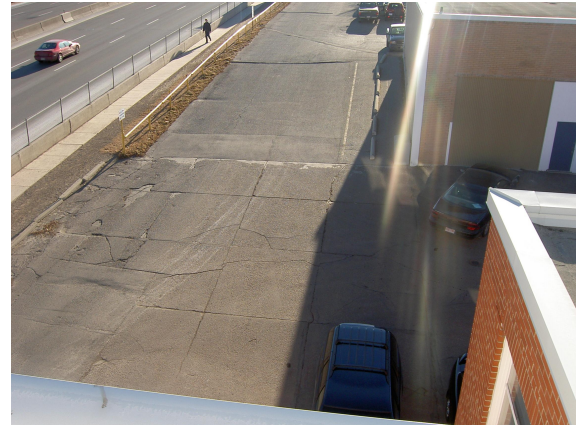
The roadway along the east side of the building is rough, cracked, crumbling and heaved in several locations.

Repair the east roadway as required.

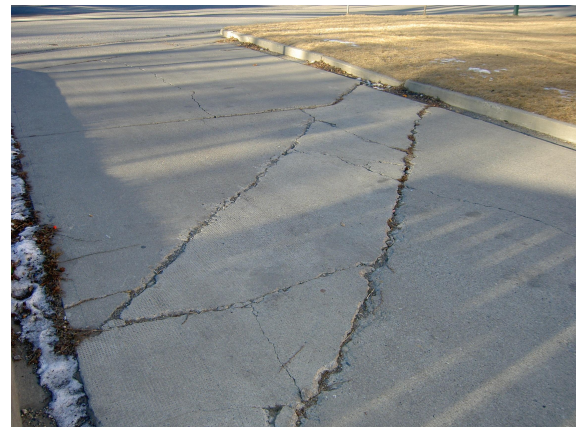
The west concrete roadway is cracked.

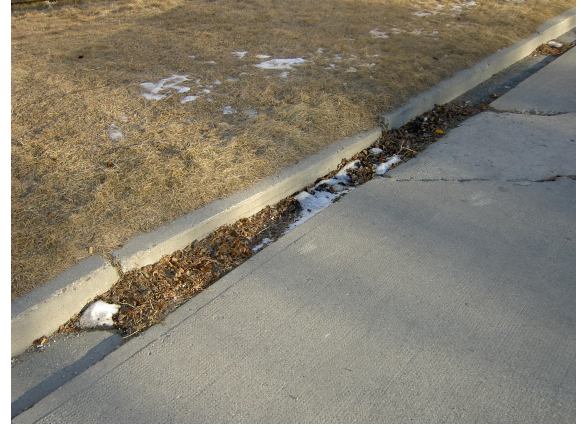
Curbs are damaged and failing in several locations

Replace damaged/failed concrete curbs

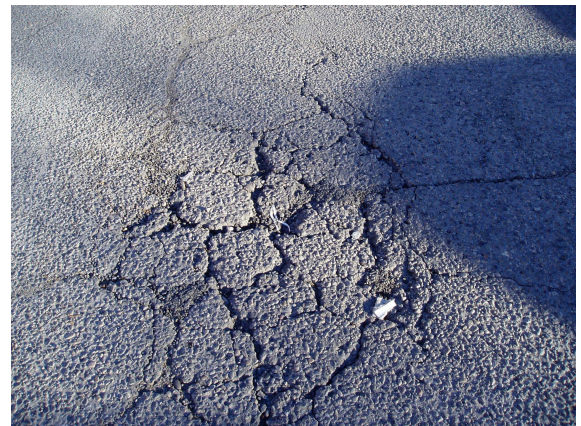
The lower south parking lot is cracked, crumbling and rough.

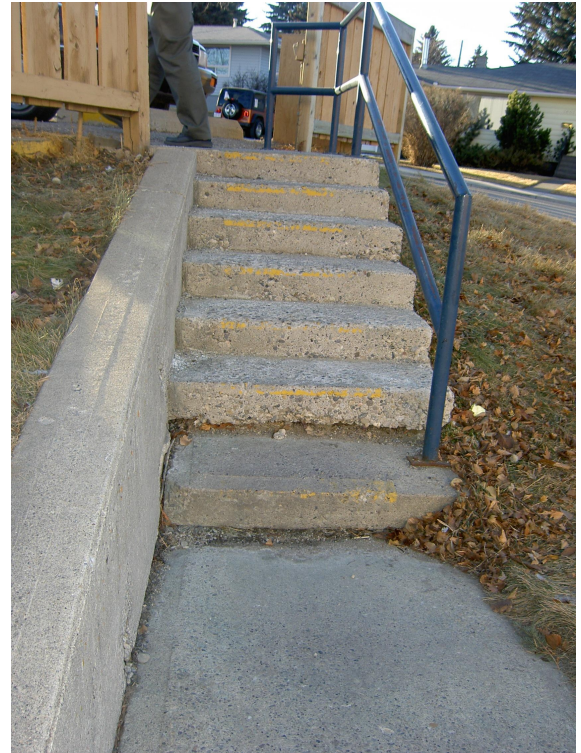
The west steps are chipped, spalling, cracked and sunken

Replace the concrete steps and reinstall the handrail

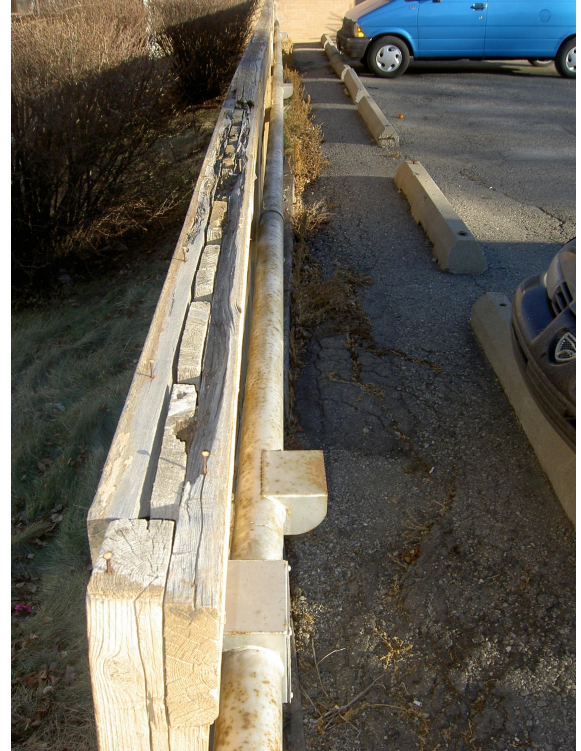
**Event:** Replace the painted wood fence at the staff parking lot

Replace the wood fence with a chainlink fence and reattach the car plug-in receptacles
