RECAPP Facility Evaluation Report

Wellington Junior High School

B3357A
Edmonton

Evaluation Company: Lotus Architecture
Evaluation Date: December 1 2004
Evaluator Name: Mr. Tonu Mitra

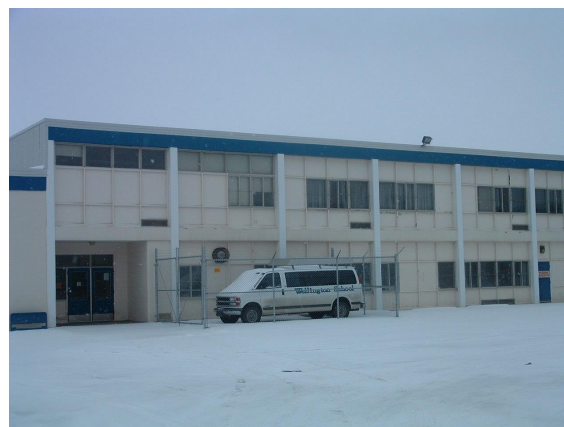
Exterior east and west walls of the west wing are infill walls (between concrete beams and columns), made of 38 x 89 mm wood studs with painted plywood and transite infill panels. No insulation provided. This is a sub-standard construction, unsafe and does not meet code requirements. Transite panels contain asbestos.

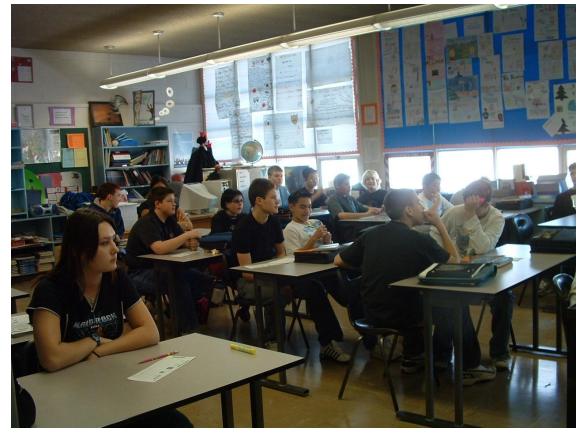
Existing original aluminum windows are poorly made and in very poor condition. Wood sections between aluminum frames are rotting due to condensation over the years. Most hopper sections do not operate. Windows have no insulating value and seal around openings are poor, allowing cold air infiltration, condensation and deterioration of wood sills. Upper portions of large windows on east wing are permanently blanked off by posters and sheets of paper to cut off direct sun and heat build up.

Replace all original windows with new thermally broken aluminum window sections, complete with hermetically sealed double glazing and awning sections. New windows on east and west wings should be only 1.2 m high. Upper portions of existing large window openings of east wing should be filled with light weight concrete block, or with stud wall assembly. Exterior envelope upgrading should be the same as recommended for all other walls - see B2010.02.03. East wing windows infill, complete with envelope upgrade: \$72,000.00.

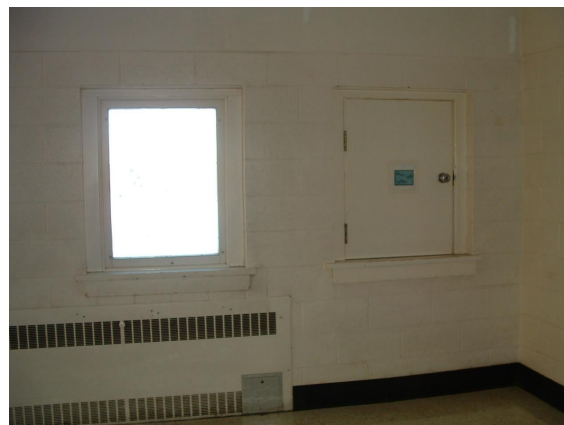
Existing utility doors are in poor condition. Paint and wood surfaces have deteriorated. Hardware is old and difficult to repair.

Plywood doors should be removed and replaced with new window sections. Access to lower roofs should be provided by means of outside ladders from higher roofs which have interior access (see B3010.09).

Replace existing utility doors and frames with new insulated steel doors and pressed steel frames, complete with new hardware.

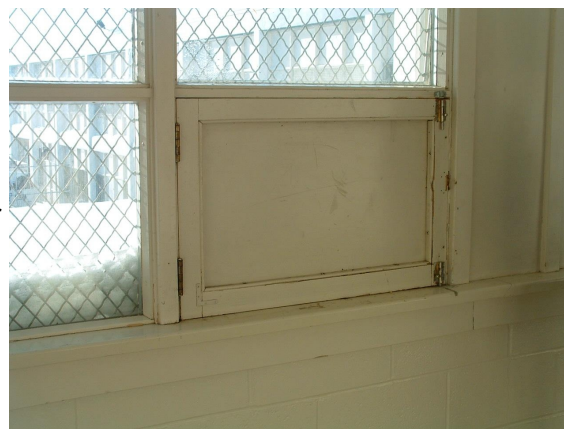
There are no ladders to safely access lower levels of roofs. Small openings (originally windows) on the second level provides access to the roof above Boiler Room and north lower roofs which are inadequate. Use of a temporary ladder is unsafe.

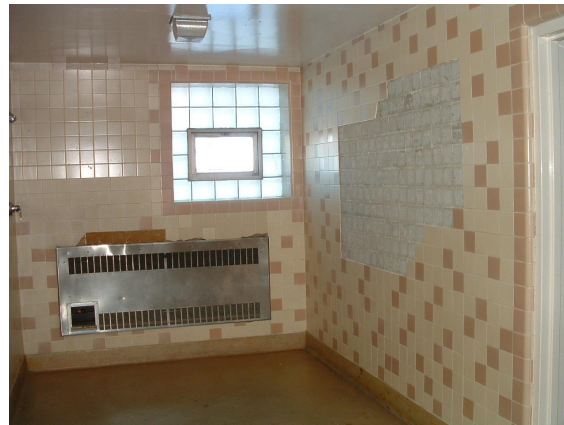
Tiles are old and dated. In some washrooms, cracks on walls are showing through wall tiles and tiles on exterior walls had fallen off due to condensation and cold surfaces. In repair areas, proper match with existing tiles is difficult. Tiles in Change Rooms have fallen and have not been replaced.

Except handicap washrooms, wall ceramic tiles should be replaced with new tiles in all washrooms as part of overall upgrading of washrooms.
