RECAPP Facility Evaluation Report

William D. Cuts School

B4087A

Evaluation Company: Holland Roth Architects
Evaluation Date: September 13 2005
Evaluator Name: Mr. David Roth

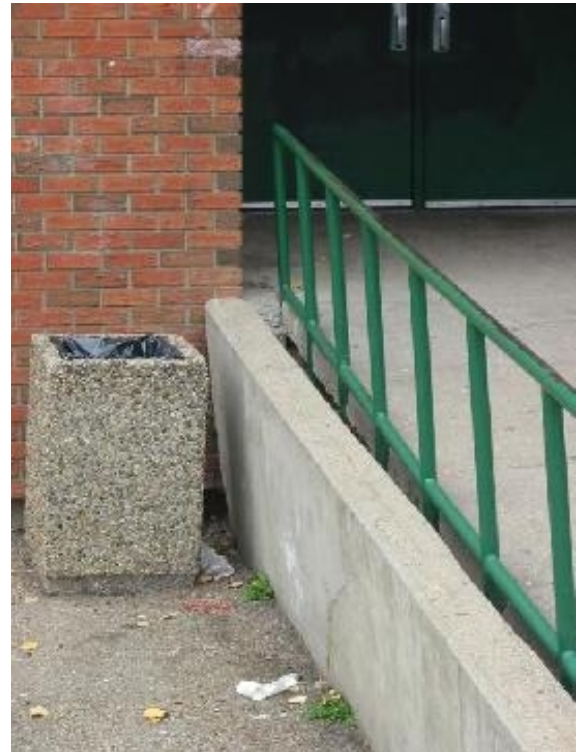
B1010.06 Ramps: Exterior**

Concrete ramp at East loading door.

<u>Rating</u>	<u>Installed</u>	<u>Design Life</u>	<u>Updated</u>
2 - Poor	0	40	SEP-05

Event: Retaining wall at East loading door has failed causing ramp to settle. Guardrail has rusted, been repaired and now is too low.

Concern:

Settlement/movement will continue to deteriorate ramp and retaining wall.

Replace wall, ramp and guardrail

<u>Type</u>	<u>Year</u>	<u>Cost</u>	<u>Priority</u>
Failure Replacement	2006	\$21,400	Medium

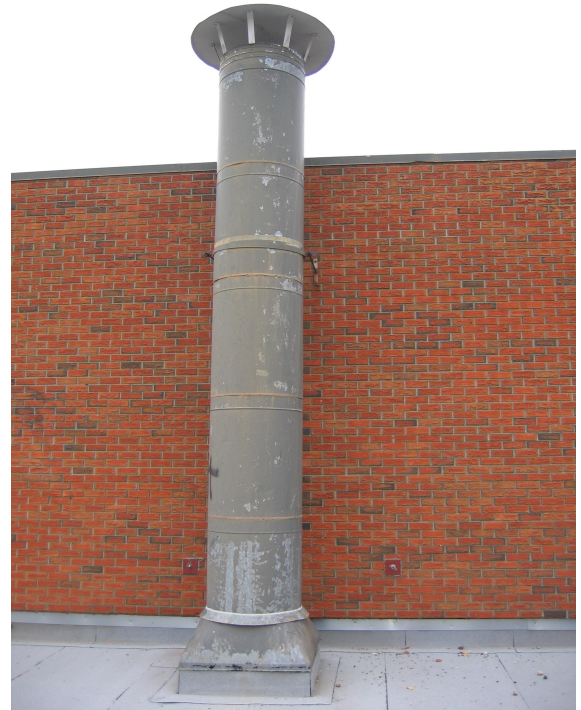
D3020.02.02 Chimneys (&Comb. Air): H.W. Boiler**

Boiler breeching and chimneys. Combustion air provided into Mechanical Room.

<u>Rating</u>	<u>Installed</u>	<u>Design Life</u>	<u>Updated</u>
3 - Marginal	0	30	SEP-05

Event: Replace boiler chimney.

Indication of rust on boiler chimney.

Replace boiler chimney.

<u>Type</u>	<u>Year</u>	<u>Cost</u>	<u>Priority</u>
Failure Replacement	2007	\$8,025	Low
