# RECAPP Facility Evaluation Report

## Winterburn Elementary / Junior High School

B3367A  
Edmonton

**Evaluation Company:** Koliger Schmidt  
**Evaluation Date:** December 1 2004  
**Evaluator Name:** Mr. Mario Macchione

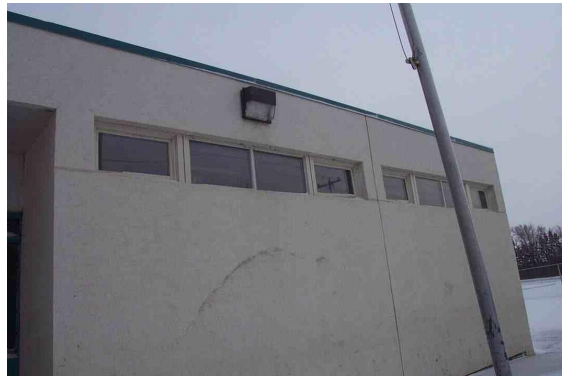
**Event:** Repair damaged walls.**Concern:**

Exterior stucco is damaged and stained in some areas.

Repair and clean areas of large staining.

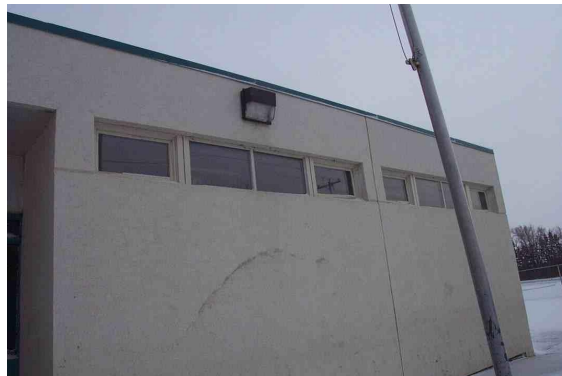
**Event: Replace wood windows.**

Replace wood windows in mechanical room, custodian office, gym storage, boys and girls washrooms. (7 double windows and 3 single windows)

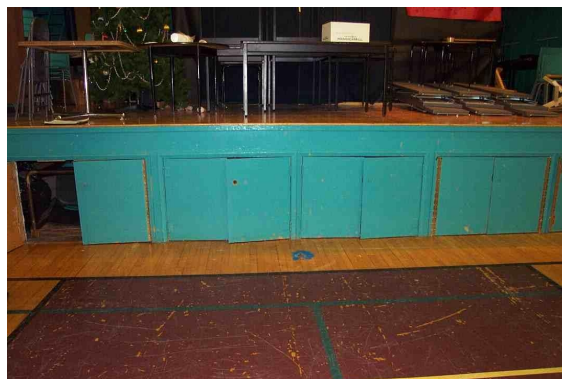
**Event:** **Replace storage doors.**

Chair storage under stage has doors don't close, are missing hardware, broken wood and hinges that cannot hold up to wear and tear.

Replace doors with appropriate closing hardware and hinges.

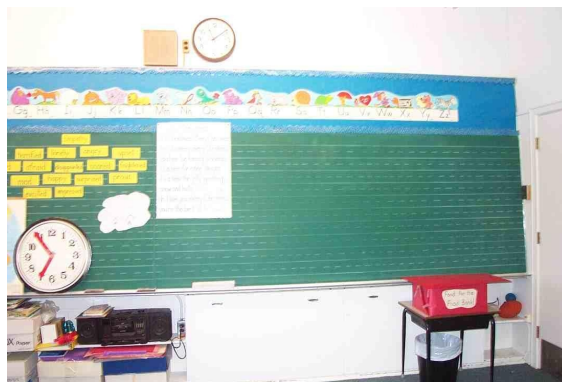
**Event:** **Replace chalkboards with whiteboards.**

Some children are allergic to chalk and also causes a mess with chalk residue on floors and walls.

Replace 7 chalkboards with whiteboards. Repair walls as needed.

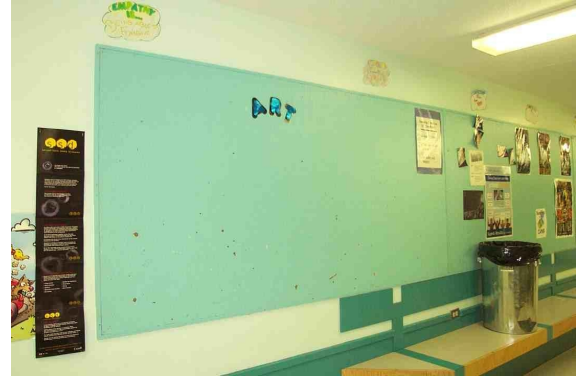
**Event: Replace tackboards**

Replace all tackboards that have been painted in hallway and in some classrooms. (10 boards)

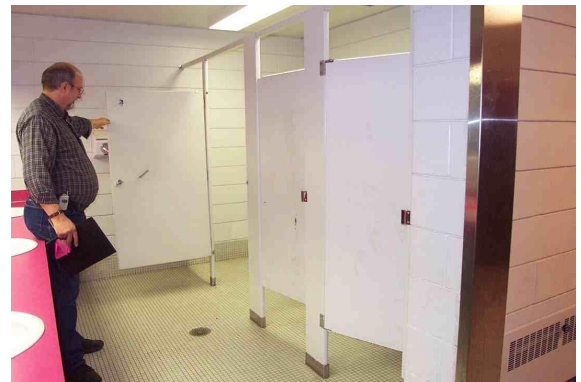
**Event: Replace partitions**

Replace all boys and girls partitions. Match girls partitions to newer burgundy ones. (2 regular stalls and 2 handicapped stalls)

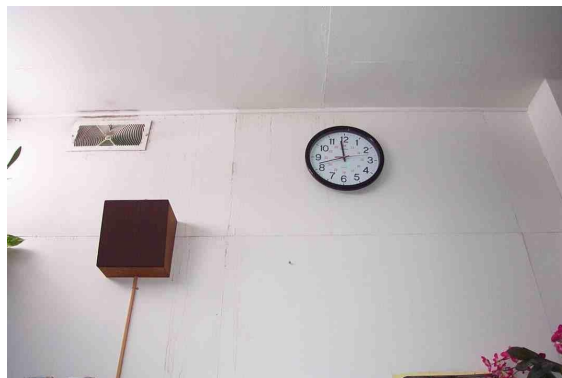
**Event: Custodians office plywood paneling requires replacement.**

**Concern:**  
Painted plywood paneling has extensive water damage.

**Recommendation:**  
Remove all plywood paneling and install drywall. Paint.

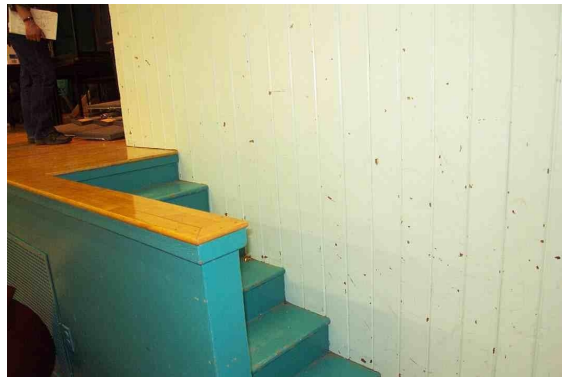
**Event: Stage wood paneling needs to be repainted.**

**Concern:**  
Paneling paint is chipped and worn.

**Recommendation:**  
Sand down and repaint wood.

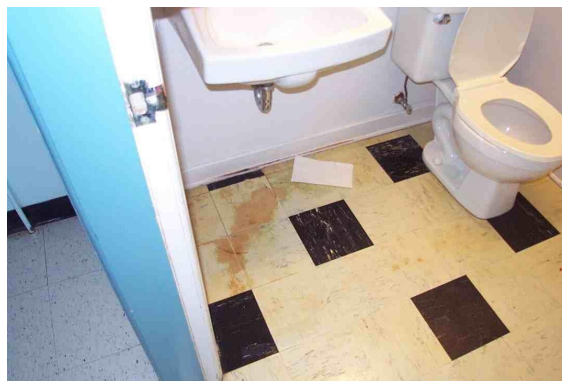
**Event:** **1957 building- Replace washroom tile flooring**

Tile flooring in womens staff washroom are old worn down tiles.

Replace 9x9 tiles with VCT tiles. See F2020.01

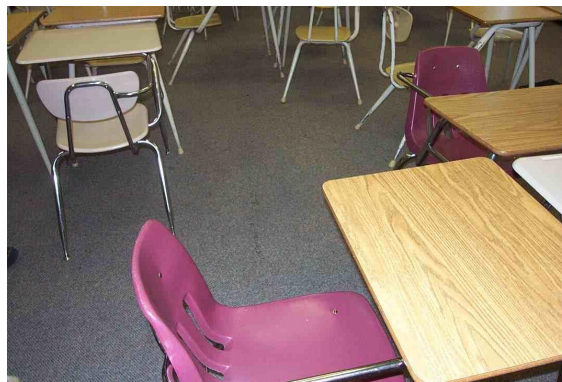
**Event: Replace carpet**

Carpet in classrooms ECS 117, sections of library 126, classrooms 139 and 136 are torn, stained, worn down and in some sections loose and rippled causing tripping hazard.

Replace carpet in these areas of the school. (approx. 320m<sup>2</sup>)

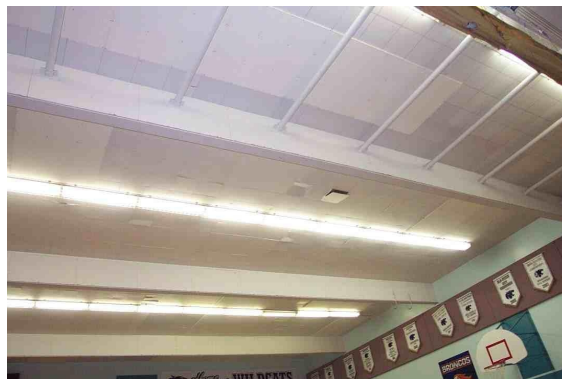
**Event: Replace ceiling finish**

Ceiling tiles are loose and falling.

Remove ceiling tiles and replace with suspended acoustical panels.

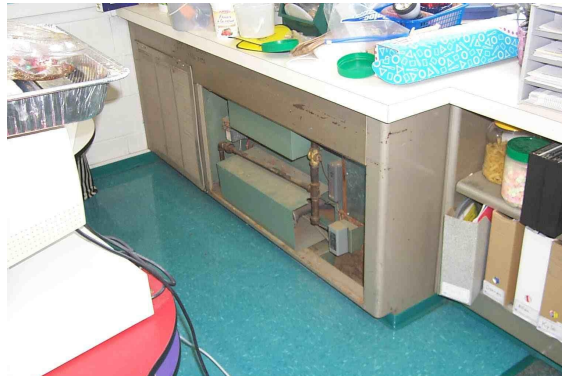
**Event: Replace furnaces with air handling unit in 1957/1959 classrooms.**

The furnaces for the classrooms are not providing sufficient fresh air for the classrooms. They are also old, showing signs of wear, and inefficient.

Remove the existing furnaces in the 1957/1959 classrooms and install a central roof top unit with ductwork run to each classroom. (\$60,000)

Also install perimeter ceiling radiant heating system with new boilers and circulating pumps. Boilers should be sized to supplement heat for new gym air handling unit (\$60,000)

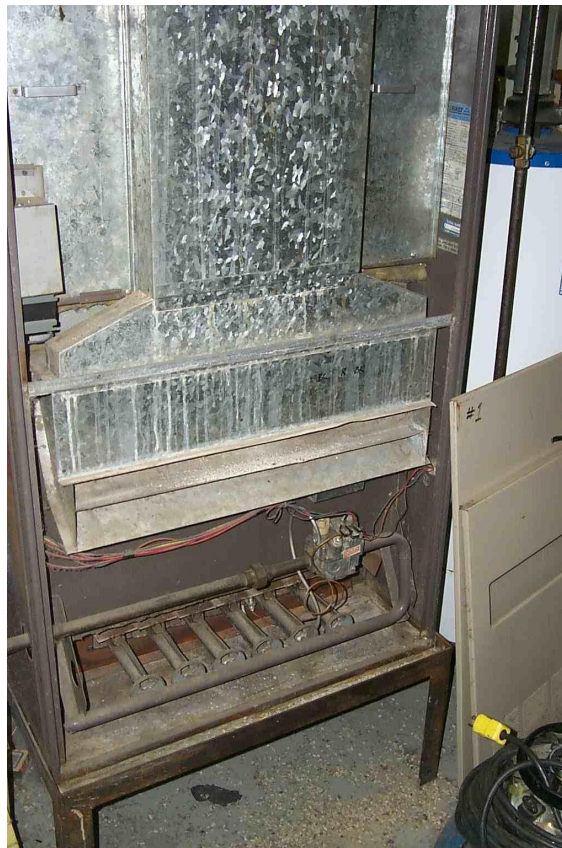
**Event: Replace gym and hallway furnaces with air handling unit**

Furnaces for gym and hallway are obsolete and showing signs of wear. Furnace not supplying sufficient fresh air.

Install air handling unit with hot water coil and economiser section to replace furnaces. Improve ductwork and diffusion in gym. Add perimeter fin heating to gym for non-occupied heating.

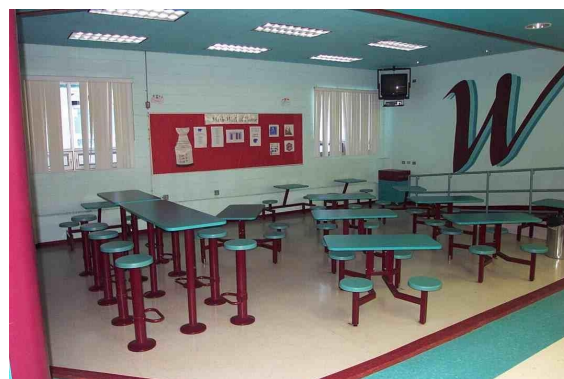
**Event: Replace blinds**

Blinds are broken and missing from high traffic areas.

Replace blinds in student lunch area (2 windows) and in bootroom in 1957 building (1 window) with roll down blinds. Make sure blind cords are fastened safely to wall to prevent strangulation.

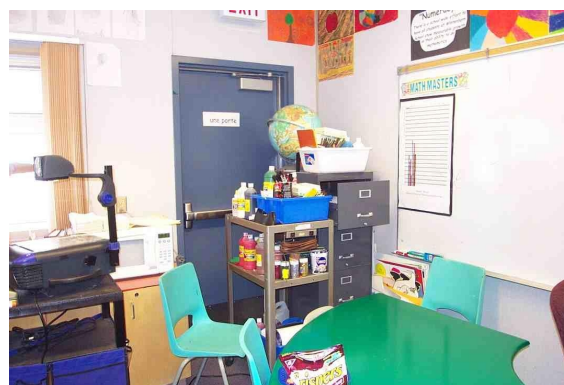
**Event: Repair fire door.**

Remove items blocking fire path and repair door.

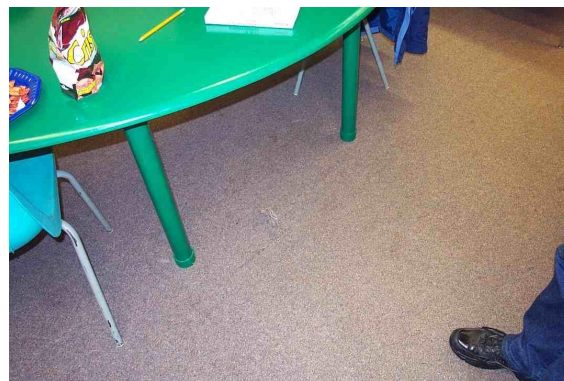
**Event: Replace carpet**

Carpet is fraying and not pulled tight enough so it has bunched up in areas causing tripping hazards.

Replace carpet. (84m<sup>2</sup>)

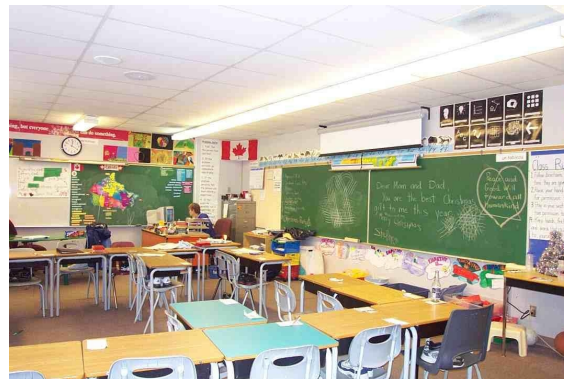
**Event: Replace chalkboards with whiteboards.**

Some children are allergic to chalk and also causes a mess with chalk residue on floors and walls.

Replace 3 chalkboards with whiteboards.

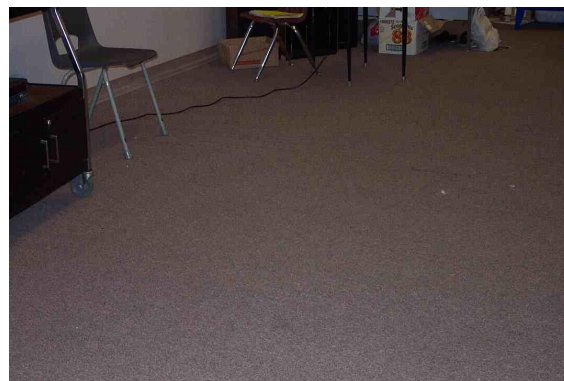
**Event: Replace carpet**

Carpet is stained and has frayed.

Replace carpet. (84m<sup>2</sup>)

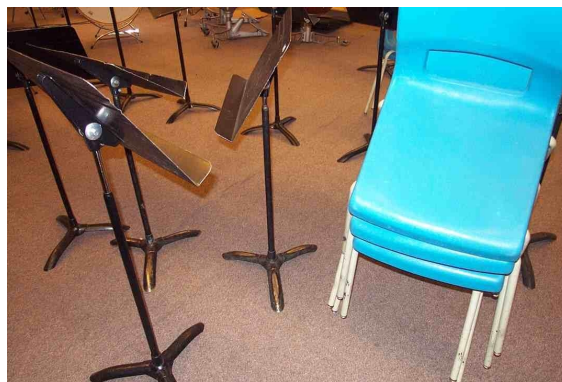
**Event: Replace carpet**

Carpet is fraying and stretched so now it has bunched up in areas causing tripping hazards.

Replace carpet. (84m<sup>2</sup>)
