RECAPP Facility Evaluation Report

Woodcroft Elementary School

B3368A
Edmonton

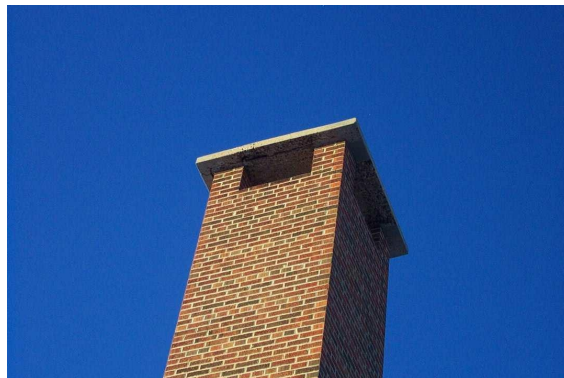
Chimney stack brick is displaying signs of deteriorating. Movement cracks are visible in wall clad with brick veneer.

Repair Chimney stack and masonry work. Repair and repoint masonry movement cracks at front entrance.

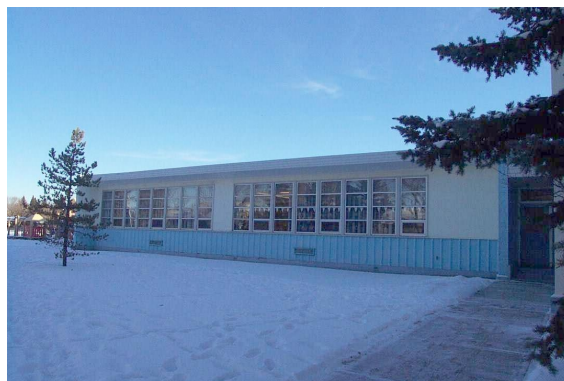
Classroom wings and library wall have in areas corrugated cement asbestos panels (lower wall), and painted plywood clad exterior facade above. Other wall facades are only painted plywood - which have deteriorated and in areas displays evidence of wood rot.

Exterior facade (1650m2) should be completely upgraded including increase of wall RSI value. Incorporate control joints and expansion joints as required. It is recommended that a hard smooth surfaced material is used at the tarmac area that will resist impact forces.

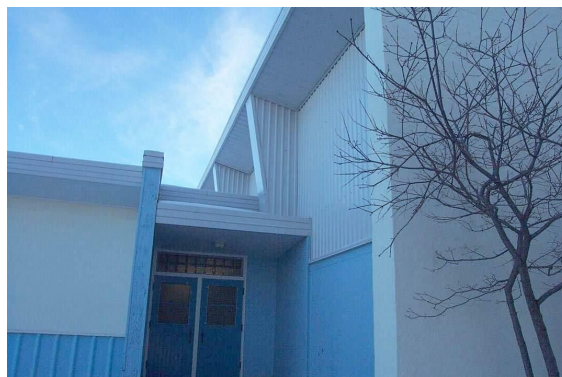
Stucco Facade has a number of horizontal cracks - all faces of building. A number of corrugated cement asbestos boards which clad the lower portion and various upper sections of the Gym are cracked.

Exterior facade (1100m2) should be completely upgraded, include increase of wall RSI value. Incorporate control joints and expansion joints as required.

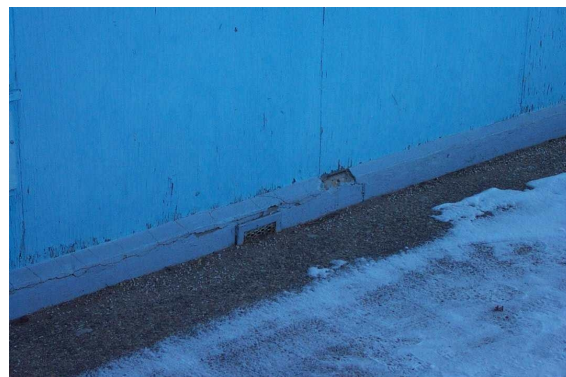
Exterior paint finish is flaking in areas. Crawlspace ventilation grilles are semi-buried. Attic ventilation is to be modified to suit new cladding recommended.

Upgrade vapour barrier as required. Make appropriate modifications to crawlspace ventilation. Incorporate required attic ventilation.

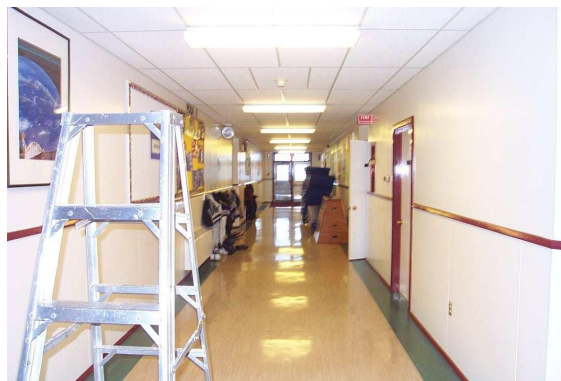
A cement asbestos board wainscot is detailed to lower portion of hallway walls. This cladding is damaged at a number of locations.

Remove all (2,210m2 footprint) pressed fibreboard wall cladding and all cement asbestos material. Upgrade all interior wall claddings to comply with current standards and codes.

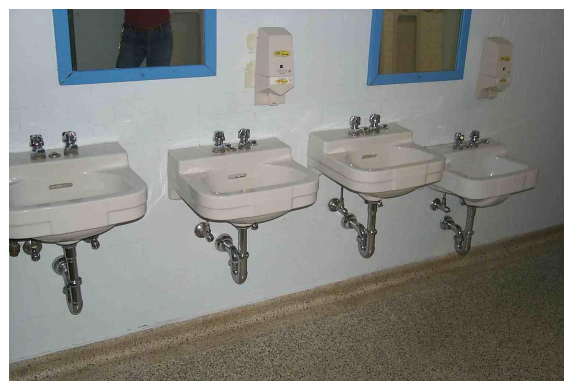
Lavatories with separate hot and cold taps represent a scalding hazard.

Install 12 new stainless steel lavatories with mixing tees in new millwork counters.

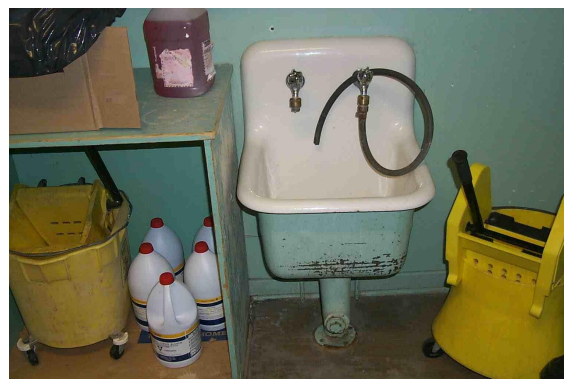
Stainless steel sinks with swing spouts in classrooms and in staffroom. Some sinks have fountain bubblers on them. Two elevated enameled steel sinks in janitor closets with separate hot/cold taps and add-on vacuum breakers.

Replace 3 janitor sinks with floor mounted versions and new mixing tee with vacuum breaker.

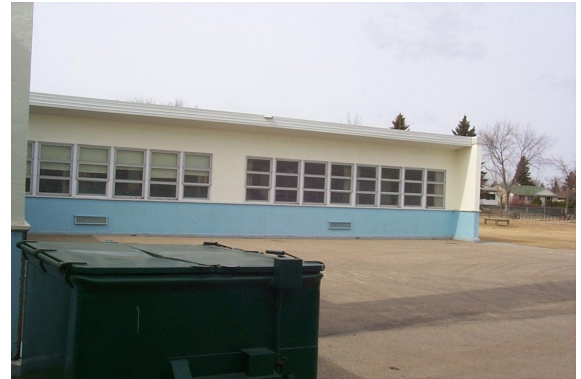
Combined parking/play area. Tarmac is in poor condition. Storm water drains toward building

Consider locating a parking area to the northwest side of building. Provide adequate barriers separating the play area from vehicular parking. Install electrical service (20 staff 800m2 asphalt pavement), catch basins and storm drainage piping as required. Repair paved play area (200m2).

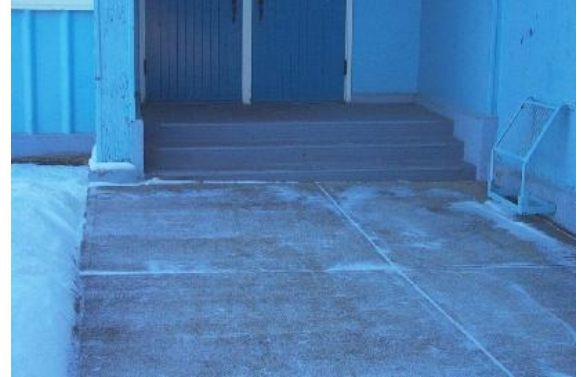
Sidewalks have moved creating tripping conditions. At a number of locations walkways slopes towards building.

Mudjack sidewalks to provide drainage away from building. Replace walkways as required to eliminate tripping hazards
