RECAPP Facility Evaluation Report

Edmonton School District No. 7

Dan Knott Junior High School

B3086A
Edmonton

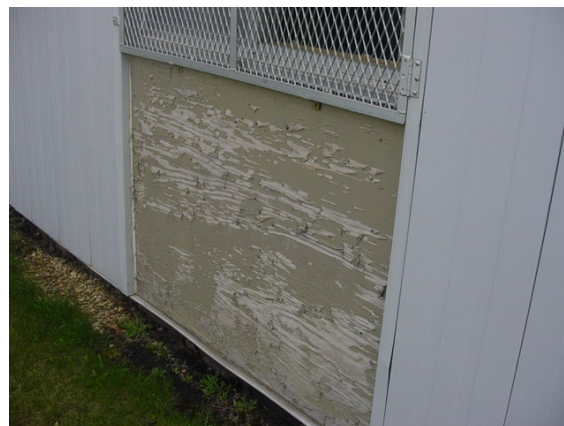
Event: Replace Wood Siding

The wood panels are rotted and water has penetrated the exterior wall assembly. Currently one of the classrooms in the Pod addition at the south end of the school is being renovated due to evidence of mould based on an earlier study conducted in 2003. A budget is being provided for potential repairs to the remaining exterior walls on the 1982 Pod additions.

Recommendation:

Replace and repair all exterior walls in the 1982 Pod additions as per the repairs conducted in classroom 102 - South Pod addition. (an estimate of \$10,000/per exterior wall with windows is recommended).

<u>Type</u>	<u>Year</u>	<u>Cost</u>	<u>Priority</u>
Failure Replacement	2007	\$86,100	High

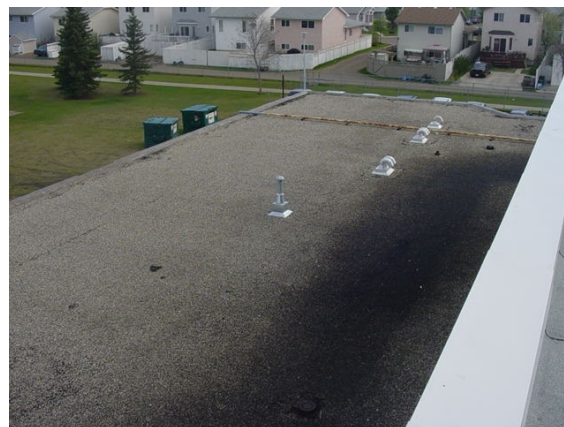
Event: Replace roof**Concern:**

Several blister and moss growth was observed on the original built up roof assembly. Excessive ponding was evident.

Recommendation:

Replace built-up roof above the original 1980 building

<u>Type</u>	<u>Year</u>	<u>Cost</u>	<u>Priority</u>
Failure Replacement	2008	\$184,500	Medium

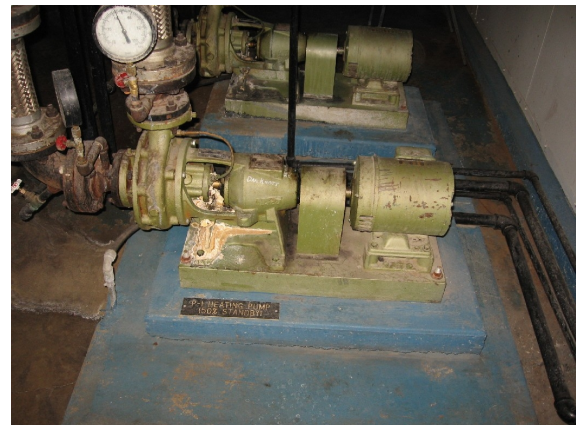
Event: Replace pump #1 to 4**Concern:**

Original hot water pumps #1 to 4 require frequent maintenance and repairs to keep the equipment in operation.

Recommendation:

Replace original hot water pumps with new.

<u>Type</u>	<u>Year</u>	<u>Cost</u>	<u>Priority</u>
Failure Replacement	2008	\$24,600	Low

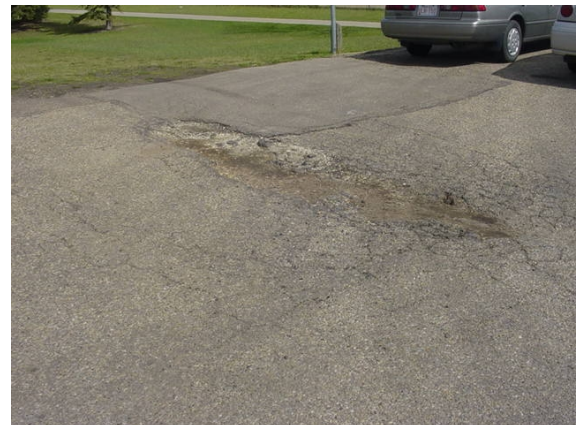
Event: Repair damaged surfaces

Recommendation:

Repair all damaged asphalt paved surfaces.

<u>Type</u>	<u>Year</u>	<u>Cost</u>	<u>Priority</u>
Repair	2007	\$6,150	Low
