# RECAPP Facility Evaluation Report

**Earl Buxton Elementary School**

B3095A  
Edmonton

**Evaluation Company:** Francis Ng Architect Ltd.  
**Evaluation Date:** June 1 2006  
**Evaluator Name:** Francis Ng

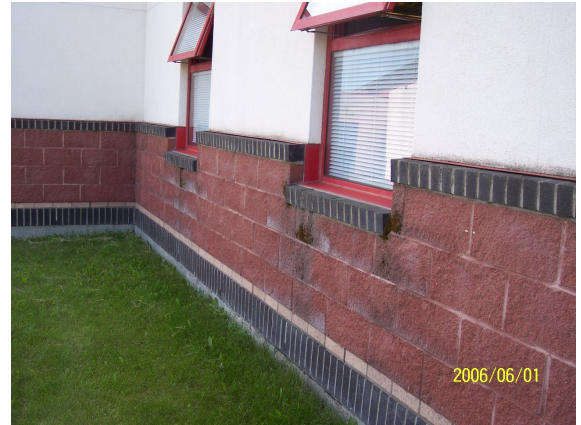
**Event: Replace facing bricks.****Concern:**

(1990) West Side - (Classrooms 122, 123) have facing bricks / concrete blocks are damaged by water and window washing materials and have moss.

Replace facing bricks (approximately 50m2)

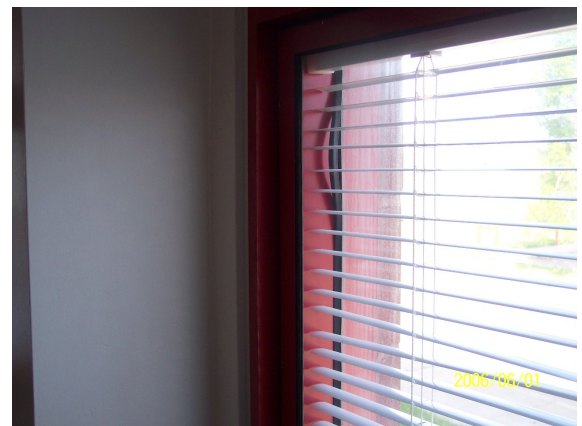
**Event: Replace window panes.**

East Learning Studio Clerestorey has broken panes.  
 Classroom 132 has broken panes.  
 Some windows have worn out gaskets.

Replace window panes. (approx. 5 panes)

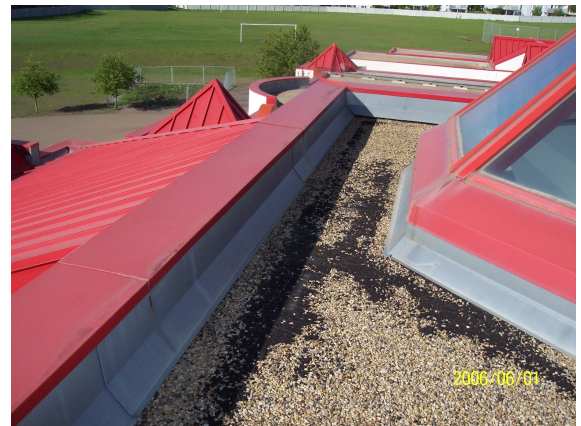
**Event: Repair built-up roofing.**

Built-up roofing has blisters, exposed area.

Repair built-up roofing.

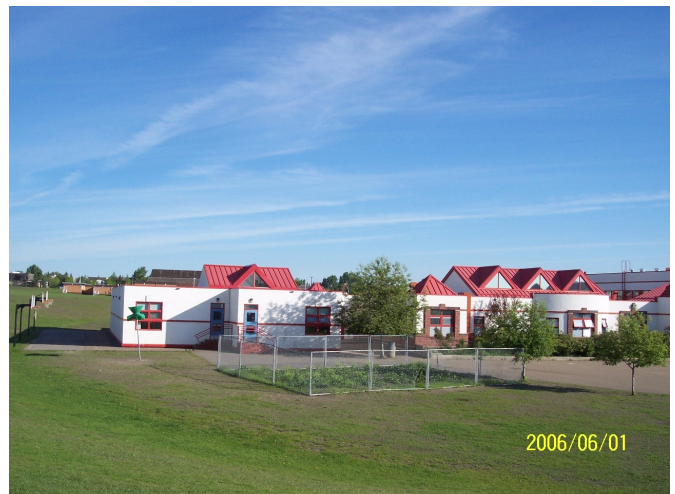
Exterior stair - wood c/w metal pipe handrails.

<u>Rating</u>	<u>Installed</u>	<u>Design Life</u>	<u>Updated</u>
3 - Marginal	1992	30	JAN-07

Replace exterior wood stairs, 8 stairs.

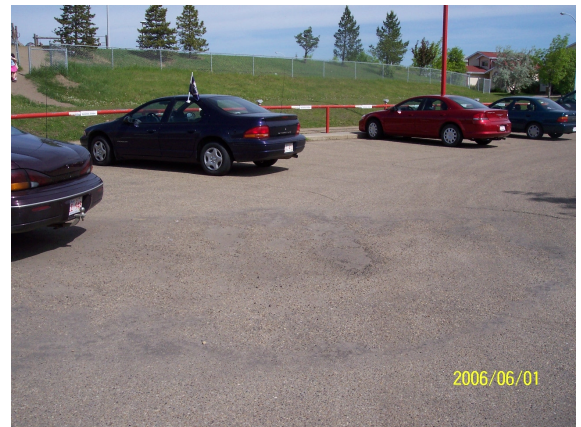
Parking lot has cracks.

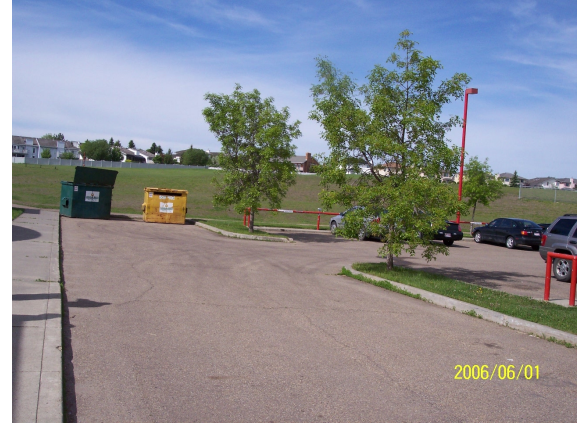
**Event:** Replace concrete curbs.

Replace concrete curbs. (approx. 60 metres)

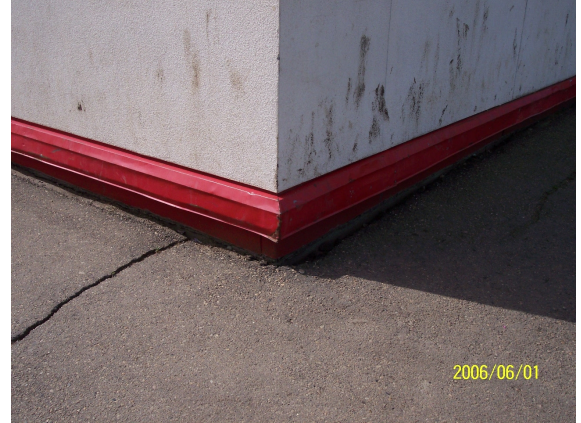
Southwest Portables - cracked asphalt sidewalk.

Repair asphalt paving.
