# **RECAPP Facility Evaluation Report**

**Edmonton School District No. 7**

## **J. Percy Page Composite High School**

B3167A  
Edmonton

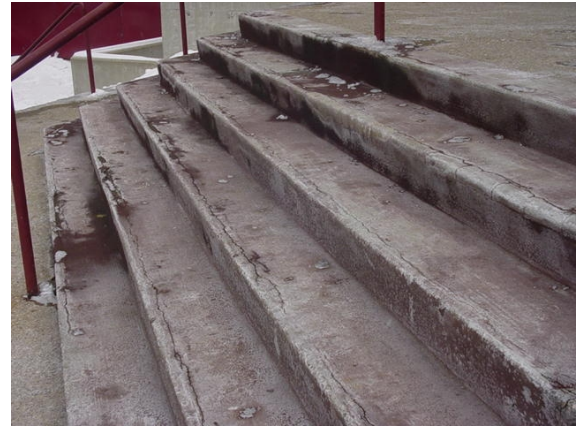
Several of the cast-in-place concrete stairs are cracked and damaged.

**Event:** Replace all deteriorated concrete stairs and curbs.

Replace all deteriorated concrete stairs and curbs.

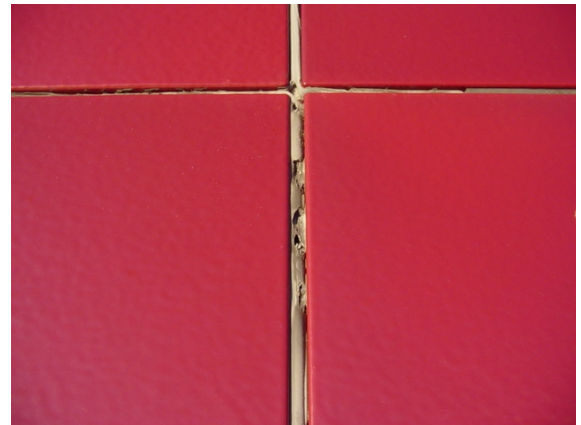
The sealant between the panels is brittle and missing in several areas.

**Event: Replace sealant on exterior cladding****Concern:**

Remove and replace building sealant between exterior panels.

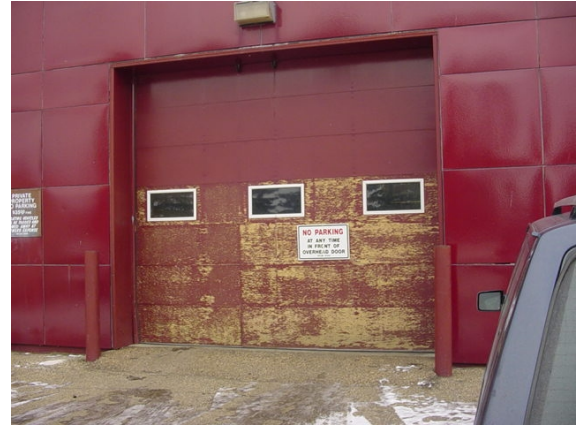
The paint finish on the overhead doors has faded and deteriorated.

**Event: Repair & repaint overhead doors****Concern:**

Repair and repaint 3 overhead doors.

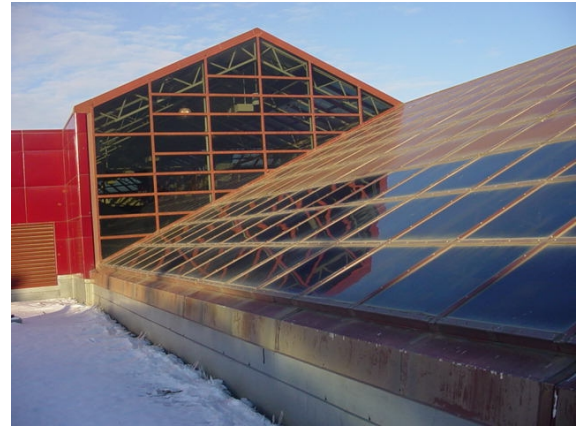
Water is entering the school in several locations throughout the atrium, however more apparent at the east end of the atrium. Water appears to be entering where the glazed panels intersect the metal panel frame. The sealant appears deteriorated from the outside face of the glazed panels. The rubber joints between the sloped glazing is also deteriorated, this was observed from the roof level. Water is also behind the metal flashing at the intersection of the roof and parapet assembly.

**Event:** Determine the extent of damage from the entire atrium assembly.

Conduct a study to determine the extent of the scope of work and cost of replacement.

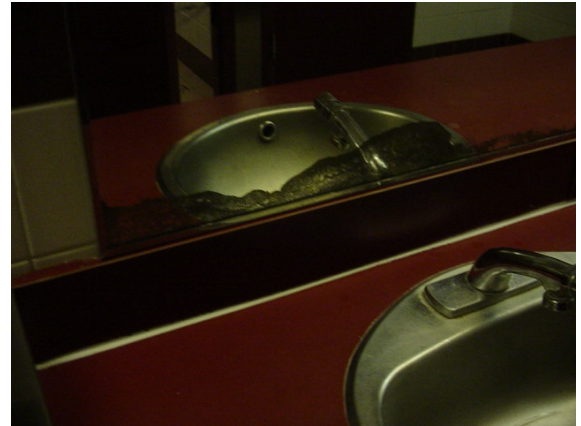
Overall, the washroom accessories are damaged, worn and in some cases non-functional.

**Event: Replace all original washroom accessories****Concern:**

Replace all damaged and missing washroom accessories.

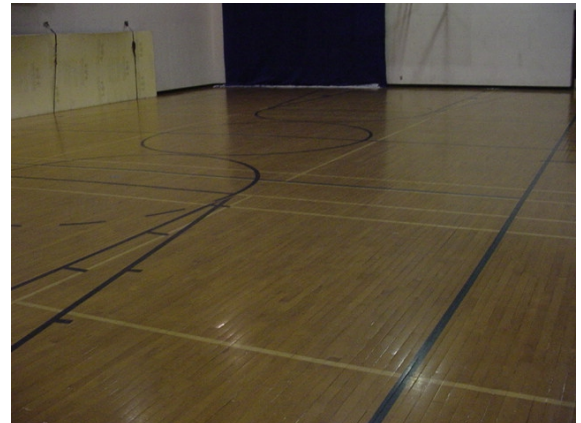
The hardwood floor in the single gym has several warped strips and the finish is deteriorated.

**Event: Repair & refinish the single gym****Concern:**

Replace warped flooring strips and refinish floor.

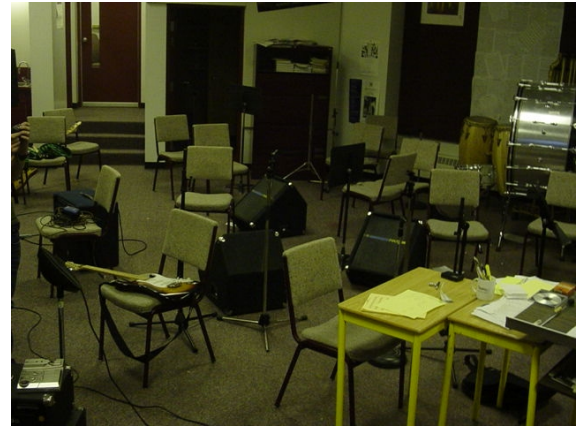
The original carpet in the library and music room is worn, damaged and stained.

#### **Event: Replace carpeting in library and music room**

Replace carpeting in the music room and library.

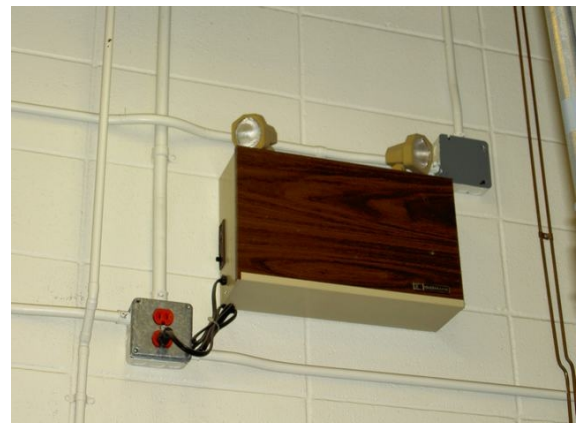
Potential problems should the emergency generator fail to start.

**Event: Replace emergency lighting unit****Concern:**

Replace emergency lighting battery unit.

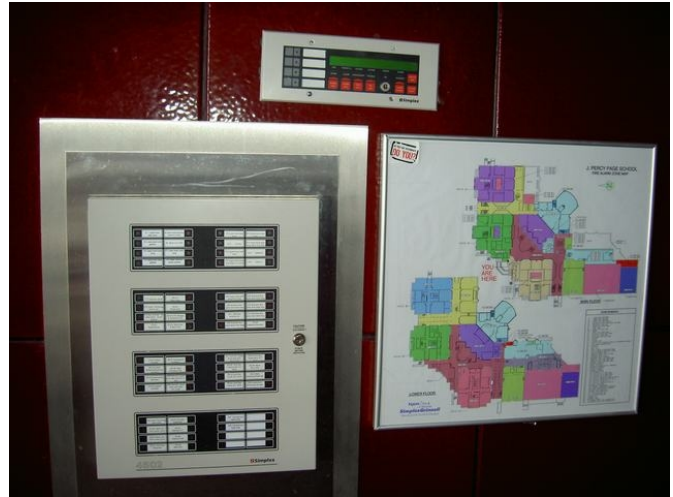
The remote annunciator is used by fire fighters to locate area in alarm. The annunciator must be operational.

**Event: Repair fire alarm system remote annunciator****Concern:**

Repair the remote annunciator immediately.

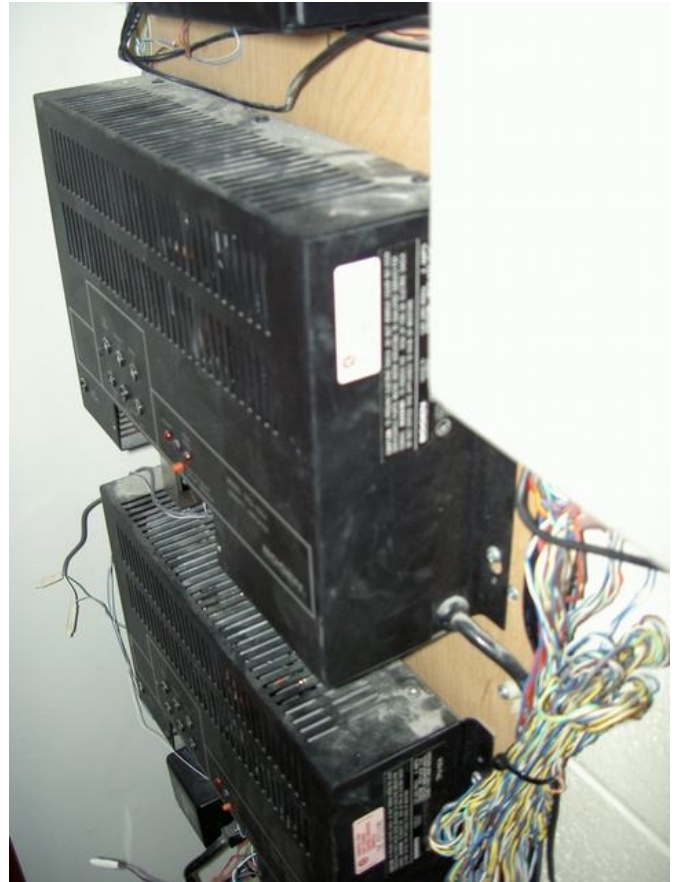
Inaudible announcements.

**Event: Upgrade P.A. System****Concern:**

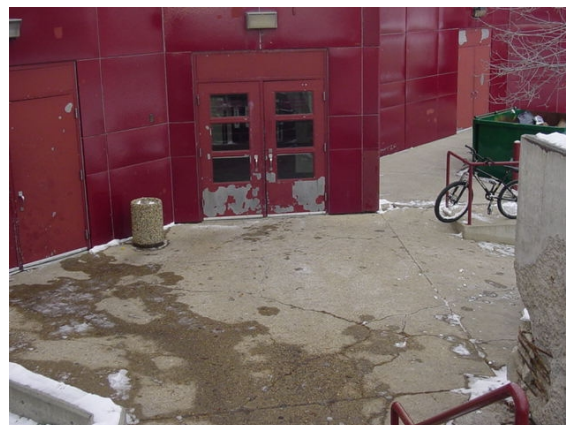
Several portions of the concrete walkways have settled and cracked.

**Event: Replace all cracked concrete walkways.****Concern:**

Replace all concrete walkways that pose a potential tripping hazard.

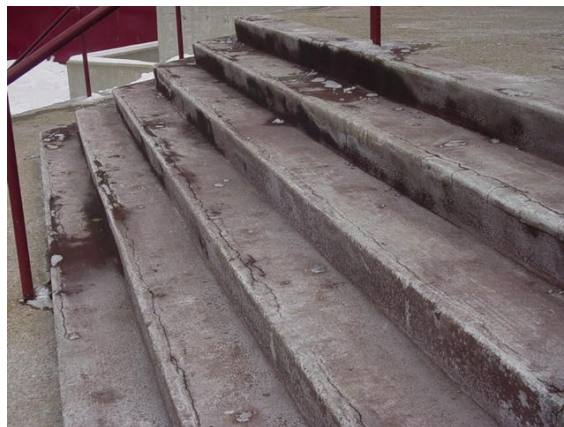
Several of the cast in place concrete stairs are cracked and damaged.

**Event: Replace all damage concrete stairs****Concern:**

Replace all deteriorated concrete stairs and curbs.
