RECAPP Facility Evaluation Report

RAH - Anderson Hall

B1029R
Edmonton

Evaluation Company: Bacz Engineering Ltd.
Evaluation Date: November 19 2013
Evaluator Name: Eric Lumley

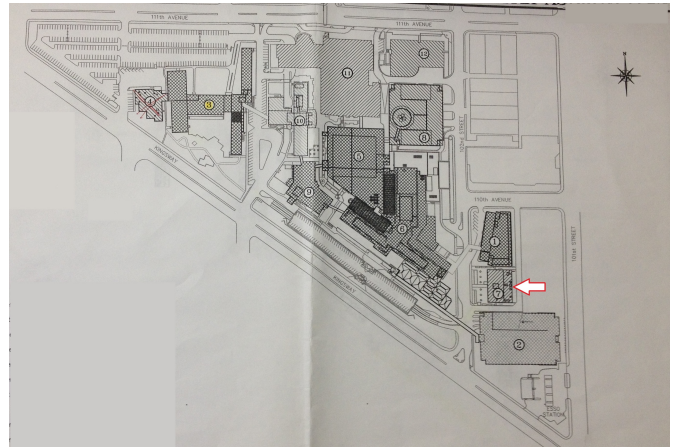
B1029R - site.jpg

The facility is eight storey high with offices and support services on the first and second levels. There is an underground parking level and a partial parking level at grade. The upper levels have living units, some of which are used as overnight accommodation for medical personnel.
