# **RECAPP Facility Evaluation Report**

**Alberta Health Services**

**Walter C. MacKenzie Health Sciences Centre**

B6631A  
Edmonton

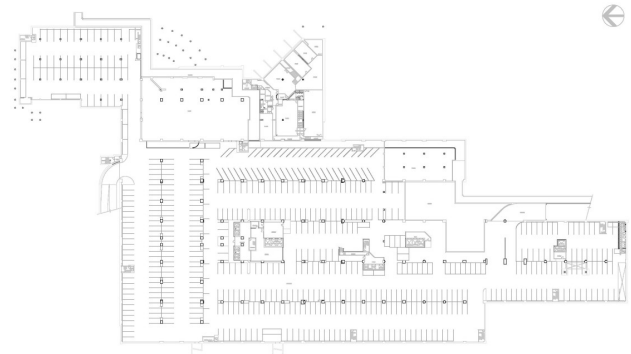
Floor plan of lower basement.
