## Asset Assessment Report

### Thickwood Public Health Building B6658A

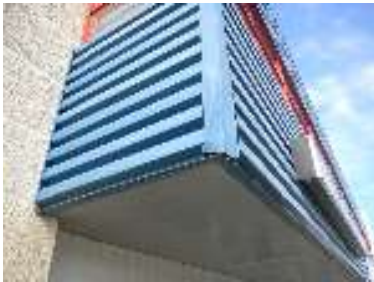
<b>Description</b>	Metal siding is faded and damaged in areas.
<b>ACL Level:</b>	ACL 2 - Check List
<b>Element Condition:</b>	3 - Marginal
<b><u>Assessment Criteria</u></b>	<b><u>Existence</u></b>
<b>Corrosion or rot</b>	
Existence	No
<b>Inconsistent surface finish</b>	
Existence	Yes
<b>Visible deformation/ loose sections</b>	
Existence	Yes
<b>Significant staining</b>	
Existence	No

Metal siding is faded and damaged in areas.

Replace metal siding.

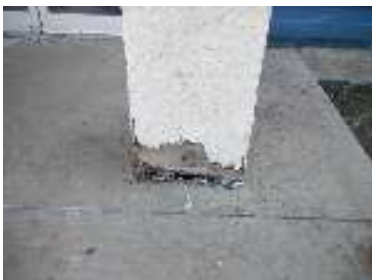
Stucco finish has failed at ground elevation exposing interior support structure.

Remove and replace stucco finish on entire column section.

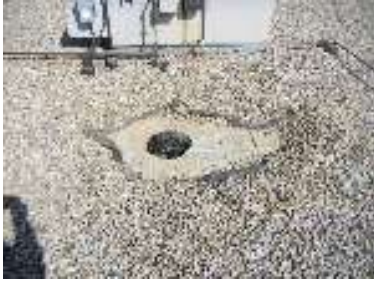
Leaks are apparent inside the building. Large sections of gravel cover missing.

Replace roof system.

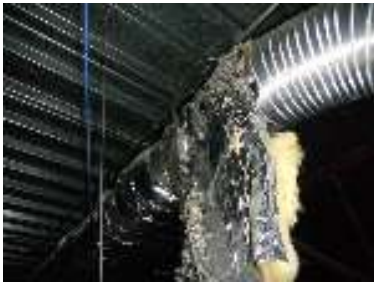
Insulation is loose and disconnected from ducting. Duct is not properly insulated decreasing efficiency of the ventilation system.

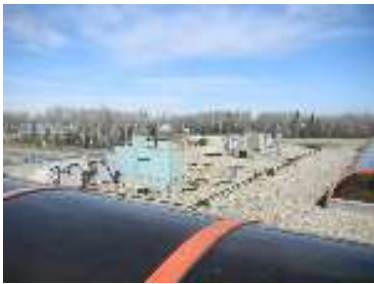
**Dirty or corroded**  
Existence Yes

**Unreliable (ask operator)**  
Existence Yes

Replace roof top units (16)
