RECAPP Facility Evaluation Report

Grasslands Regional Div #6

Central Elementary School

Brooks

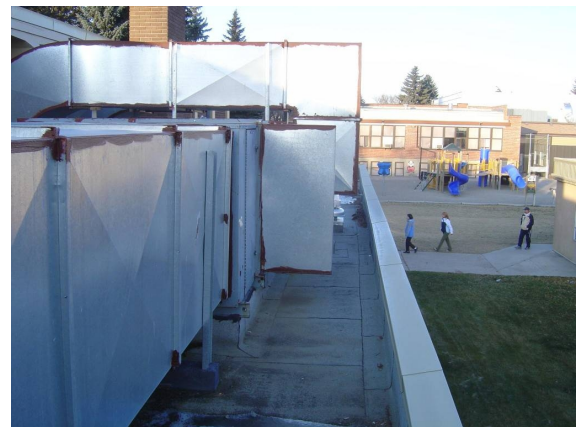
Service limitations at roof parapet for AHU-4.

Recommendation:

<u>Type</u>	<u>Year</u>	<u>Cost</u>	<u>Priority</u>
Code Upgrade	2012	\$5,000	High
