# RECAPP Facility Evaluation Report

## Calgary School District #19

### **Annie Foote Elementary School**

**Evaluation Company:** Williams Engineering Canada Inc.  
**Evaluation Date:** September 19 2012  
**Evaluator Name:** WEC - Jennifer Lavier Jankovic

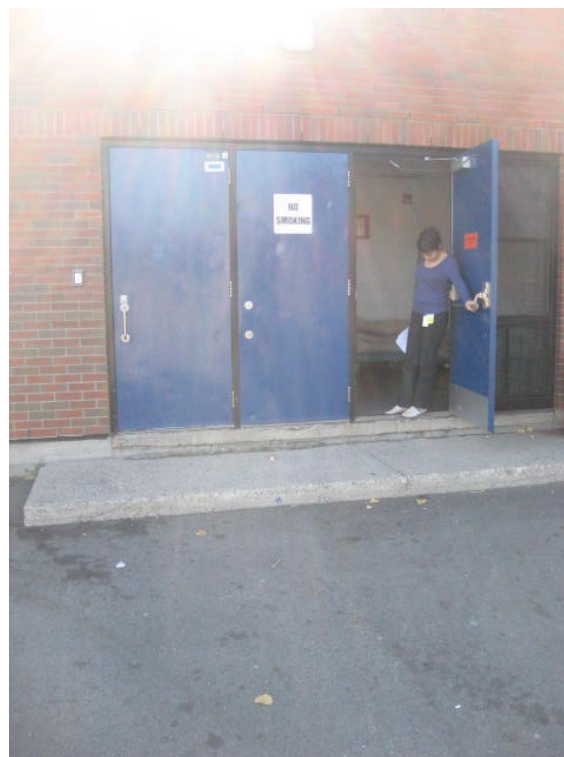
Northwest doors have step at entry. By Code 3.4.6.10, step may not exceed 150 mm. Grade has evidently settled since installation.

Landing at northwest entry.

Raise landing and asphalt.
