RECAPP Facility Evaluation Report

Calgary School District #19

Brentwood Elementary School

B2549A

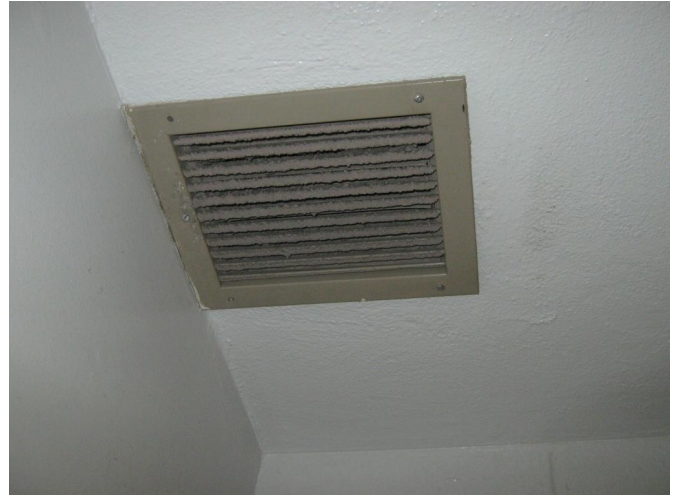
IMG_2772.jpg

Exhaust air grills and grates are metal / aluminum construction. Some grills were covered in dust bunnies.

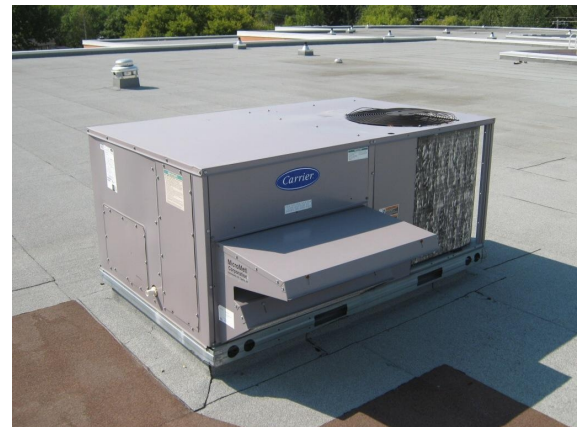
IMG_2705.jpg

D3050.01.02 Packaged Rooftop Air Conditioning Units (& Heating Units)**

Poor cooling efficiency and premature system breakdown.

Comb all condenser coil fins to "as new" condition.

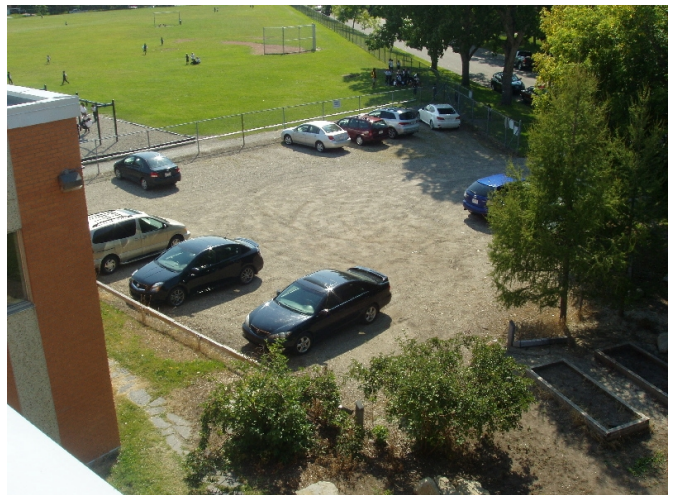
Storm water drains to the city from the parking lot and roof drains. Facility is connected to the city water and sewer system. All utilities enter the facility through underground lines The gas and water enter at the west side of the building. Irrigation is available and hose bibs are spaced around the building.

Parking lot at rear of building
