# **RECAPP Facility Evaluation Report**

## **Calgary School District #19**

### **Colonel Walker Community School**

B2587A

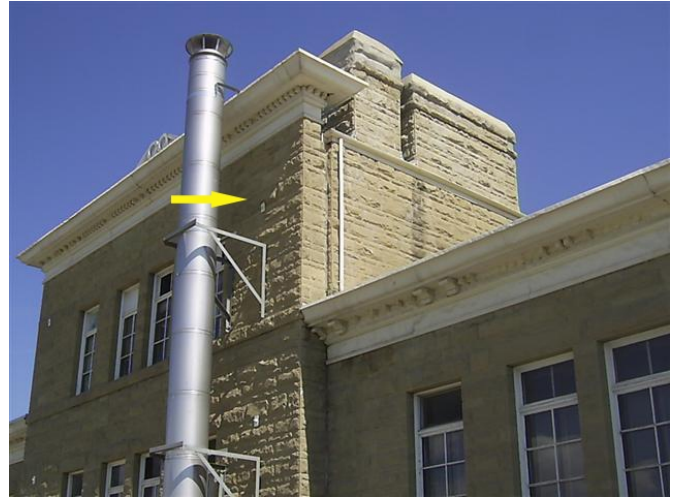
The exterior walls of the 1912 building has load-bearing sandstone (also see B2010.01.03). Previous repairs to stabilize movement detected at upper floors at the rear (south) of the building were observed. It was reported that the repairs are satisfactory with no further evidence of movement in the facade detected or reported. No further action warranted at this time.

South facade. Arrow points to stabilizer anchors at penthouse floor.
