RECAPP Facility Evaluation Report

Calgary School District #19

Dr. E. P. Scarlett High School

Evaluation Details

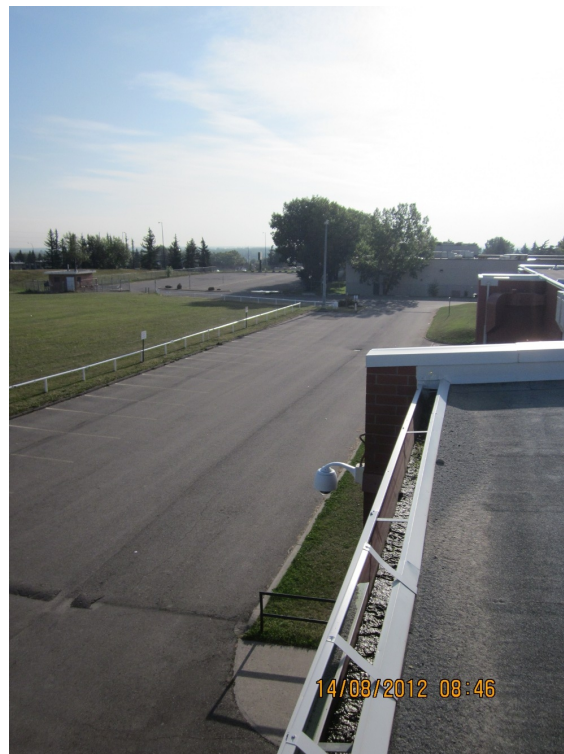
View of NE portion of rear parking and site

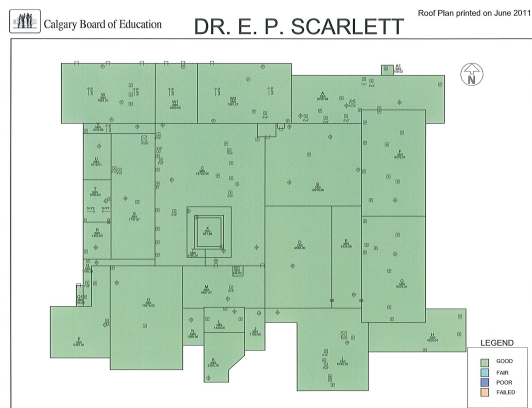
Roof plan (CBE)
