RECAPP Facility Evaluation Report

Calgary School District #19

Glenbrook Elementary School

B2650A

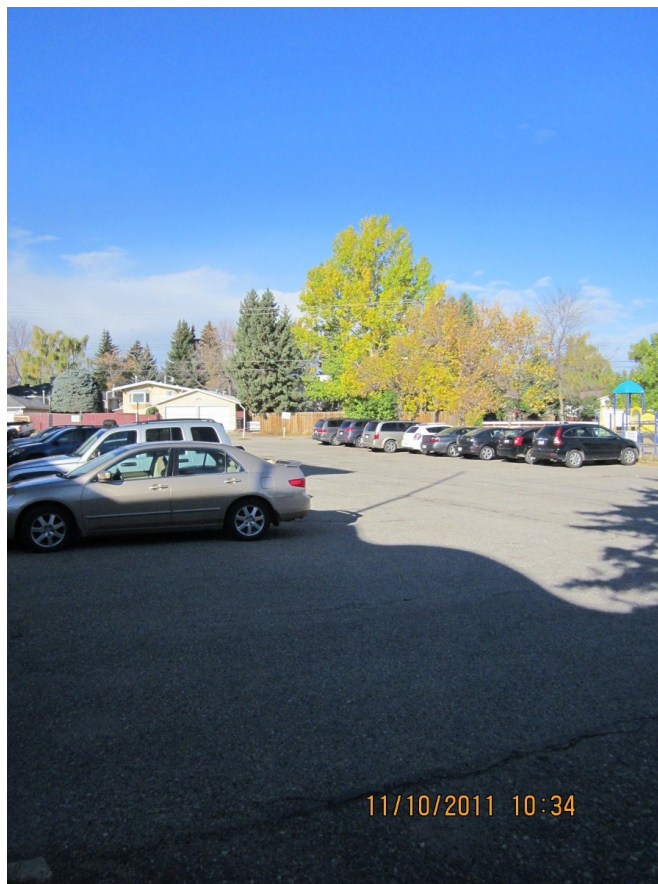
Power is underground fed from pad mounted transformer owned by the utility. Car receptacles are rail mounted.

View of parking lot
