# RECAPP Facility Evaluation Report

## Calgary School District #19

### Richmond Elementary School

**Evaluation Company:** Asset Evolution Inc.  
**Evaluation Date:** October 2 2009  
**Evaluator Name:** Mario Plastina

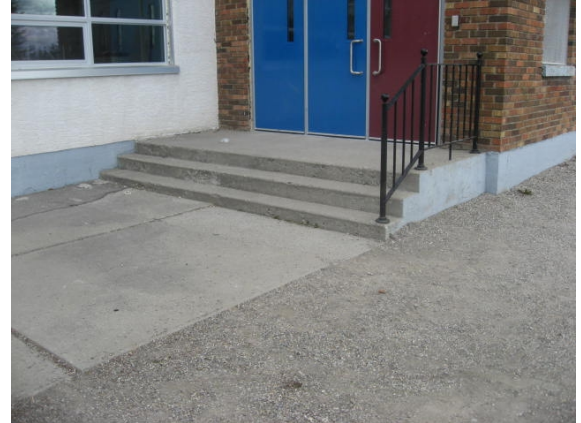
Several of the concrete stairs & landings are cracked.

Cracked stairs at north-west entrance.

Repair concrete stairs at the north and south end entrances.

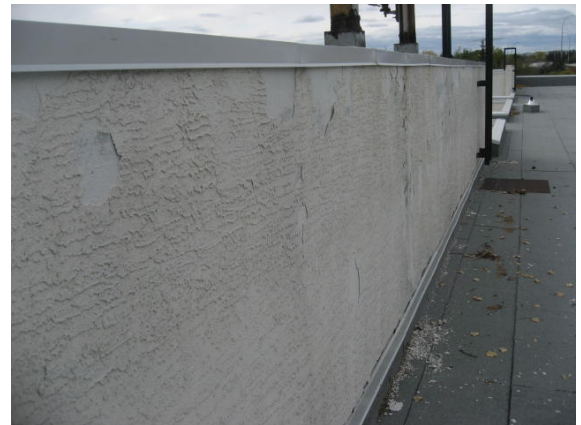
The stucco finish has deteriorated on the firewalls above the roof level.

Deteriorated cement plaster finish on firewall - Roof Level

Repair firewalls (Parapet) above the roof line

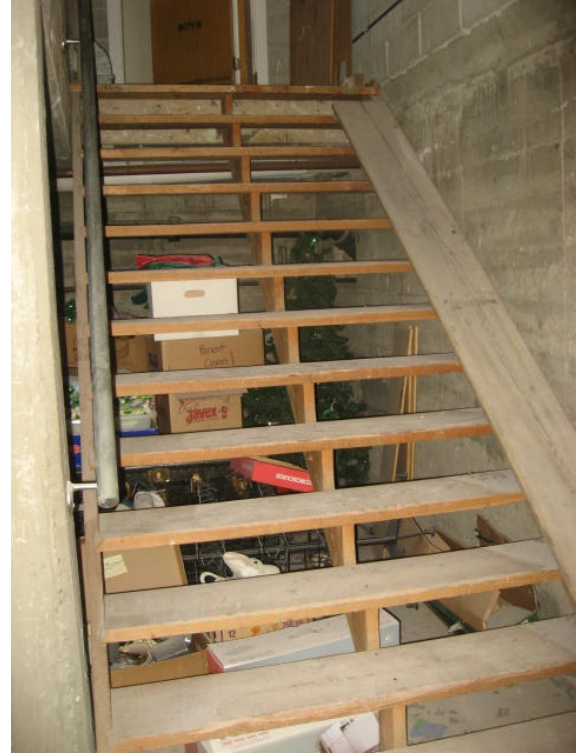
Stairs have improper rise to run ratio.

Stairs to basement storage area.

Replace existing wood stairs.

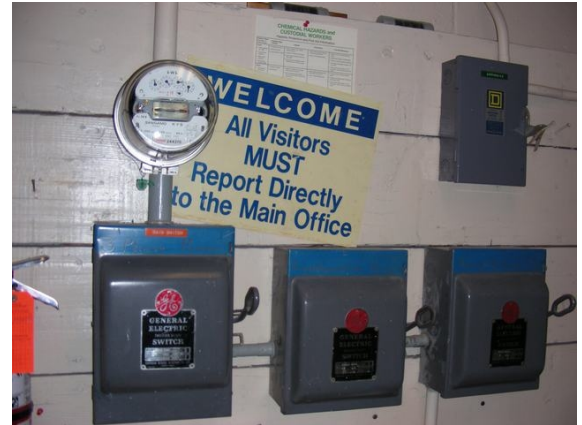
Aged 60A, 120/208V, 3-phase, 3-wire service.

Replace both incoming services with a new 120/208V 3-phase service sized to accommodate the total building load. A new breaker type service entrance switchboard c/w surge protection should be installed.

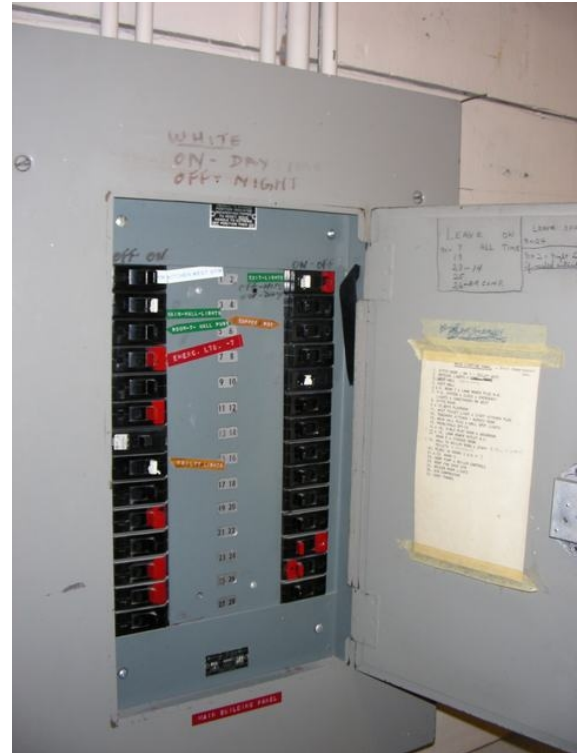
The branch circuit panels (1950-1954) are at the end of their life expectancy. Over the life of the panel, breaker contacts become worn and the breakers will no longer operate correctly and may trip unnecessarily. Older panels do not readily accept newer style breakers.

Deferring replacement could lead to partial power outages and intermittent tripping of breakers as well as increased maintenance costs.

Aged branch circuit panel in main electrical room.

Replace aged panelboards. If service is upgraded to a 3-phase service then the single phase panels should be replaced with 120/208V, 3-phase, 4-wire panels.

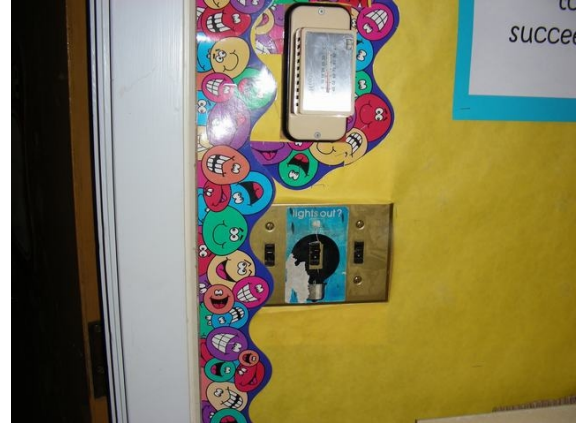
Many of the lighting switches are aged. Play in the switches indicates contacts are wearing, which could lead to short circuits.

Aged 120V lighting switches.

Replace aged lighting switches.

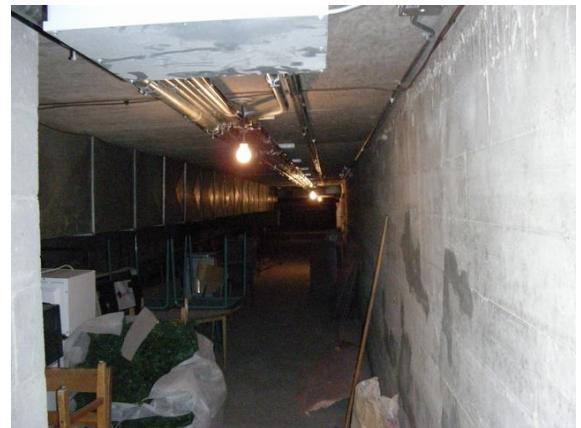
The incandescent fixtures are not energy efficient. Additional maintenance is required for incandescent lighting due to the short lamp life. Some fixtures are damaged.

Incandescent lighting in service tunnel.

Replace existing incandescent fixtures with energy efficient fluorescent fixtures.

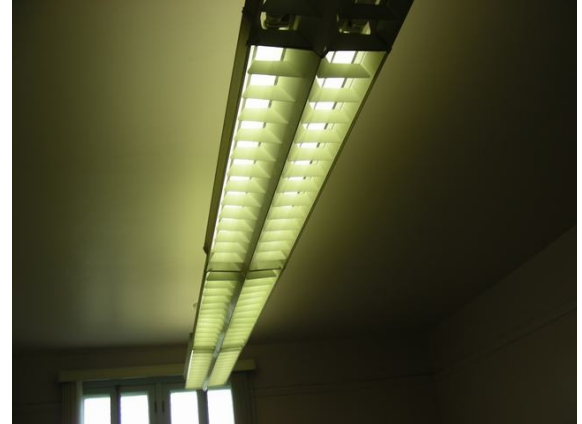
Aged louvered T12 fluorescent fixtures.

Replace existing T12 fluorescent lighting with new T5 or T8 fluorescent fixtures. Incorporate lamp reduction where possible.
