# **RECAPP Facility Evaluation Report**

**Calgary School District #19**

**Rosscarrock Elementary School**

B2765A

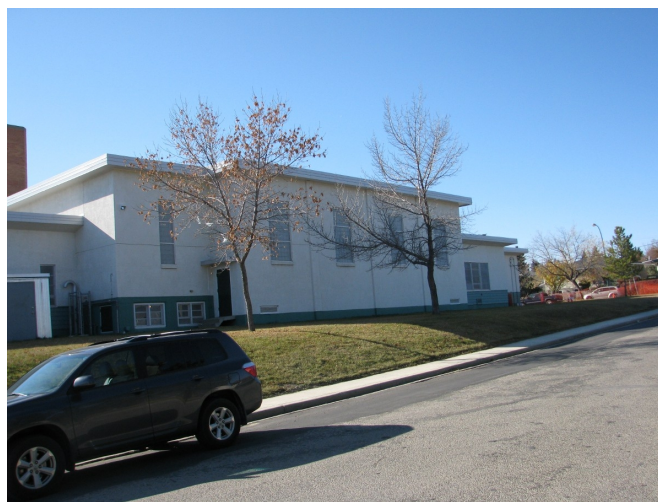
School front (north)
