RECAPP Facility Evaluation Report

Calgary School District #19

Southwood Elementary School

Evaluation Company: Halsall Associates Limited.
Evaluation Date: November 12 2010
Evaluator Name: Chris Love, B. Tech., RRC, LEED AP

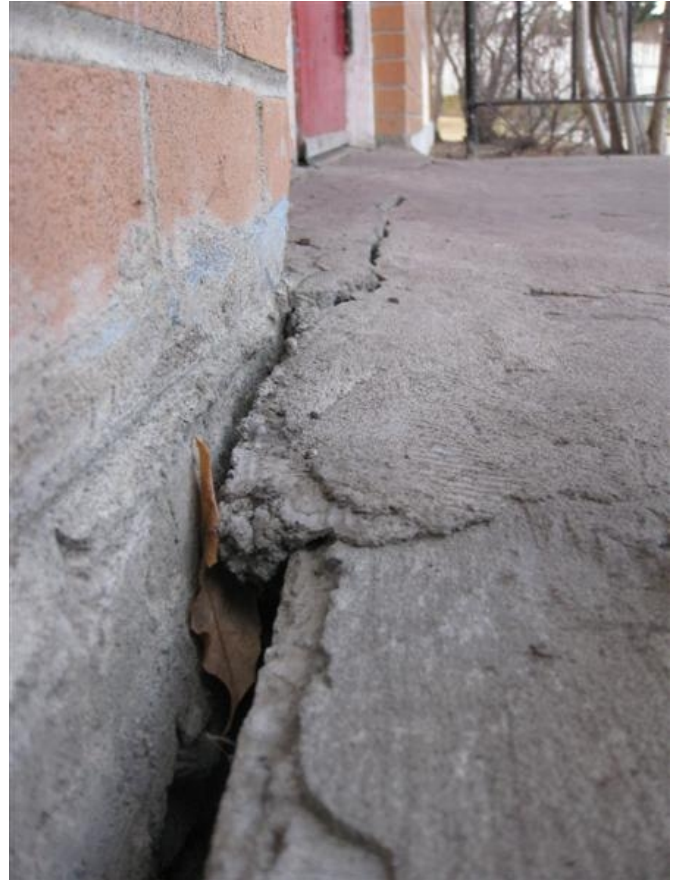
IMG_5336 (Medium).JPG

Located on north, and west elevations.

<u>Rating</u>	<u>Installed</u>	<u>Design Life</u>	<u>Updated</u>
3 - Marginal	1962	0	APR-11

(1962) North stairs landing surface has separated from the building, leaving a 1.5 inch gap. Attempts to patch the crack have failed, and the crack poses a tripping hazard.

Repair the landing and stairs. Ensure that the crack is fully filled and that the surface is free from tripping hazards.

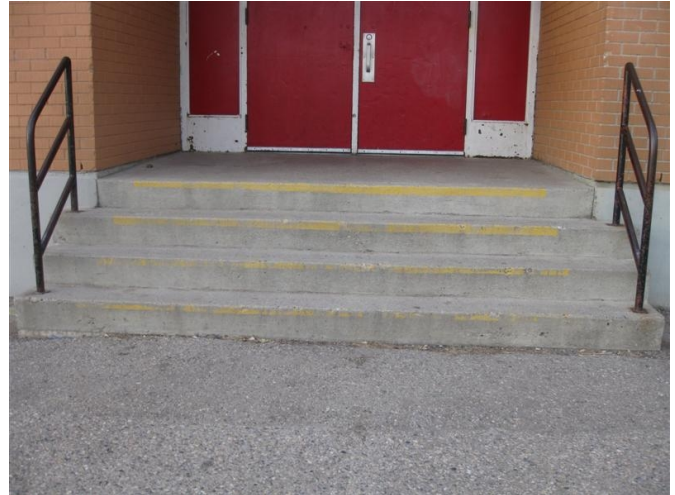
IMG_5291 (Medium).JPG

Located on east elevation.

<u>Rating</u>	<u>Installed</u>	<u>Design Life</u>	<u>Updated</u>
4 - Acceptable	1971	0	APR-11

Replace handrails with ones that are code compliant.

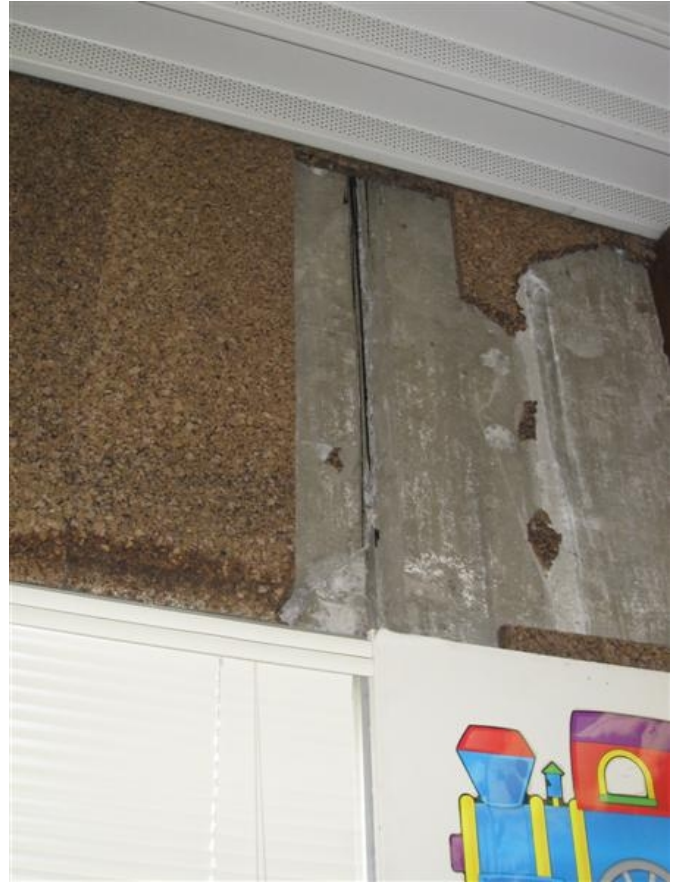
IMG_5384 (Medium).JPG

Precast panels around the perimeter of the addition (1971).

<u>Rating</u>	<u>Installed</u>	<u>Design Life</u>	<u>Updated</u>
2 - Poor	1971	0	APR-11

Cracking and movement observed on the south elevation of the building, allowing moisture to infiltrate into the building.

Cracking and movement observed on the south elevation of the building. Suspect that replacement of the window below contributed to the failure in the building envelope.

Repair building envelope.

Perform an in-depth study to determine the cause of the damage and the cost of repair.

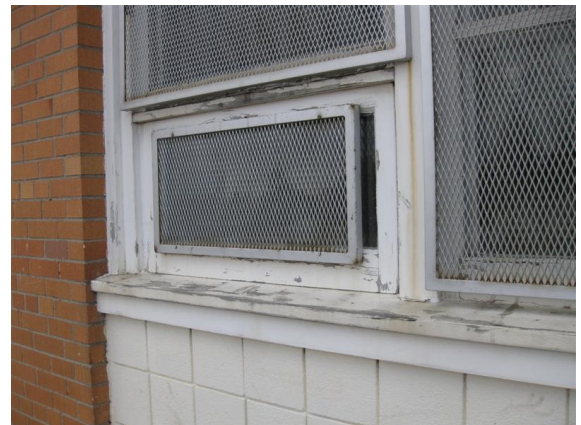
IMG_5318 (Medium).JPG

The original frames are rotted, and the finish has deteriorated beyond repair.

Window frames and windows are beyond their service life, and existing finishes are deteriorated beyond repair.

Replace existing windows with new aluminum double glazed units.

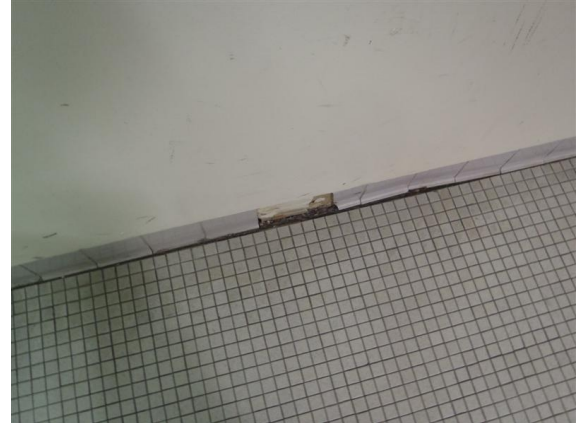
PB120202 (Medium).JPG

(1971) Tiles are missing and there is evidence of water infiltration behind the tile.

Investigate the extent of damage to the flooring sub base, and repair tile flooring.

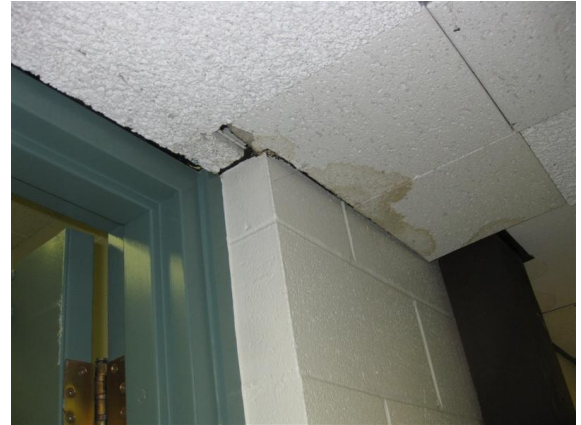
IMG_5389 (Medium).JPG

Evidence of water staining.

Investigate what is causing the leakage and replace stained glue on acoustical ceiling tile.
