# RECAPP Facility Evaluation Report

## Calgary School District #19

### Sir William Van Horne High School

<b>Evaluation Details</b>	
<b>Evaluation Company:</b>	Asset Evolution Inc. (AEI)
<b>Evaluation Date:</b>	October 5 2009
<b>Evaluator Name:</b>	Mario Plastina

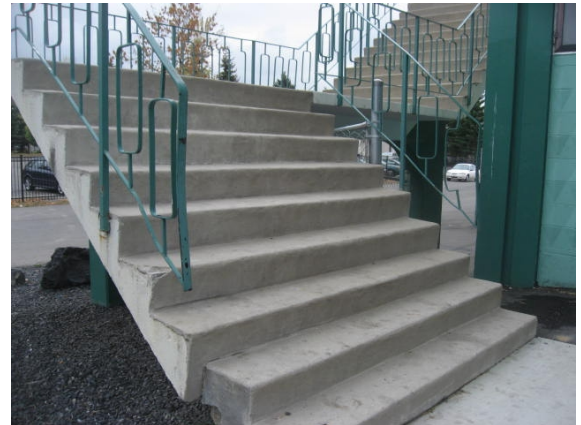
The stair treads and risers are uneven from previous repairs, creating a potential tripping hazard. All the handrails do not conform to the current ABC standards.

Uneven treads throughout stairs. Handrails not to current ABC code standards.

Repair and /or replace concrete stairs and replace all handrails.

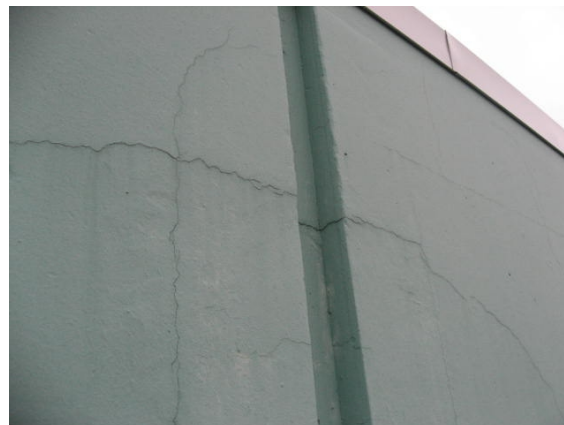
Several cracks were observed on the cement plaster finish on the 3rd floor level.

Cracked cement plaster walls on west wall - 1966 Section

Repair cement plaster finish on 3rd floor exterior concrete walls

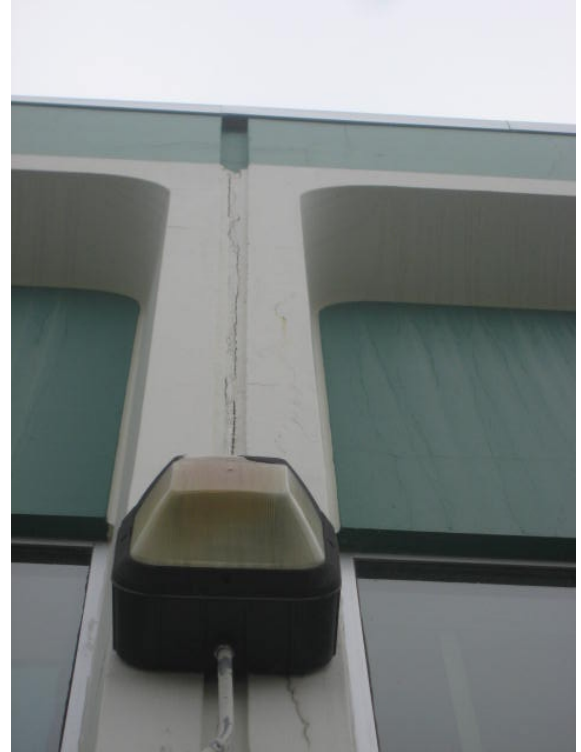
Caulk joint failure at precast connections.

Replace sealant on windows, doors and cladding assemblies.  
Replace sealant with window replacement.

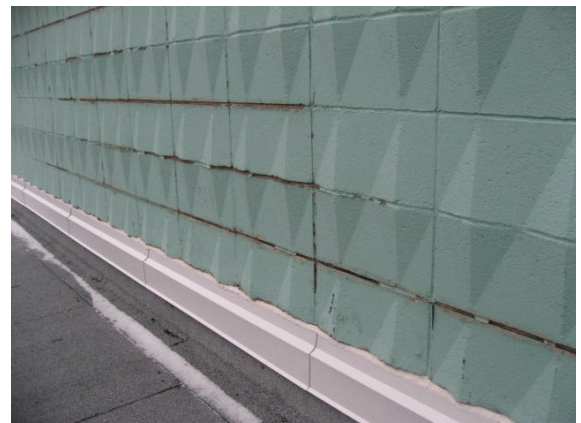
The paint finish on the concrete block walls and precast walls is worn and faded.

Deteriorated paint finish on concrete block walls

Repair & repaint all exterior concrete, concrete block and metal siding walls

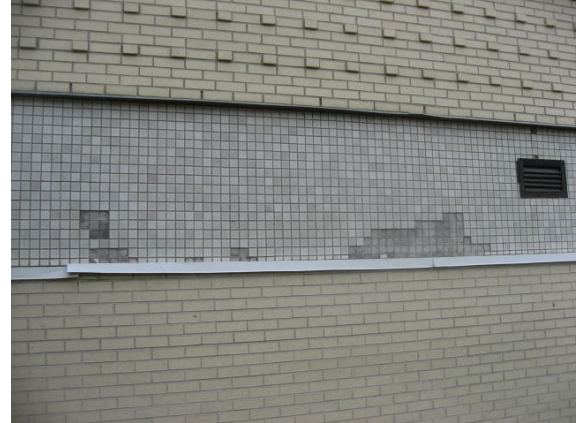
Several of the mosaic tiles are missing on the west wall of the 1983 Section.

Missing tiles on west elevation of the 1983 Section.

Repair & replace all missing ceramic tiles on the south & west walls

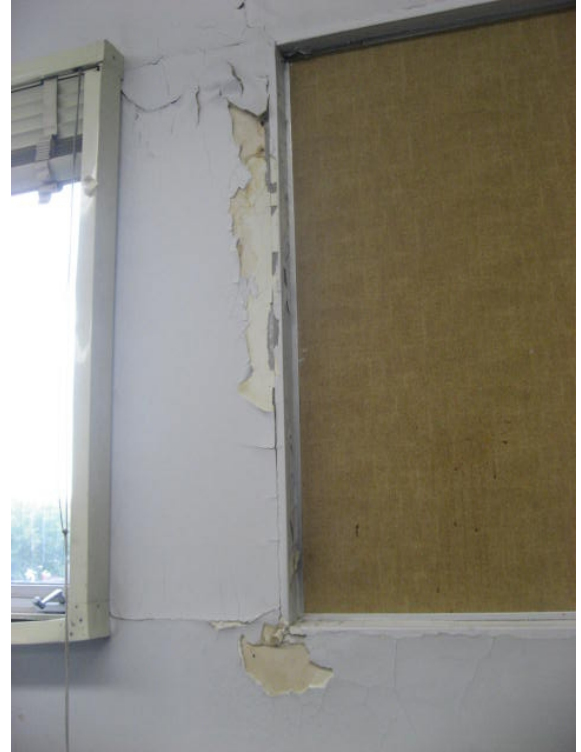
The seals are deteriorated, air & moisture penetration was observed on several window intersections.

Water penetration on south wall.

Replace Aluminum Windows - 1966 Section - 1st & 2nd floor only ( 100 Units)

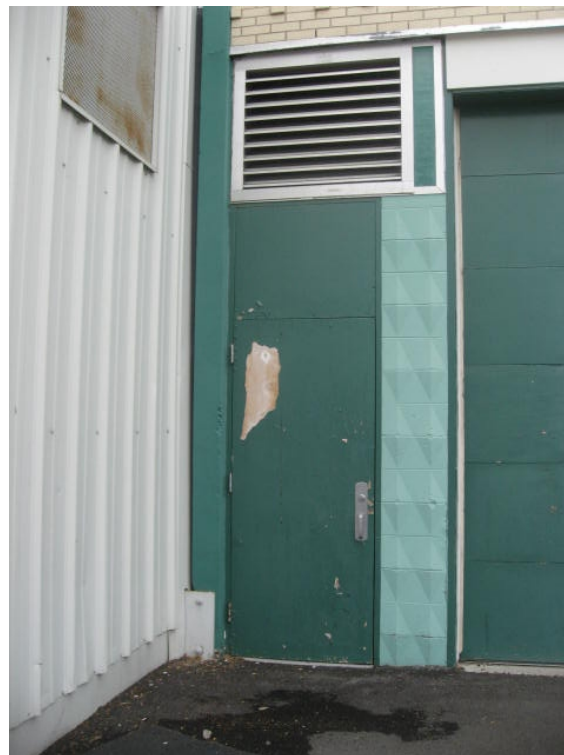
Several of the exterior wood doors on the roof level are deteriorated and no longer secure.

Typical deteriorated wood door in 1966 Section

Replace all utility doors including roof level doors - 22 Doors

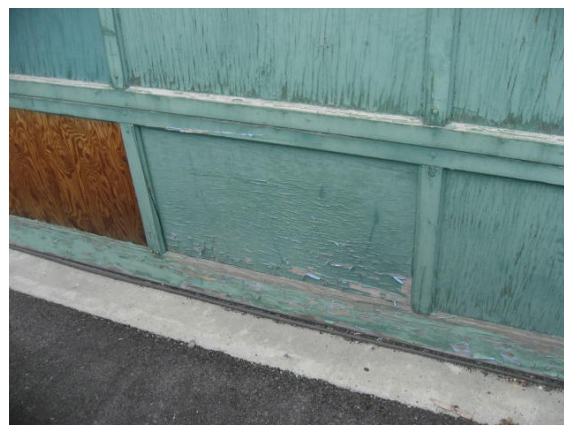
Several of the wood doors are deteriorated and not secure.

Deteriorated door panels in 1975 Building Construction Shop.

Repair and/or replace all overhead doors in shop areas - 12 doors

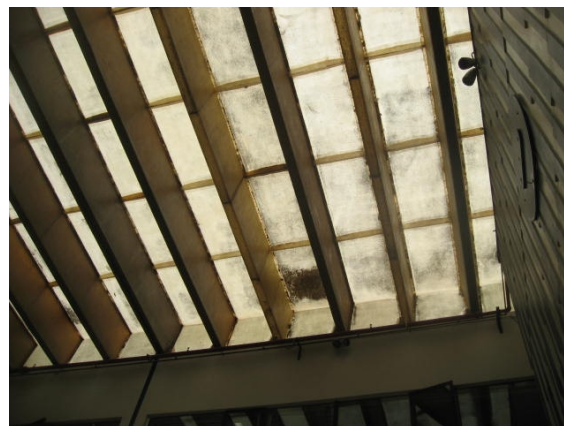
The fibreglass enclosure has deteriorated and water penetrated at the seams. Aesthetically, the enclosure is not appealing.

Interior view on enclosed courtyard.

Replace skylight enclosure in Courtyard (Approx. Area 300m2)

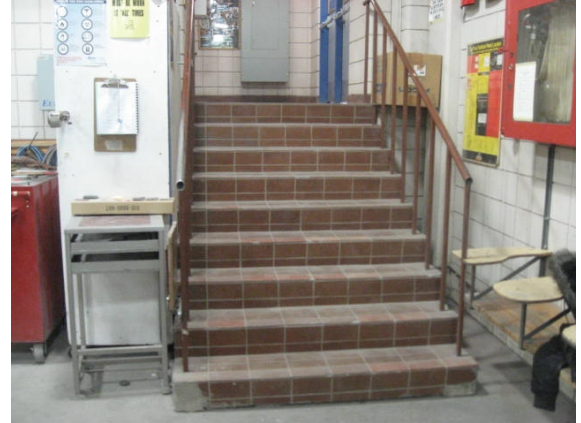
Several quarry tiles are broken at the auto-body entrance.

Cracked quarry tiles on stairs

Replace broken quarry tiles where applicable & auto body entrance stairs

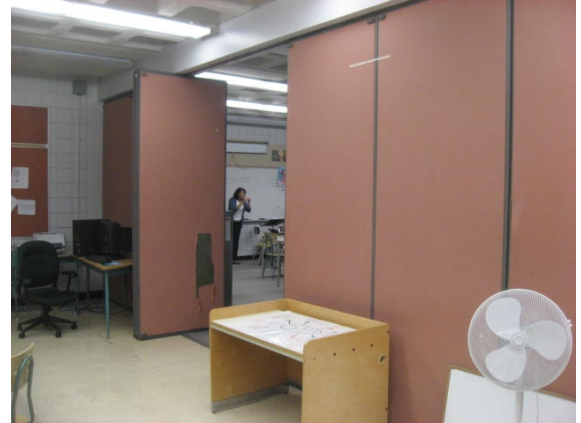
Several isolated panels are damaged and the vinyl wall covering is torn.

Damaged wall finish on folding partitions.

Repair and /or replace all damaged vinyl covering on wall panels

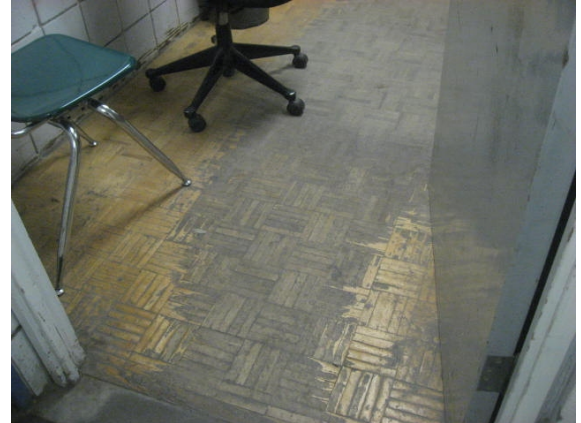
The parquet flooring finish is worn and deteriorated.

Deteriorated floor finish in the building construction shop area.

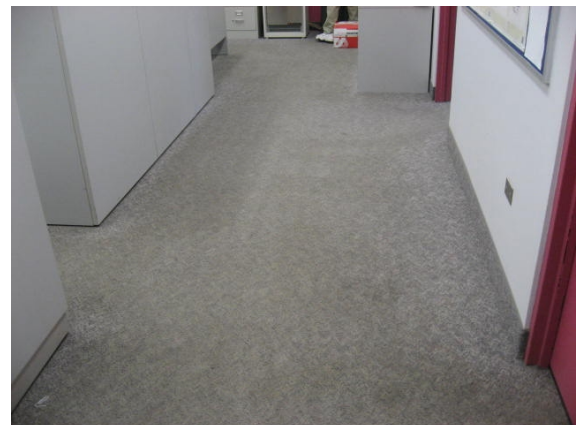
The majority of the carpet is worn, torn and stained.

Worn carpeting typical throughout the office areas.

Replace carpet flooring ( Approx Area - 1100m2)

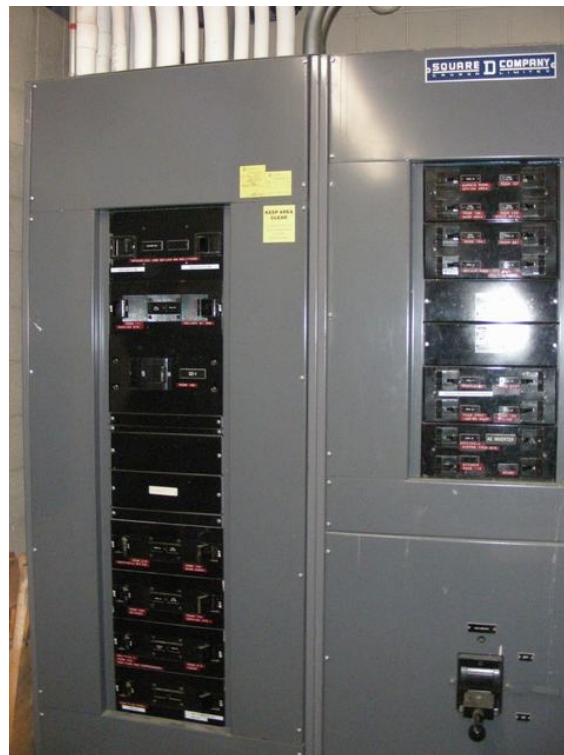
2000A, 120/208V Square D main switchboard.

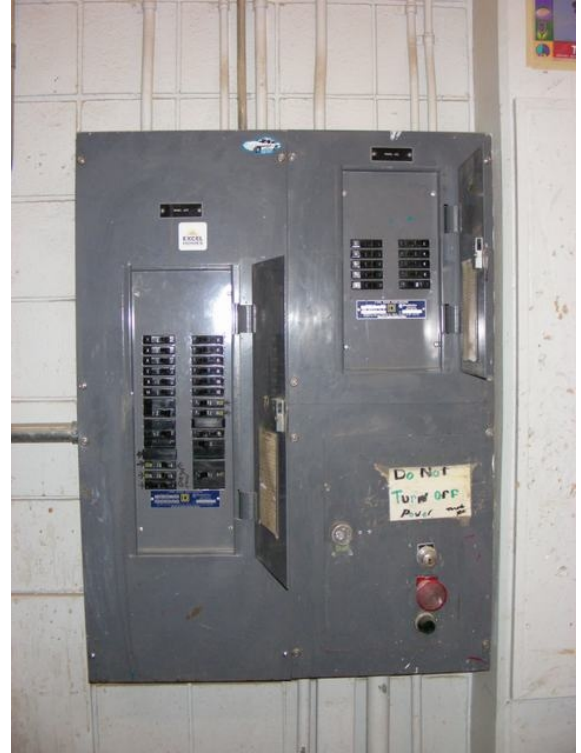
Aged Square D panel in shop area.

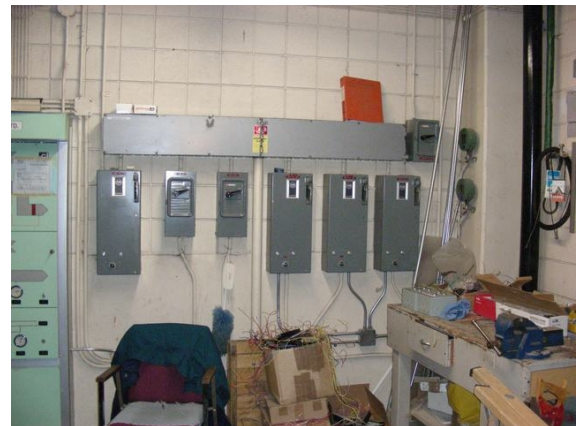
Allen Bradley motor starters.

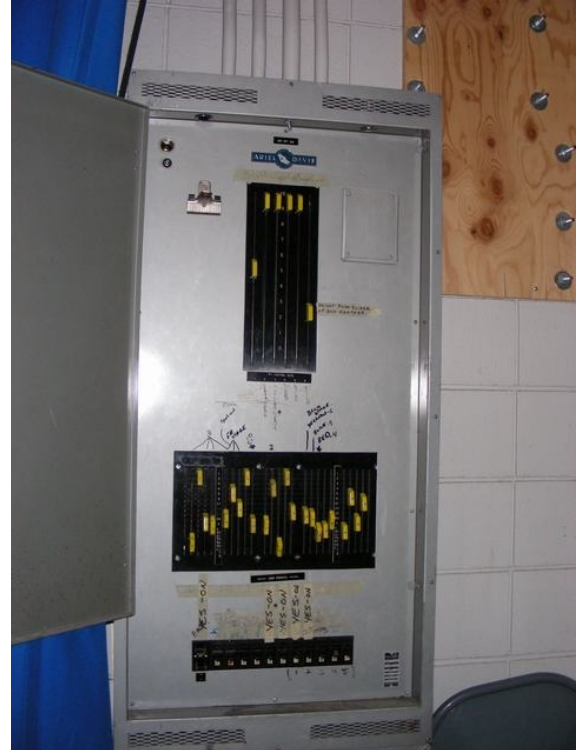
Obsolete Ariel Davis dimming system.

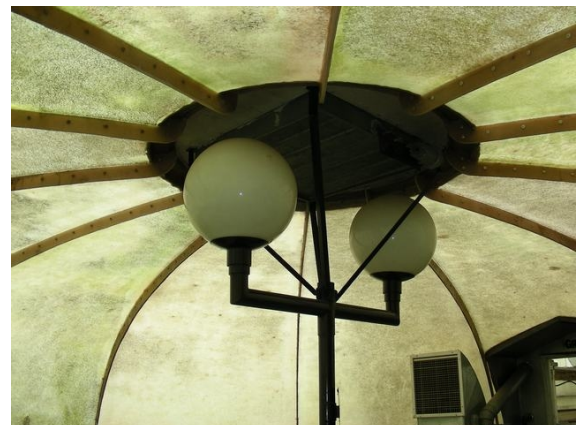
Incandescent pole mounted lighting in greenhouse.

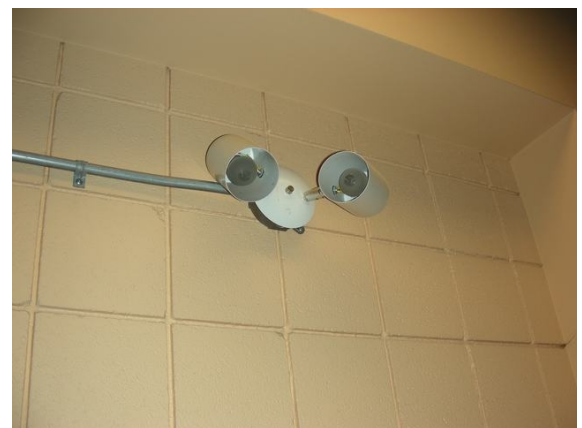
Incandescent emergency lighting heads.

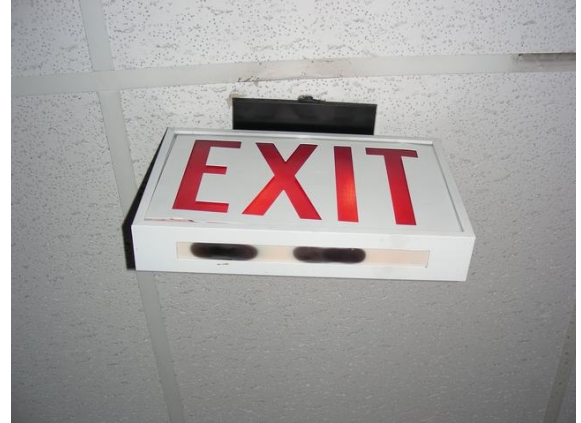
Incandescent exit sign.

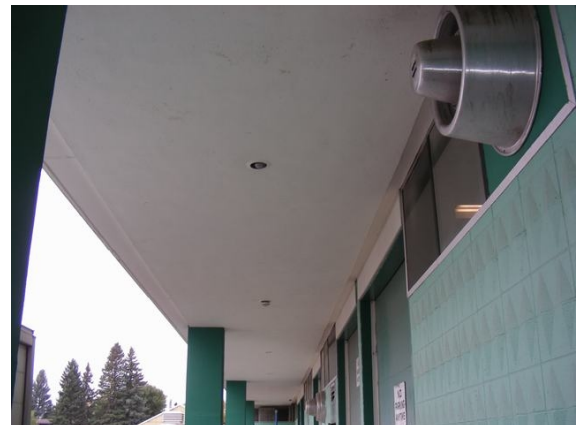
Exterior recessed incandescent lighting in canopy.

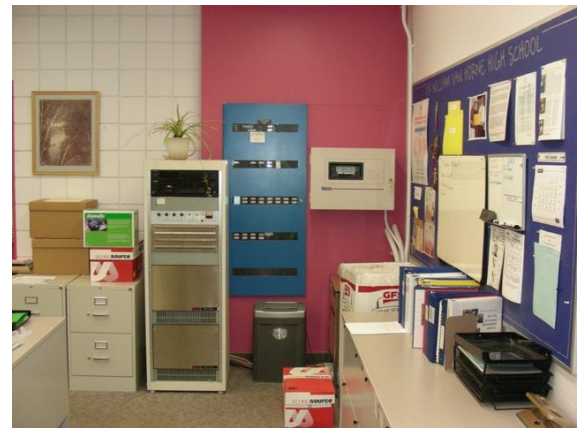
Pyrotronics System 3 fire alarm control panel in general office.
