RECAPP Facility Evaluation Report

Annunciation Catholic Elementary School

B3039A
Edmonton

Evaluation Details	
Evaluation Company:	Asset Evolution Incorporated (AEI)
Evaluation Date:	October 26 2011
Evaluator Name:	Mario Plastina

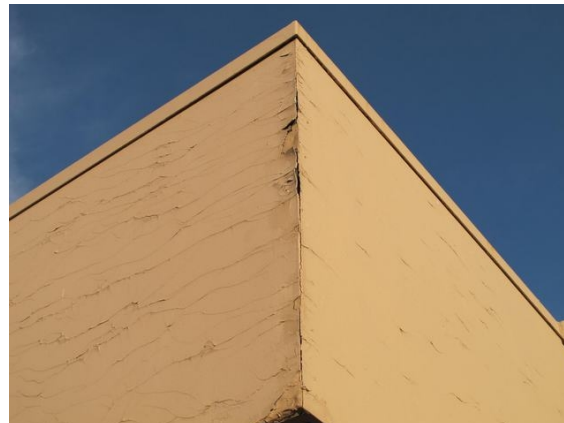
The cement plaster finish is damaged at isolated corners of the school.

Damaged cement plaster finish at south-east corner of the 1969 Addition.

Repair cement plaster finish on exterior south-east corner and gymnasium walls.

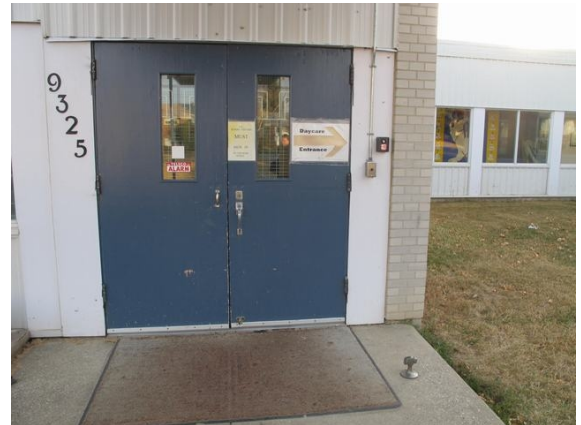
The doors are worn, deteriorated and no longer close properly. The hardware is original at most entrances.

Main entrance wood doors - West Elevation

Replace all exterior wood doors c/w hardware (12 doors)

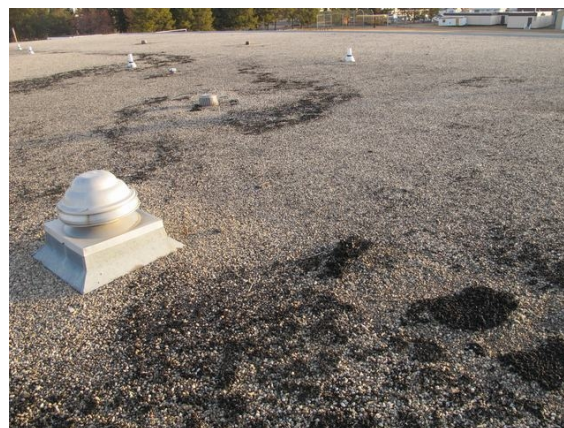
Several repairs have been conducted over recent years and the roof has surpassed its life expectancy.

Original roof above the 1969 Addition

Replace entire roof assembly of the 1969 Addition - Area - 887m2

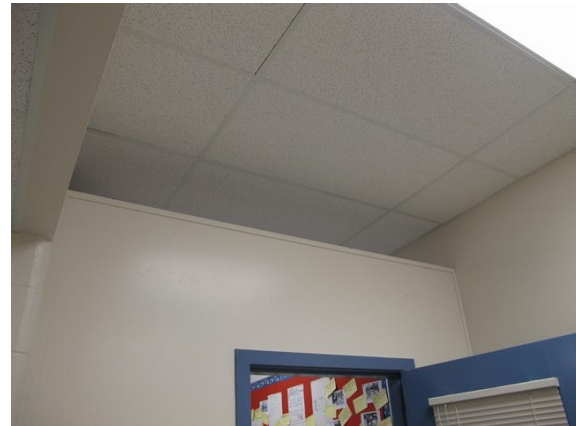
Large opening were observed in the entrances to classrooms 11 and 15 in the 1969 Addition. The fire separation between the corridor and classrooms is compromised.

Openings between the corridor and classrooms 11 and 15.

Event: **Code Repair - Seal the openings in the fire separation with a listed fire stop material.**

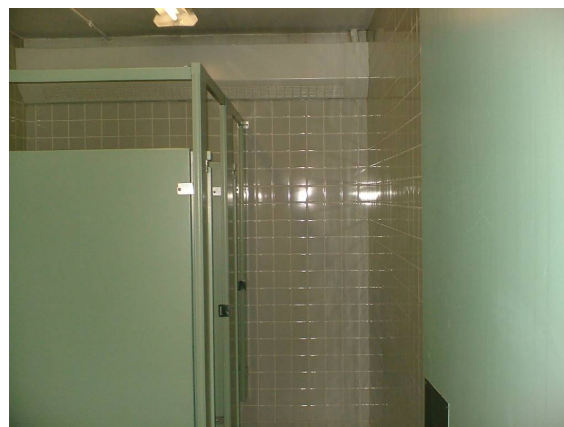
Ceramic wall tiles in washroom.

Event: Replace ceramic wall tiles (Area - 120m2)

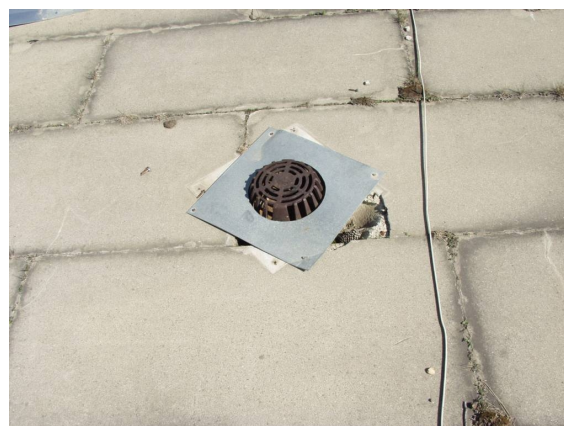
P5170065.JPG

Two of the roof drains for the c.1969 building addition are missing strainers.

Replace the missing strainers for two of the building addition roof drains.

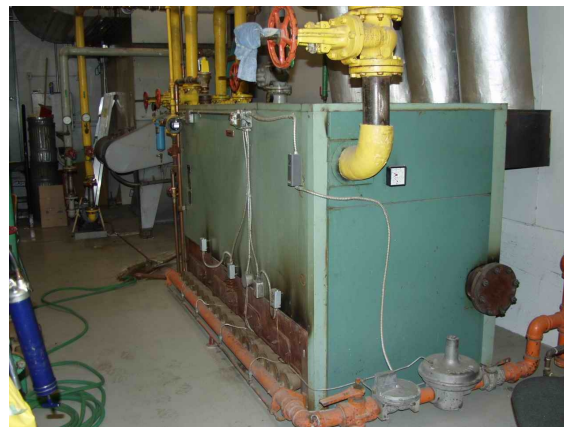
The hot water heating boiler is in marginal condition due to age, wear, corrosion and obsolescence. The boiler is showing signs of insulation and refractory deterioration and the efficiency of the boiler is low.

Heating Boiler

Replace the hot water heating boiler two smaller capacity boilers.

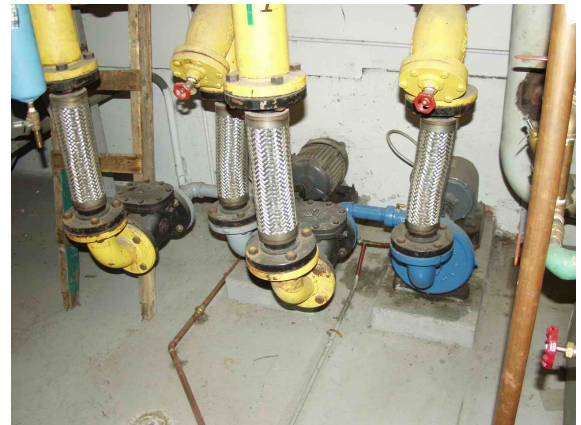
Concern:
The hot water heating pumps P1, P2 and P3 are in marginal condition due to age and wear. Replacement parts are not readily available.

Heating Pumps

Recommendation:
Replace the hot water heating pumps P1, P2 and P3 when the boiler is replaced.

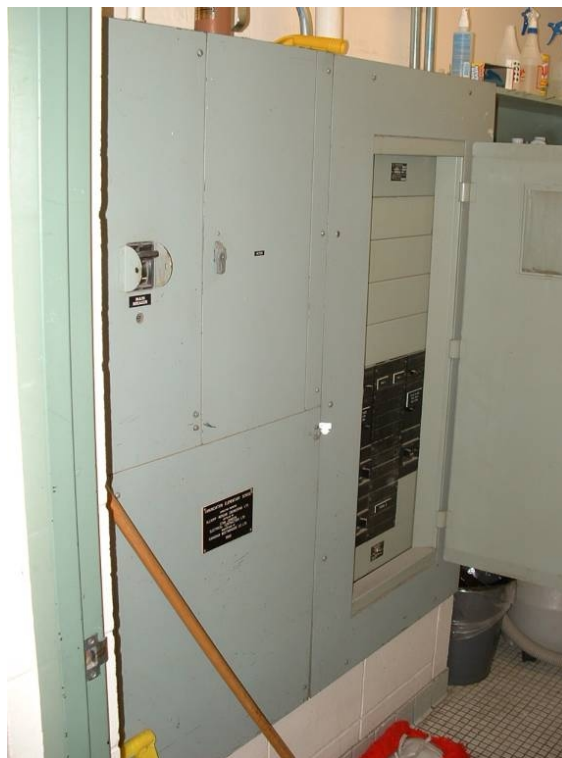
Due to the age of the molded case circuit breakers, they may not function properly in the event of a fault condition.

Main Westinghouse switchboard, 400A, 120/208V.

Replace the main switchboard and the breakers.

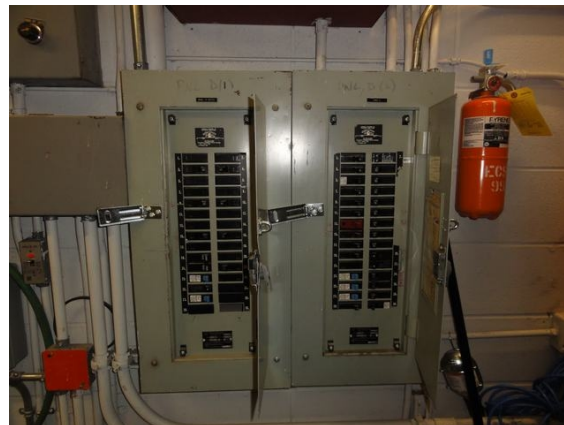
The branch circuit panels installed between 1966 and 1969 are well past their life expectancy. Over the life of the panel, breaker contacts become worn and the breakers will no longer operate correctly and may trip unnecessarily. Older panels do not readily accept newer style breakers.

Aged Westinghouse branch circuit panels.

Replace panels with new 120/208V branch circuit panels c/w sufficient circuits to accommodate building loads and provide capacity for additional loads in the future.

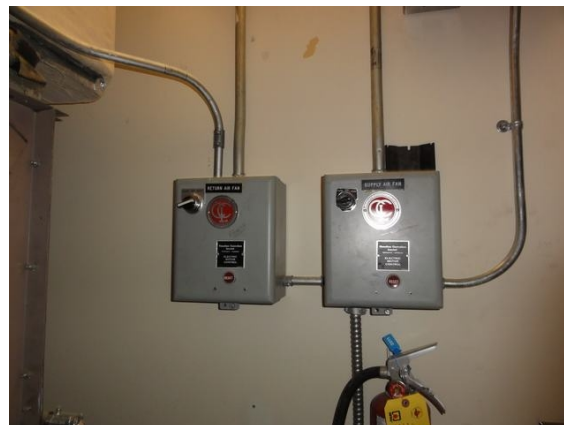
The motor starters installed between 1966 and 1969 are aged. Replacement parts are no longer readily available.

Aged CCL motor starters.

Replace individual motor starters and manual motor starter switches.

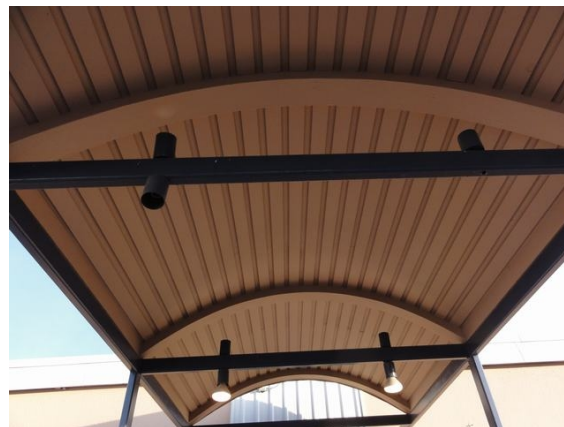
The exterior incandescent lighting is not energy efficient. Some fixtures have deteriorated.

Incandescent lighting fixtures in entrance canopy.

Replace incandescent exterior lighting with new energy efficient exterior lighting fixtures.

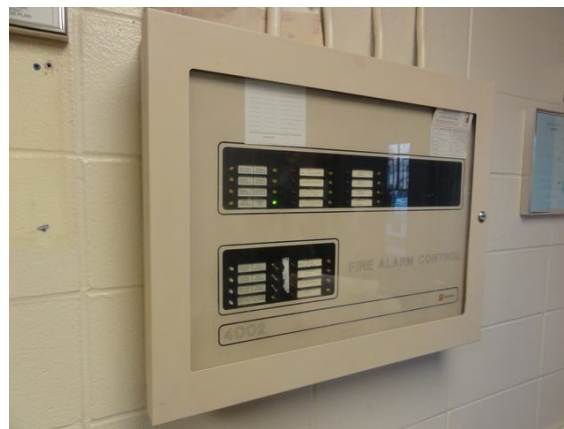
Simplex 4002 fire alarm control panel at main entrance.

Provide new addressable fire alarm system to current code requirements. Provide strobe coverage throughout.

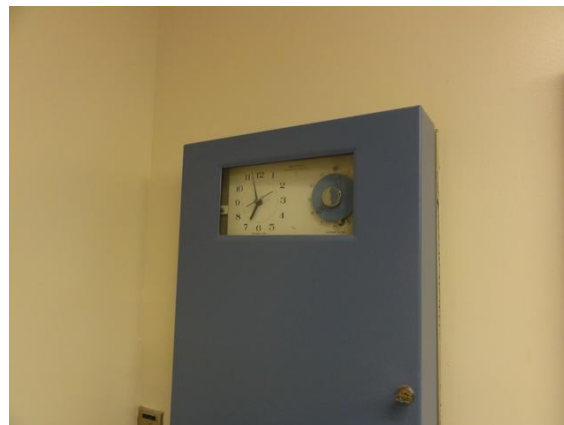
Obsolete Edwards clock system.

Replace existing clocks with new wireless GPS synchronized clock system. Remove old Edwards clock system.

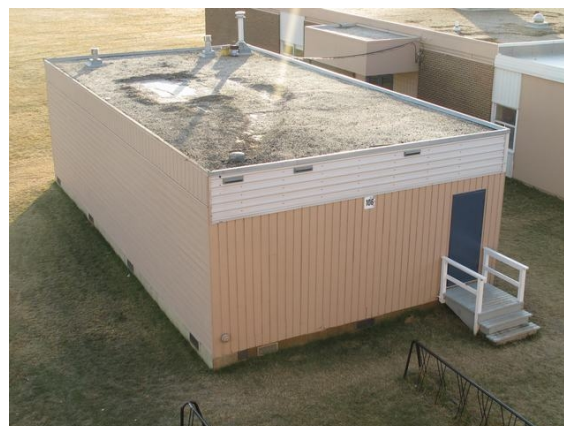
BUR assembly on portable 106.

-Replace roof assembly on Portable 106 - Area - 83m²
