# RECAPP Facility Evaluation Report

Edmonton School District No. 7

**Avonmore Elementary School**

B3047A  
Edmonton

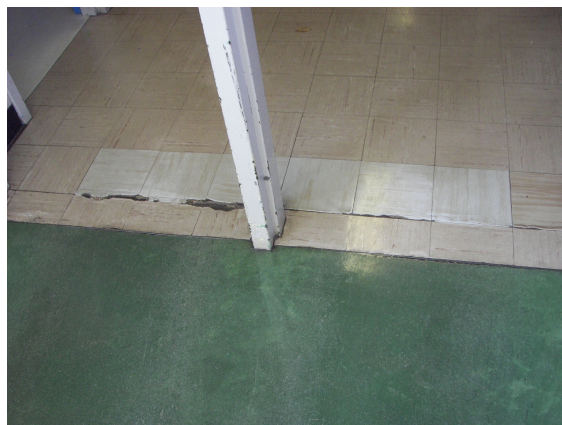
(1961) Addition (Corridor connecting to 1955 section) - has cracked floor slab.

Repair cracked floor slab. (approx. 2 linear metres)

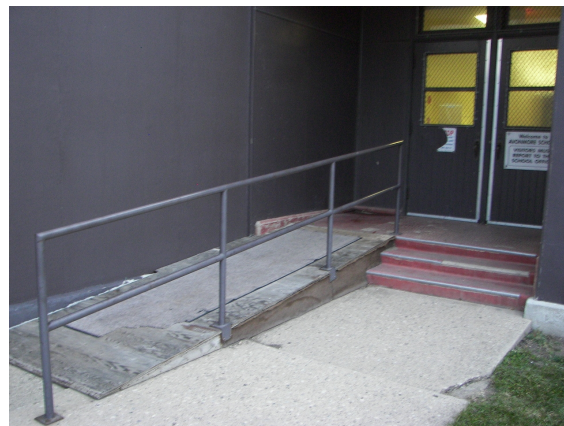
(1956) Addition (East Corridor Entrance) - wood ramp is rotten and handrail is not up to barrier free standards.  
 (1956) Addition (South Corridor Entrance) - handrail is not up to barrier free standards, missing bottom bar.  
 (1961) Addition (West Entrance Near Boys Washroom 34; Southwest Entrance) - ramps have settled.

(1956) Addition (East Corridor Entrance) - wood ramp is rotten and handrail is not up to barrier free standards.

Repair ramps and handrails. (4 ramps)

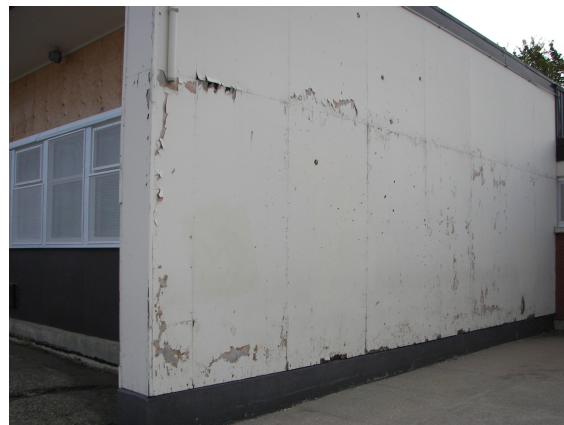
(1955) Original Building (South End Wall) - has damaged plywood finish.

Replace plywood panels and wood trim. (approx. 100 sq. m.)

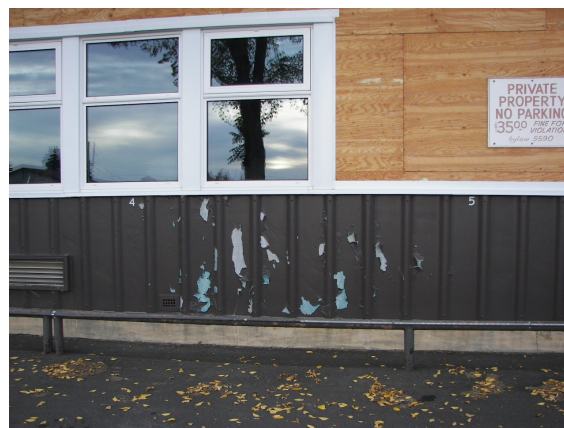
Vertical corrugated asbestos panels contain asbestos and are damaged.

(1955) Original Building (North Lower Wall of Library 93; East Lower Wall of Classrooms) - have damaged vertical corrugated asbestos panels.

Replace vertical corrugated asbestos panels. (approx. 280 sq. m.)

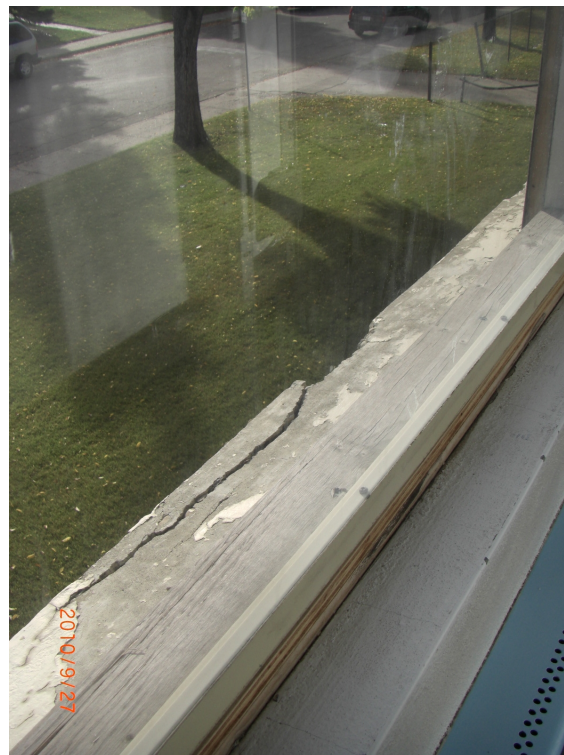
Wood windows have worn out.

(1961) Addition (Upper Floor - Classroom 40)- wood windows have worn out.

Replace wood windows. (46 windows)

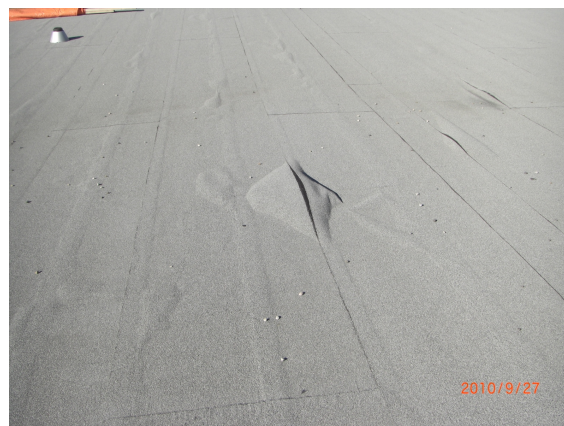
(1956) Addition (Classrooms) - SBS roofing has bubbles. (approx. 500 sq. m.)

Repair SBS roofing. (approx. 530 sq. m.)
