RECAPP Facility Evaluation Report

Edmonton School District No. 7

Brander Gardens Elementary School

B3063A
Edmonton

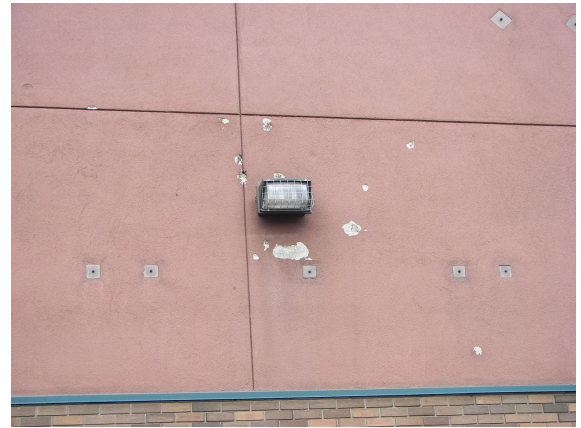
(1975) (East wall of Gymnasium 8) - has damaged stucco.

Repair stucco. (approx. 30 square metres)

<u>Type</u>	<u>Year</u>	<u>Cost</u>	<u>Priority</u>
Repair	2011	\$4,500	Low

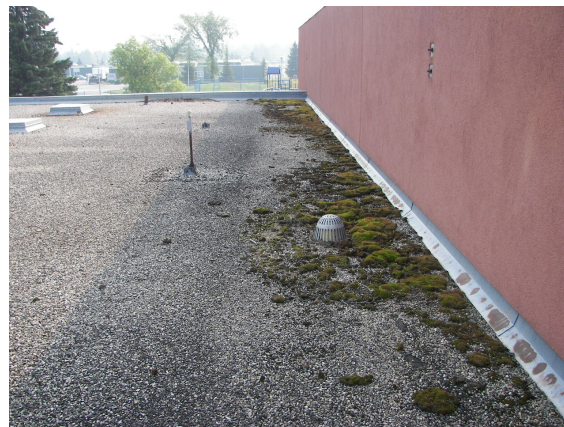
(1975) (North wall of Gymnasium 8) - has moss.

Replace built-up roofing. (approx. 2280 square metres)

<u>Type</u>	<u>Year</u>	<u>Cost</u>	<u>Priority</u>
Failure Replacement	2011	\$456,000	Low

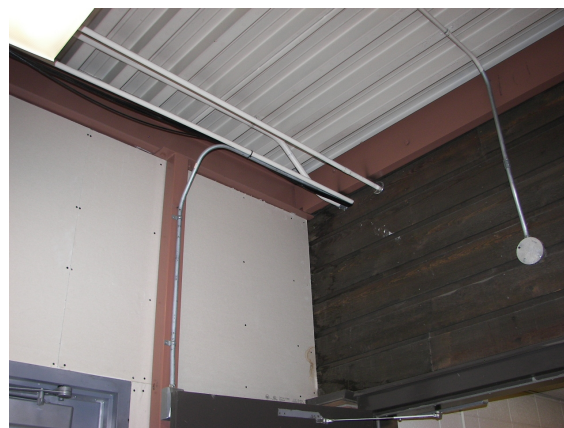
(1975) (Links to Portables 1975 and 1976) - have rotten wood siding above Corridor doors.

Replace wood siding. (approx. 10 square metres)

<u>Type</u>	<u>Year</u>	<u>Cost</u>	<u>Priority</u>
Failure Replacement	2011	\$1,000	Low

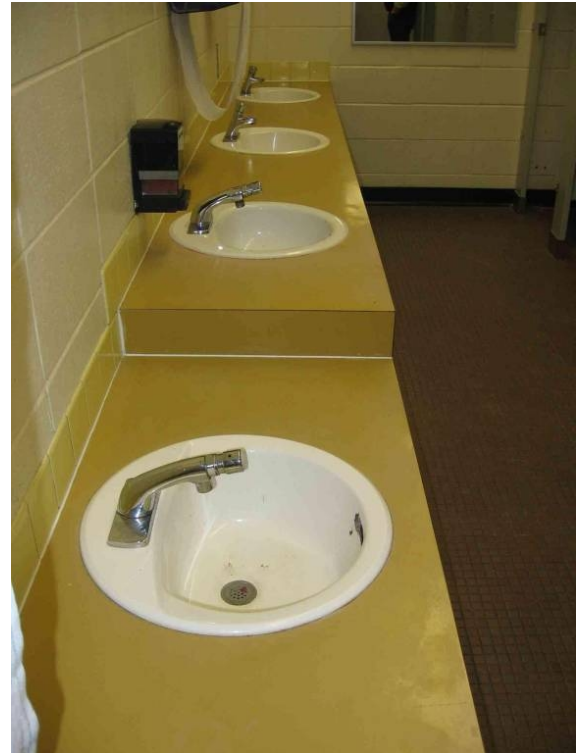
Lavatories are rusting at overflows. Porcelain has been chipped away, exposing rusting steel.

Event: Replace 18 WC's and 4 Urinals.

<u>Type</u>	<u>Year</u>	<u>Cost</u>	<u>Priority</u>
Lifecycle Replacement	2014	\$40,000	Unassigned

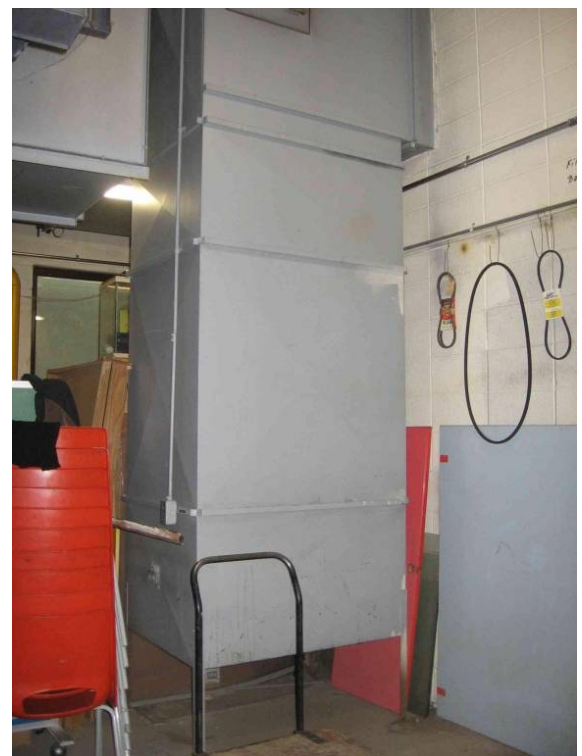
Combustion air duct outlet without baffle trap.

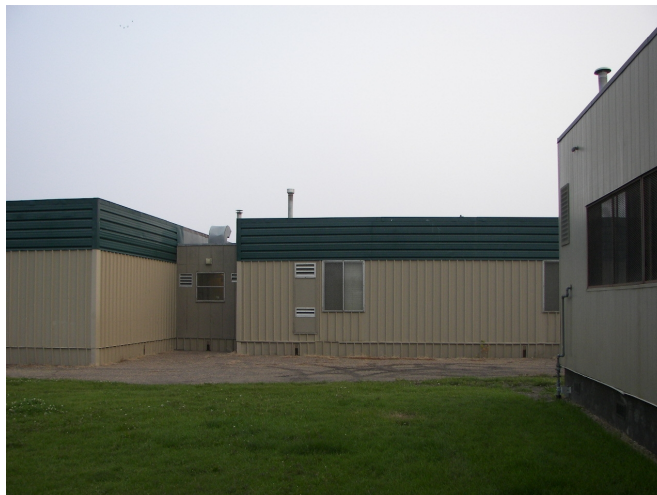
(1975) Portables - South Elevation

1. Classroom coat area ceiling - has stained and damaged acoustic ceiling tiles.
2. Classroom coat areas and Storage 16, Furnace 19 - have worn out vinyl tile flooring.

1. Built-up roofing - has ponding and damaged roof drains.
2. Metal siding - has dented areas.
3. Metal siding skirting - has dented areas.
4. Paint of exterior classroom exit wood doors - has faded.

1. Replace acoustic ceiling tiles. (approx. 60 square metres)
\$1000
2. Replace vinyl tile flooring. (approx. 75 square metres)
\$7500

1. Replace built-up roofing (approx. 412.5 square metres) and 10 roof drains. \$61875
2. Repair metal siding. (approx. 80 square metres) \$8000
3. Repair metal siding skirting. (approx. 80 square metres) \$4000
4. Paint exterior classroom exit wood doors. (4 doors) \$2000

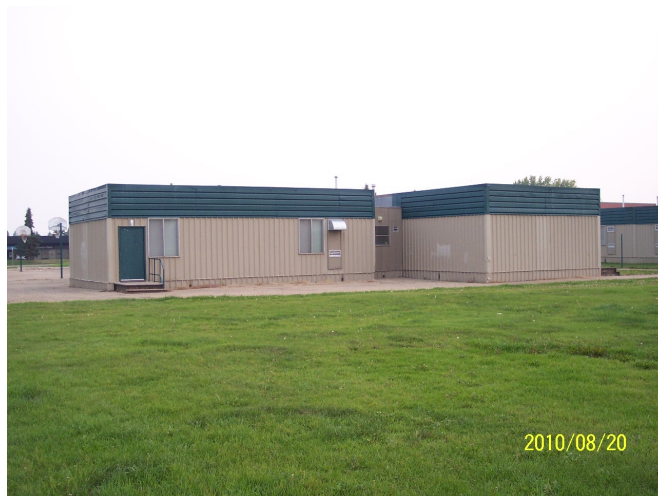
(1976) Portables - South Elevation.

1. Classroom coat area ceiling - has stained and damaged acoustic ceiling tiles.
2. Classroom coat area, Storage 28, Furnace 29 - have worn out vinyl tile flooring.

1. Built-up roofing - has ponding and damaged roof drains.
2. Metal siding - has dented areas.
3. Metal siding skirting - has dented areas.
4. Paint of exterior classroom exit wood doors - has faded.

1. Replace acoustic ceiling tiles. (approx. 60 square metres)
\$1000
2. Replace vinyl tile flooring. (approx. 75 square metres)
\$7500

1. Replace Built-up roofing (approx. 412.5 square metres) and 10 roof drains. \$61875
2. Repair metal siding. (approx. 80 square metres) \$8000
3. Repair metal siding skirting. (approx. 80 square metres) \$4000
4. Paint exterior classroom exit wood doors. (4 doors) \$2000
