# **RECAPP Facility Evaluation Report**

**Crawford Plains School**

B3082A  
Edmonton

**Evaluation Company:** Asset Evolution Incorporated (AEI)  
**Evaluation Date:** October 17 2011  
**Evaluator Name:** Mario Plastina

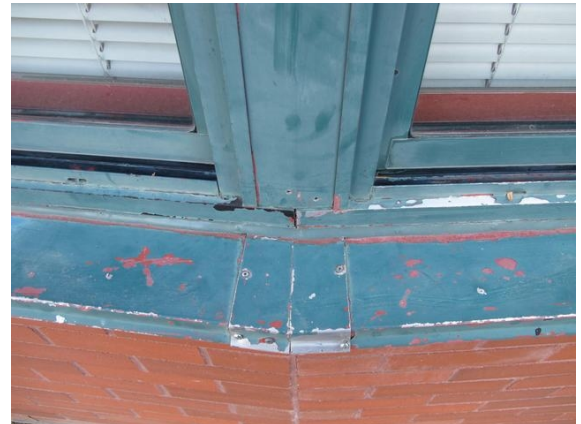
The sealant around the windows and doors has deteriorated and is brittle.

Deteriorated sealant along window assembly.

Replace sealant around windows and doors.

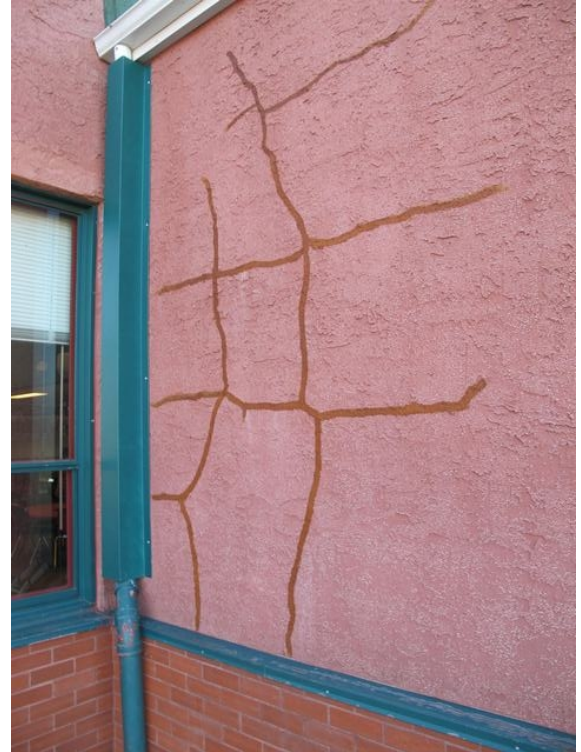
Several cracks were observed on the exterior wall assembly. The paint finish is aged and worn on the stucco and window frames

Cracks on stucc wall assembly.

Repair & repaint exterior stucco walls & windows (Based on GFA -3241m2 & 90 windows)

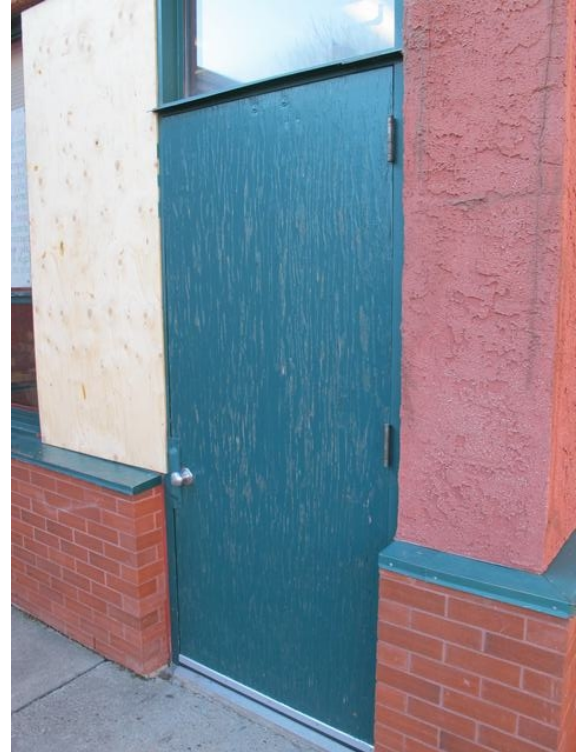
Several of the original wood doors are worn, rotted and deteriorated.

Deteriorated wood door assembly.

Replace all exterior wood doors c/w hardware (14 doors)

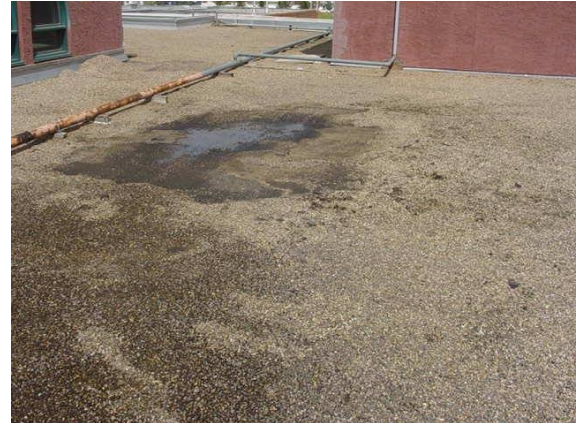
Typical condition of Built-up roof assembly.

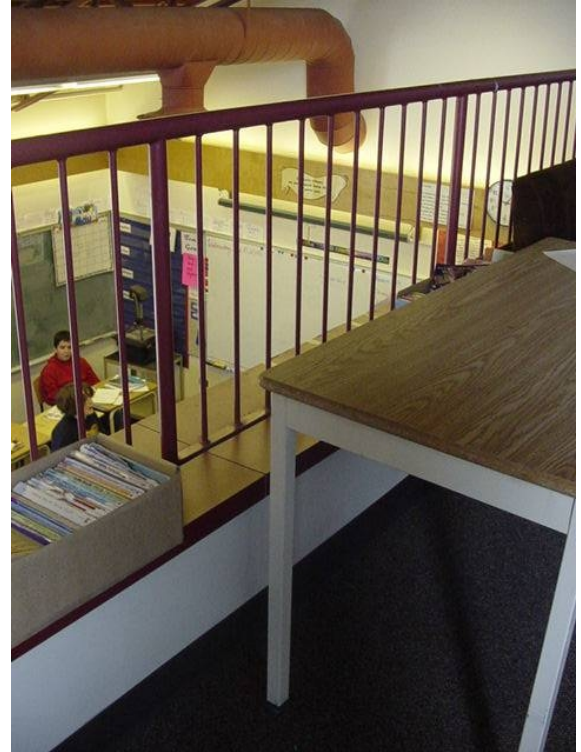
Railing height on mezzanine does not meet building code.

**Event: Code Repair - Increase railing height to conform to building code**

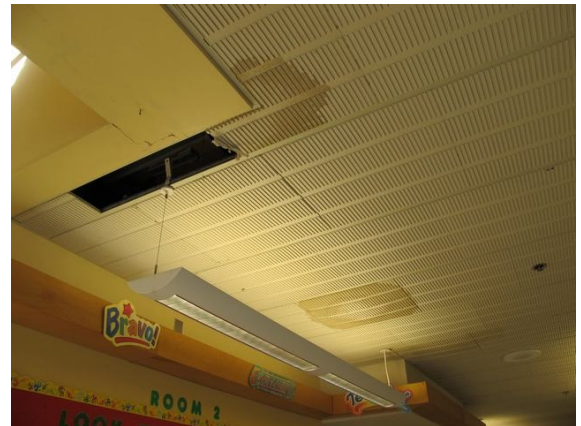
Several stained and damaged tiles were observed in the main corridor due to earlier roof leaks.

Missing and stained ceiling tiles in the main corridor.

Replace all damaged, missing and stained tiles.

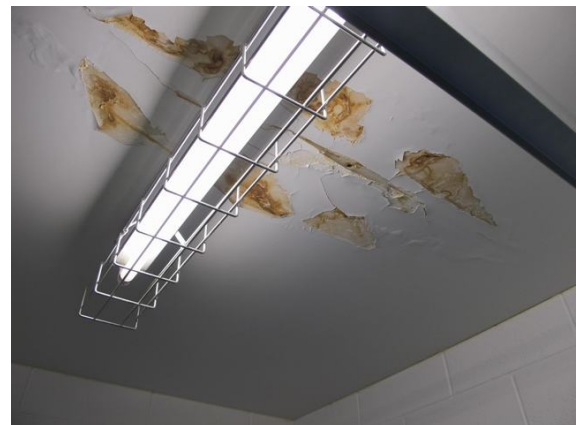
Water damaged to the ceiling was observed in the girl's change.

Damaged ceiling in girl's change room.

Repair and repaint ceiling.

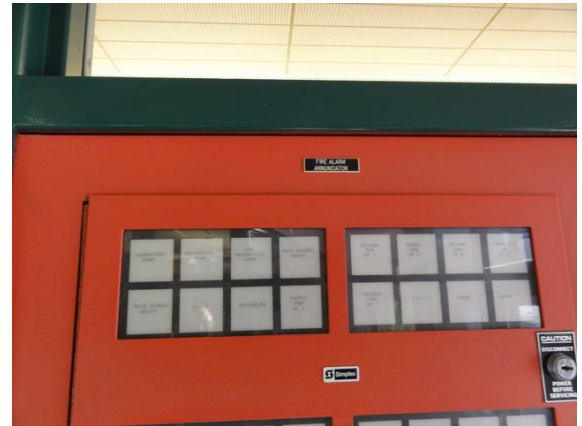
Existing Simplex 2002 fire alarm panel is no longer manufactured and repair parts no longer available. Fire devices are aged and may no longer be reliable. There are no strobes in the school.

Remote fire alarm annunciator at main entrance.

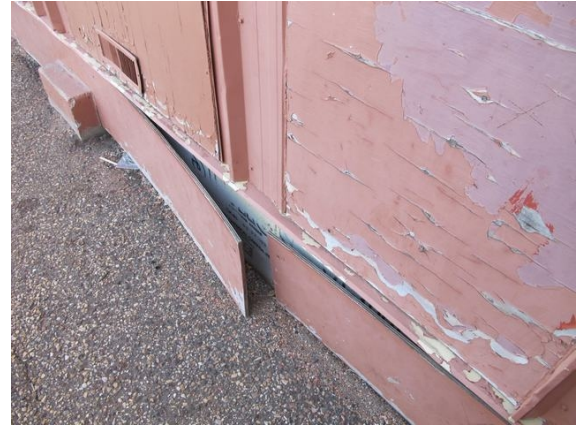
Deteriorated skirt and wood panels.
