RECAPP Facility Evaluation Report

Edmonton School District No. 7

Delton Elementary School

B3087A
Edmonton

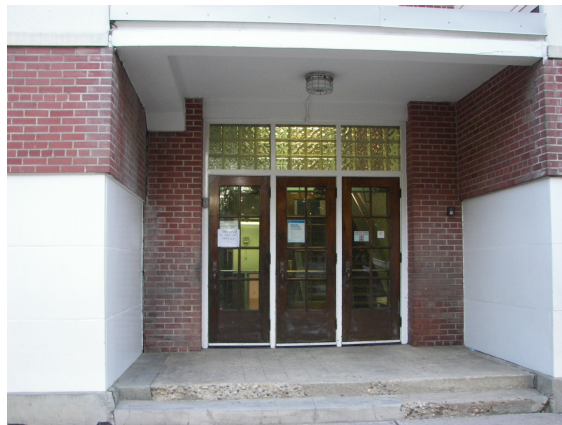
(1946) Original Building (Southeast Entrance) - has chipped steps.

Repair steps. (2 steps)

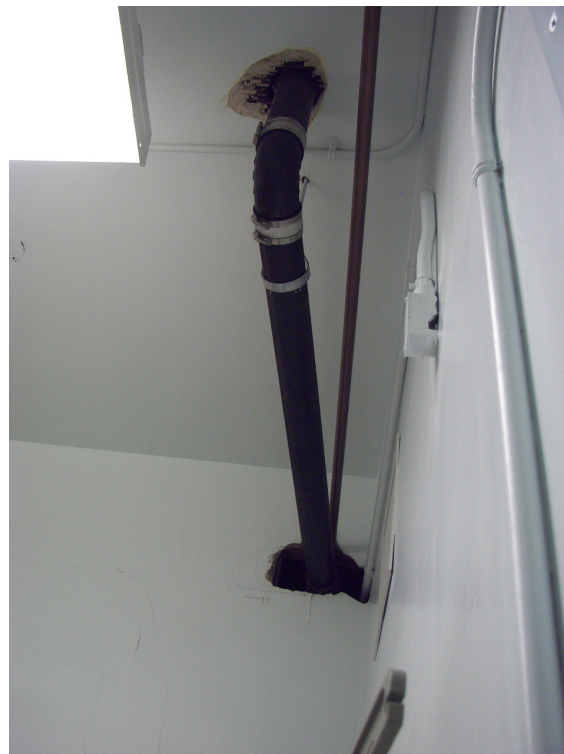
(1946) Original Building (Main Floor - Storage 26) - has space around pipe penetration.

Repair wall and ceiling. (approx. 10 pipes)

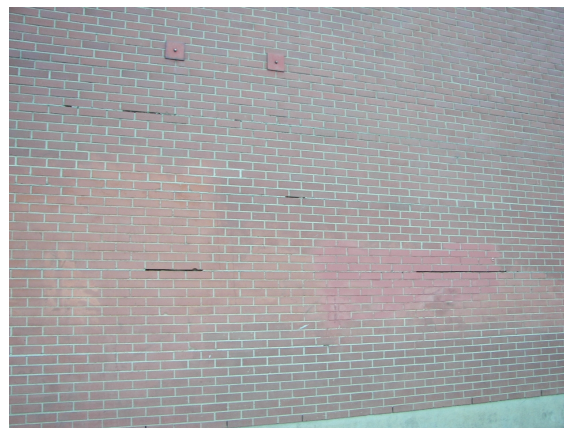
(1963) Addition - Mortar joints are worn out.

(1963 Addition - Mortar joints are worn out.

Repair mortar joints. (approx. 100 sq. m.)

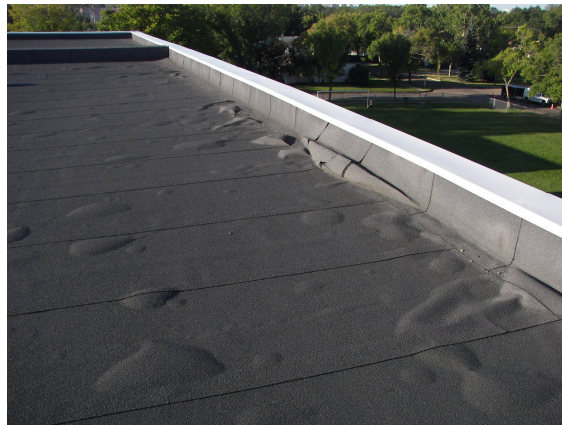
(1946) Original Building (west side) - has bubbles.

Repair SBS roofing. (approx. 200 sq. m.)

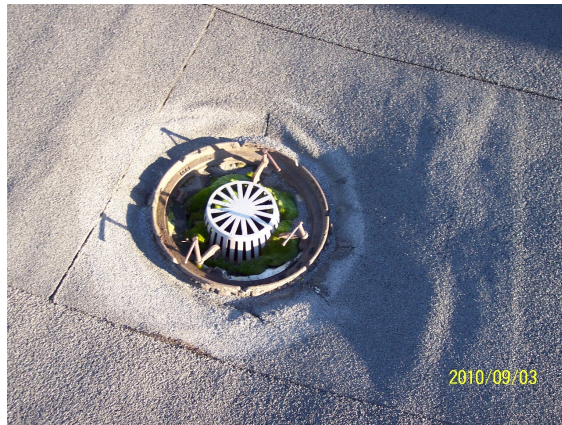
Roof drains have moss.

Repair roof drains. (approx. 11 drains)

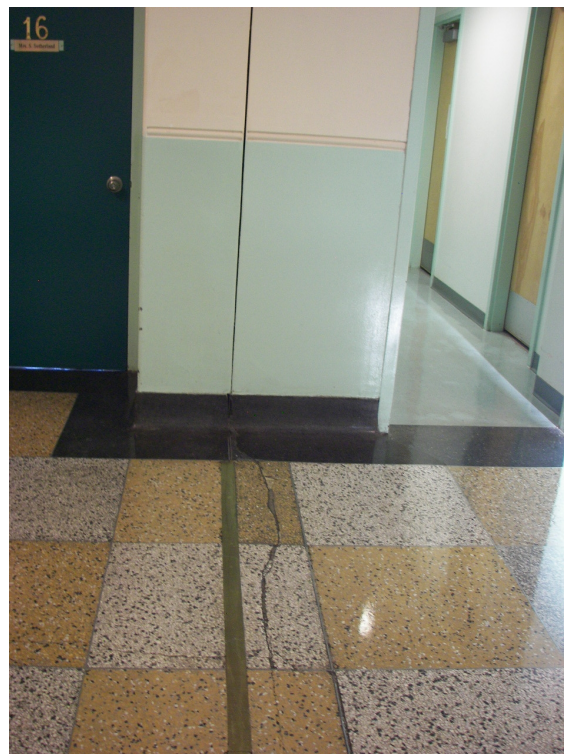
Areas between 1946 and 1950, 1946 and 1955 have cracked control joints.

Repair control joints. (6 joints)

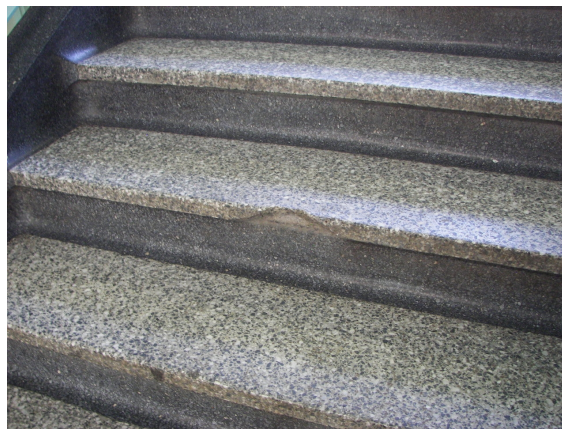
(1946) Original Building (Southeast Stair) - has damaged terrazzo stair finish.

Repair terrazzo stair finish. (1 stair)
