# RECAPP Facility Evaluation Report

Edmonton School District No. 7

## Glendale Elementary School

B3129A  
Edmonton

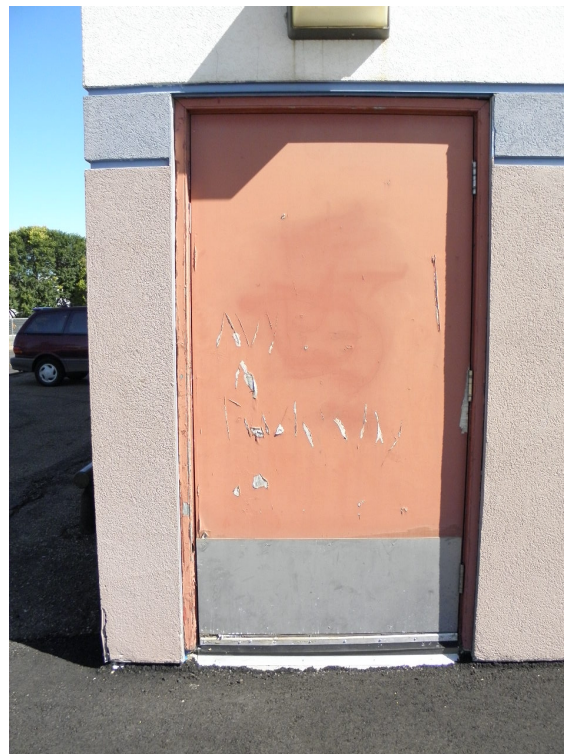
(1956) Addition (Main Floor - Corridor C8 Exit, Corridor C9 Exit) - wood doors and wood frames have worn out.

(1956) Addition (Main Floor - Corridor C9 Exit) - wood door and wood frame has worn out.

Replace exterior utility doors. (2 doors)

<u>Type</u>	<u>Year</u>	<u>Cost</u>	<u>Priority</u>
Failure Replacement	2012	\$2,000	Low

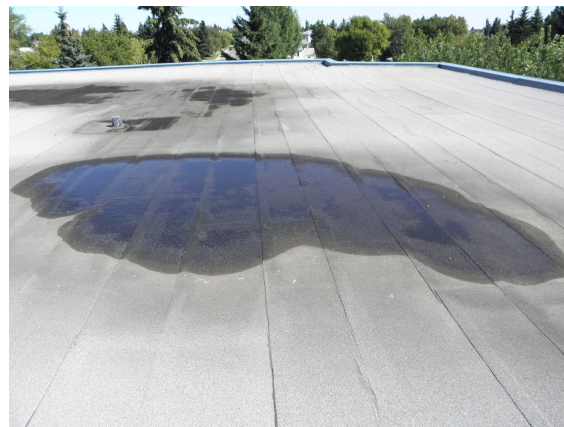
(1951) Original Building (Roof) - SBS roofing has ponding.

Repair SBS roofing. (approx. 300 square metres)

<u>Type</u>	<u>Year</u>	<u>Cost</u>	<u>Priority</u>
Repair	2012	\$45,000	Low

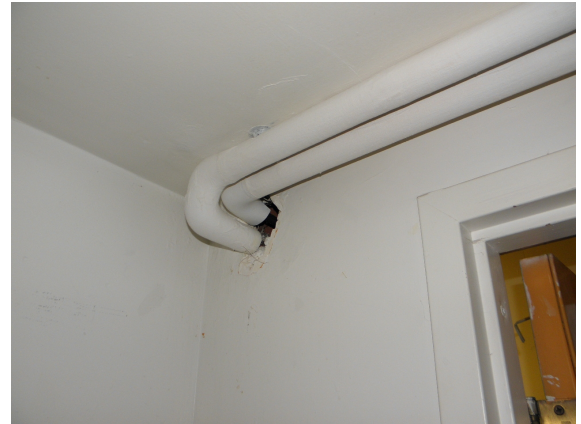
(1951) Original Building (Mechanical Room 16) - mechanical piping through wall need firestopping.

<u>Type</u>	<u>Year</u>	<u>Cost</u>	<u>Priority</u>
Repair	2012	\$1,000	Low

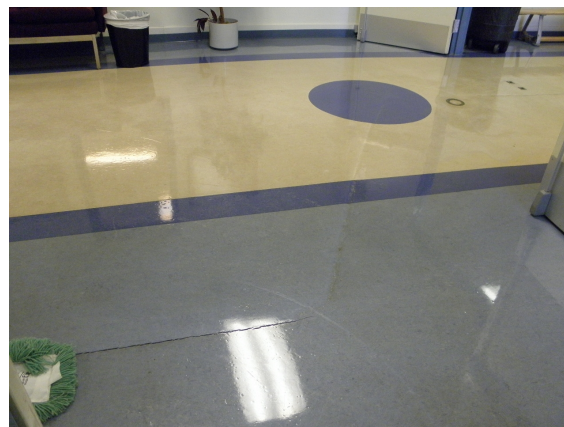
(1951) Original Building (Main Floor - partial Administration 1, Corridor C2) - have cracked sheet vinyl flooring.

(1951) Original Building (Main Floor - Corridor C2) - has cracked sheet vinyl flooring.

Replace resilient flooring. (approx. 40 square metres)

<u>Type</u>	<u>Year</u>	<u>Cost</u>	<u>Priority</u>
Failure Replacement	2012	\$4,000	Low

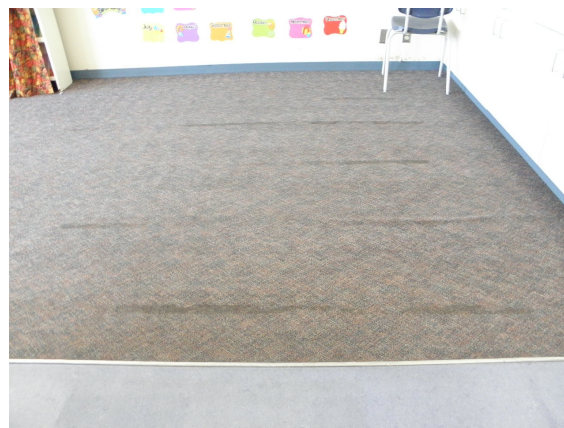
(1960) Addition (Second Floor - partial Classroom 33) - has rippled carpet flooring.

Replace carpet flooring. (approx. 15 square metres)

<u>Type</u>	<u>Year</u>	<u>Cost</u>	<u>Priority</u>
Failure Replacement	2012	\$1,500	Low

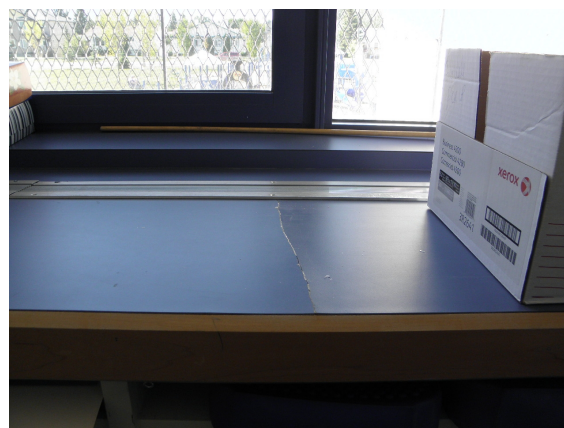
1960) Addition (Second Floor - Classroom 33) - has damaged countertop.

(1960) Addition (Second Floor - Classroom 33) - has damaged countertop.

Repair countertop. (approx. 2 linear metres)

<u>Type</u>	<u>Year</u>	<u>Cost</u>	<u>Priority</u>
Repair	2012	\$1,000	Low
