RECAPP Facility Evaluation Report

Edmonton School District No. 7

Greenfield School

B3138A
Edmonton

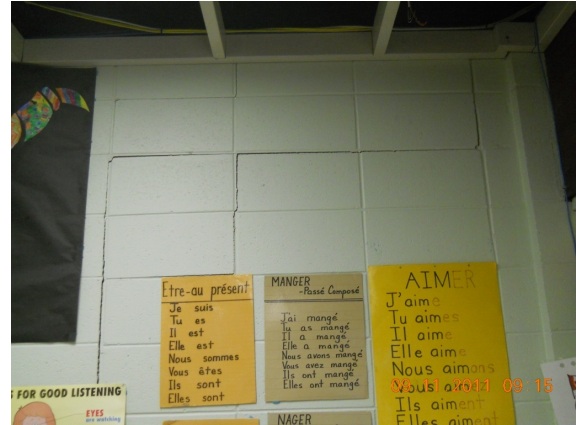
Event: Repair Wall Cracks (20m)**Concern:**

Due to shifting of the structure there are numerous locations where mortar joints in the concrete block walls have opened. This is unsightly and site personnel indicate that in some locations the voids have extend entirely through the wall. There is evidence that patch repairs are done regularly and this practice should be continued and combined with possible major local structural upgrades if the movement becomes excessive.

CRACKED MASONRY - ROOM 11

Patch and paint portions of block walls exhibiting the worst cracks.
