# **RECAPP Facility Evaluation Report**

**Edmonton School District No. 7**

**Harry Ainlay Composite High School**

B3145A  
Edmonton

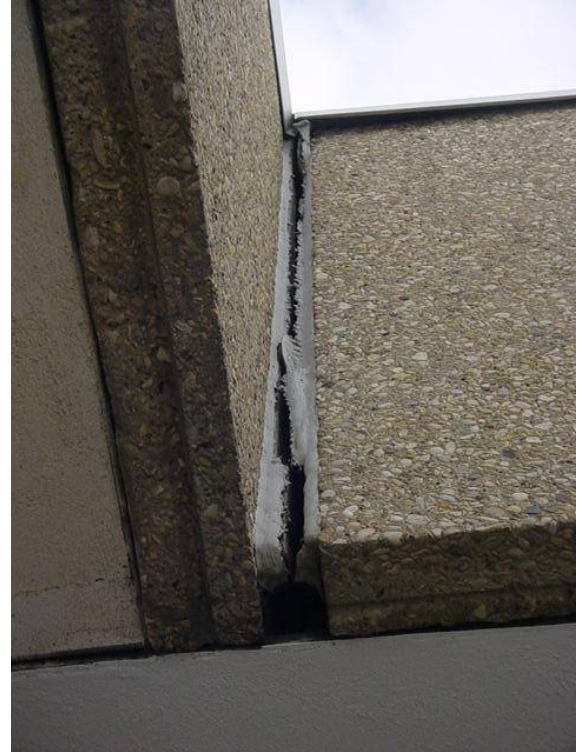
Many panels have shifted and some have hairline cracks indicating possible anchorage problems.

The sealant is brittle, broken, and has lost its adhesive qualities.

DETERIORATED SEALANT AND SHIFTING FASCIA PANELS

Retain a consultant to assess the structural integrity of the precast concrete fascia panels and to make recommendations for repair.

Remove and replace sealant.

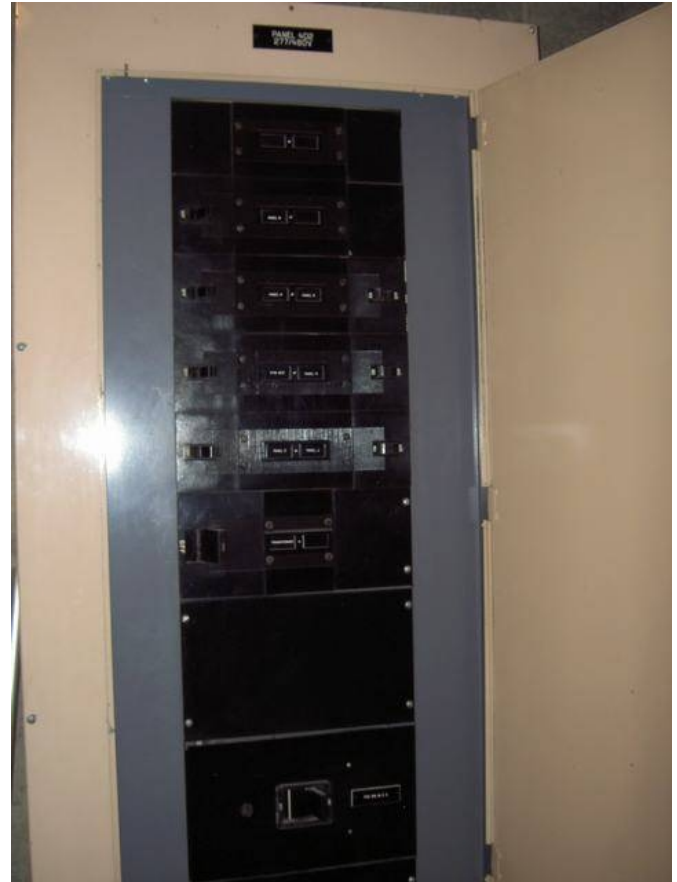
Aged distribution panel.

**Event: Replace Distribution Panelboards (2 - 277/480V & 2 - 120/208V) and Branch Circuit Panelboards (18 - 277/480V & 38 - 120/208V)**

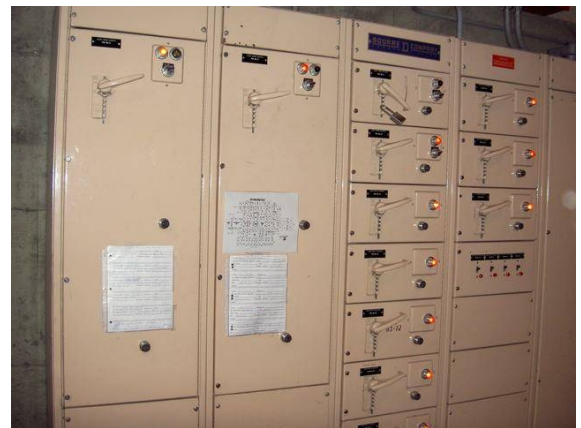
AGED SQUARE D MOTOR CONTROL CENTRE
