RECAPP Facility Evaluation Report

Edmonton School District No. 7

Highlands Junior High School

B3149A
Edmonton

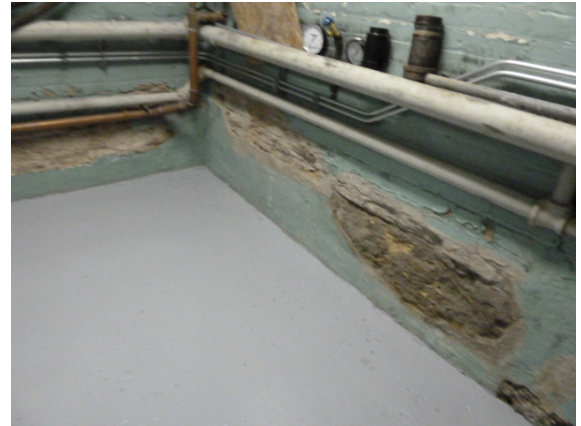
(1914) Original Building (Basement - Mechanical Room 1) - has damaged concrete foundation walls.

Repair concrete foundation walls. (approx 100 square metres)

<u>Type</u>	<u>Year</u>	<u>Cost</u>	<u>Priority</u>
Repair	2012	\$10,000	High

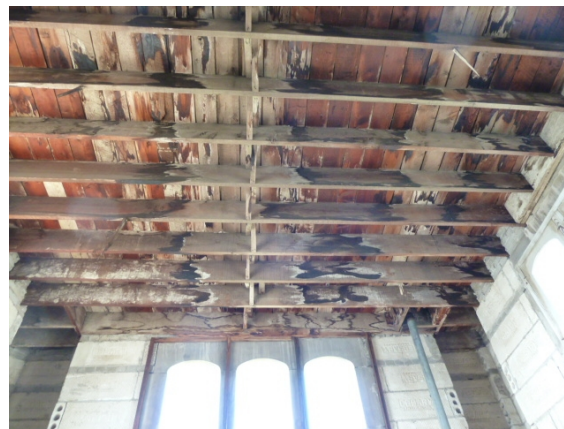
(1914) Original Building (Tower Roof) - has rotten roof wood deck and wood joists.

Replace rood joists and wood deck. (approx. 30 square metres)

<u>Type</u>	<u>Year</u>	<u>Cost</u>	<u>Priority</u>
Failure Replacement	2012	\$3,000	Low

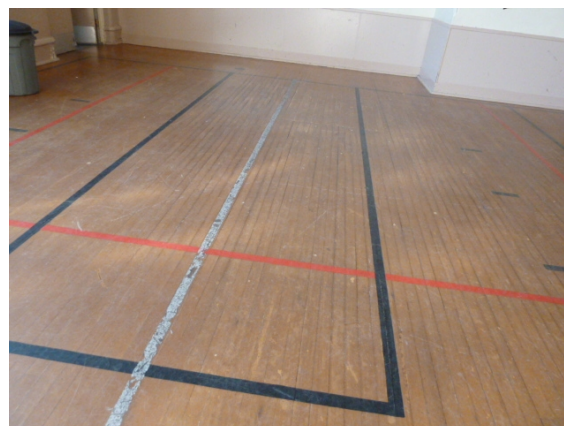
(1914) Original Building (Basement - Industrial Arts 24, Office 26) - have worn out wood strip flooring. (approx. 150 square metres)
 (1914) Original Building (Main Floor - Gymnasium 108) - has worn out wood strip flooring. (approx. 310 square metres)

(1914) Original Building (Main Floor - Gymnasium 108) - has worn out wood strip flooring.

Refinish wood flooring. (approx. 460 square metres)

<u>Type</u>	<u>Year</u>	<u>Cost</u>	<u>Priority</u>
Repair	2012	\$23,000	Low

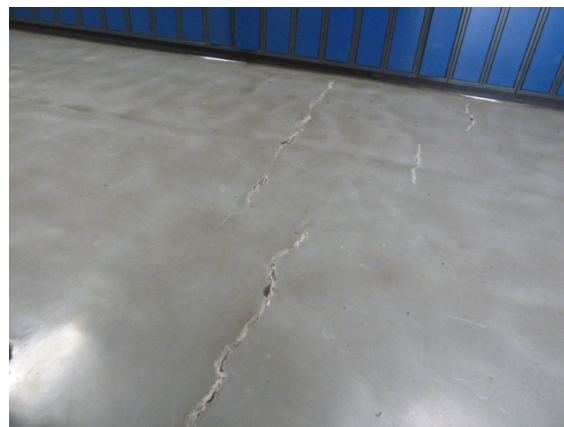
(1914) Original Building (Main Floor - Corridor C2) - has cracked linoleum flooring. (approx. 215 square metres)
 (1914) Original Building (Second Floor - Science Prep 212) - has worn out linoleum flooring. (approx. 30 square metres)

(1914) Original Building (Main Floor - Corridor C2) - has cracked linoleum flooring. (approx. 215 square metres)

Replace resilient flooring. (approx. 245 square metres)

<u>Type</u>	<u>Year</u>	<u>Cost</u>	<u>Priority</u>
Failure Replacement	2012	\$24,500	Low

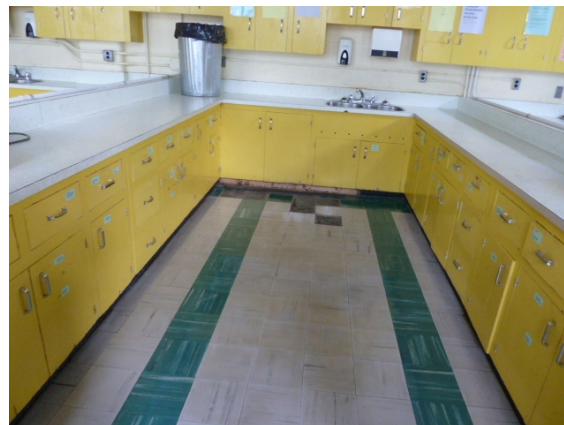
(1955) Annex (Home Economics 147) - has worn out, damaged and missing vinyl asbestos tile flooring. (approx. 150 square metres)

(1955) Annex (Home Economics 147) - has worn out vinyl asbestos tile flooring.

Replace resilient flooring. (approx. 150 square metres)

<u>Type</u>	<u>Year</u>	<u>Cost</u>	<u>Priority</u>
Failure Replacement	2012	\$15,000	Low
