RECAPP Facility Evaluation Report

Edmonton School District No. 7

Hillview Elementary School

B3151A
Edmonton

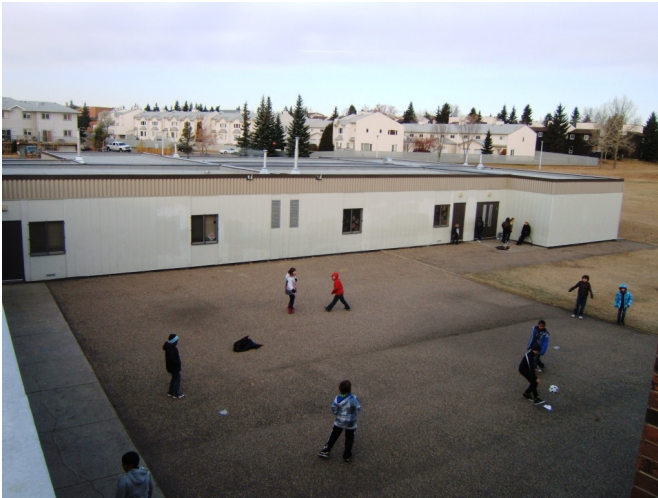
1. Electrical Branch Circuit Panels: Six single phase, 3 wire 120/240V and rated 125A service panels were installed in portable sections of the building. Lifecycle replacement shall be occurred in 2015 and the cost will be \$18,000

2. Motor Starters and Accessories: Six load switches for these portable furnaces, lifecycle replacement shall be occurred in 2015 and the cost will be \$3,600

3. Interior Fluorescent lights: Fixtures are original T-12 lamp and completed with magnetic ballast. Lifecycle replacement shall be occurred in 2015 and the cost will be \$26,000.

4. The HPS wall packs were installed above the exit doors.
5. LED exit signs are provided for this portables.
6. The fire alarm system devices were connected to main building fire alarm panel, Lifecycle replacement shall be occurred in 2015 and the cost will be \$10,000.

7. The intrusion system devices were connected to main school security panel and Lifecycle replacement shall be occurred in 2022 and the cost will be \$5,000.

8. The PA system devices were wired to main school systems and lifecycle replacement shall be occurred in 2022 and the cost will be \$2,500.
9. The Telephone, data system outlets were installed in each class room.

<u>Rating</u>	<u>Installed</u>	<u>Design Life</u>	<u>Updated</u>
4 - Acceptable	1982	30	MAR-12

View of portables
