# RECAPP Facility Evaluation Report

**Holyrood Elementary School**

B3156A  
Edmonton

**Evaluation Company:** Kenneth M. Lee Architect  
**Evaluation Date:** November 4 2005  
**Evaluator Name:** Mr. Kenneth Lee

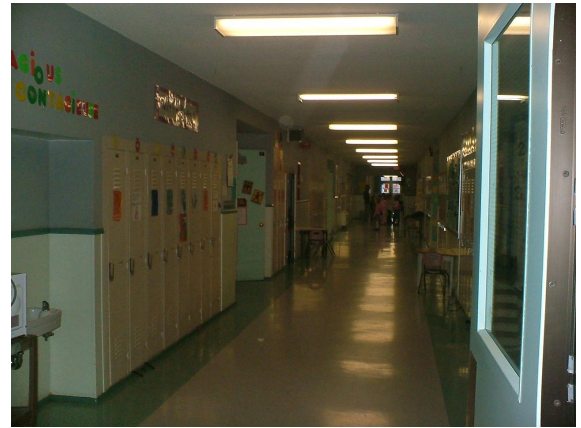
1957 - The original 1957 metal lockers in the corridor and in the entrance hallway from the parking lot.

The school has 414 students and has less than 200 lockers. These lockers are located in the 1957 addition. It is inconvenient for the students in the 1955 original building to use these lockers.

Install 200 new single tier metal lockers in the 1955 original building.

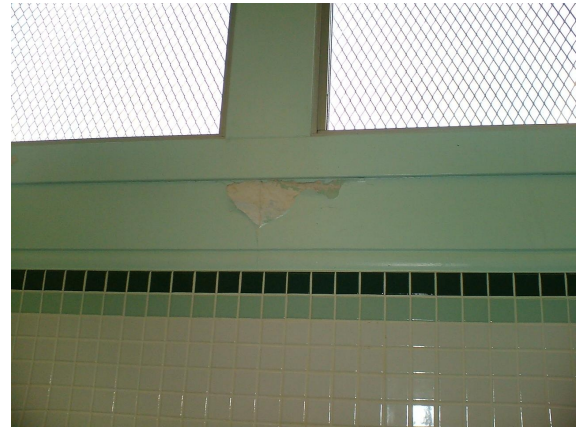
Paint peeling off, chipped and stained in various rooms.

Paint damaged surfaces in the building.

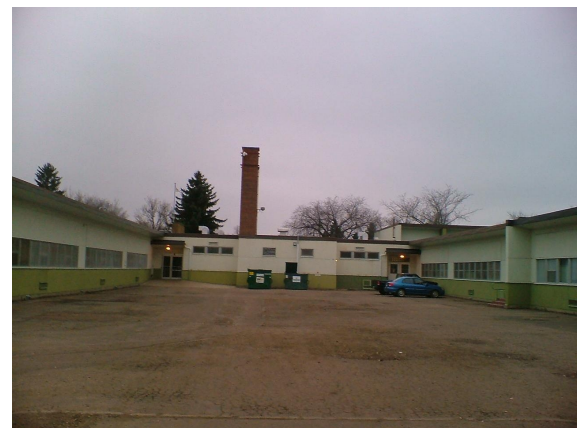
There is a central parking lot (asphalt) between the 1955 original building and the 1957 addition. The asphalt pavement is not in good condition.
