RECAPP Facility Evaluation Report

Edmonton School District No. 7

J. A. Fife Elementary School

B3164A
Edmonton

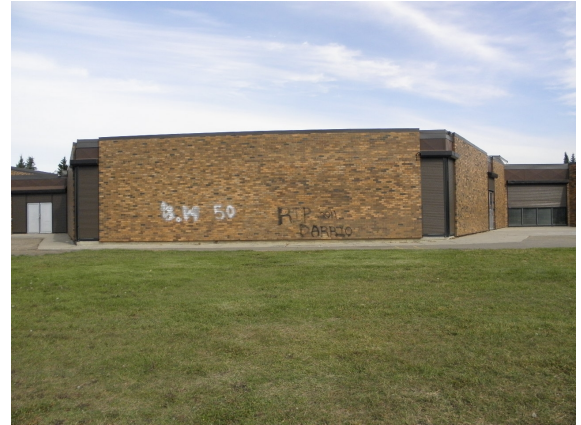
(1968) Original Building (Classroom 38, 39 - West side) - has graffiti on face brick

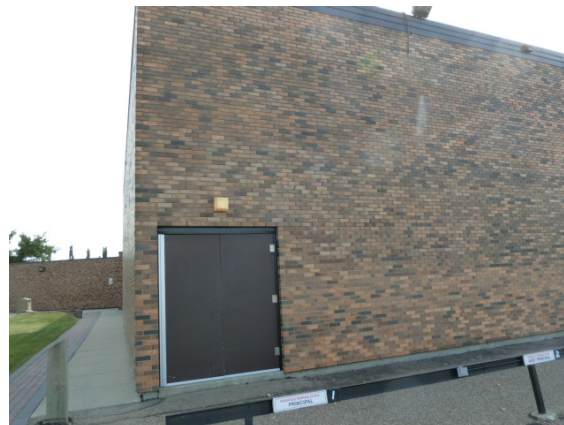
- (1968) Original Building (Main Floor - Gymnasium 1) - has damaged wood doors and uneven hinges. (2 doors)
- (1968) Original Building (Main Floor - Storage 60) - has worn out wood door. (1 door)
- (1968) Original Building (Mezzanine - Storage 3) - has worn out wood door. (1 door)

(1968) Original Building (Main Floor - Gymnasium 1) - has damaged wood doors and uneven hinges.

Replace exterior utility doors. (4 doors)

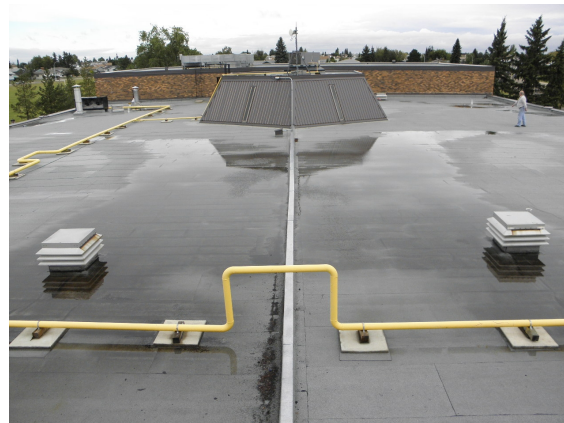
(1968) Original Building (Main Roof) - SBS roofing has ponding. (approx. 1000 square metres)

Repair SBS roofing. (approx. 1000 square metres)

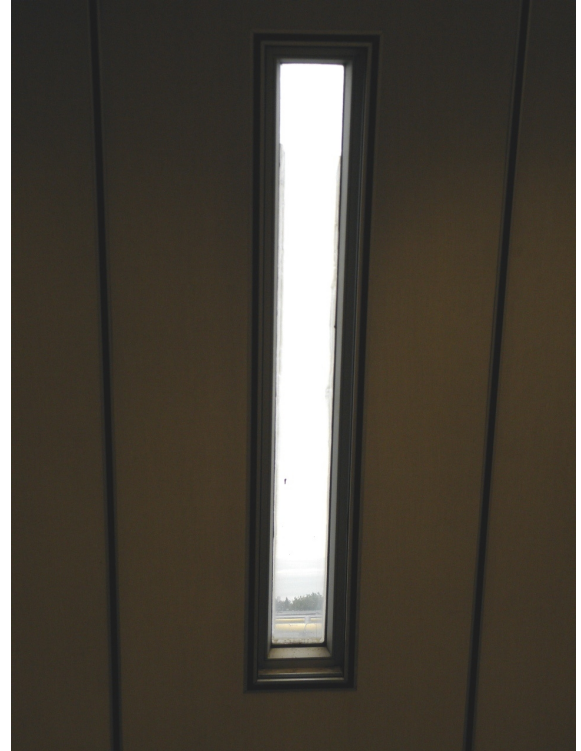
(1968) Original Building (Mezzanine - Staff Room 23, Library 42) - gaskets have worn out and leak. (12 windows)

(1968) Original Building (Mezzanine - Staff Room 23) - gaskets have worn out and leak.

Replace sloped aluminum windows (Glass & Frame). (12 windows)
