RECAPP Facility Evaluation Report

Louis St. Laurent Catholic Junior / Senior High School

B3198A
Edmonton

Evaluation Company: Robert Irlam Consulting Inc.
Evaluation Date: September 21 2010
Evaluator Name: J. R. Irlam

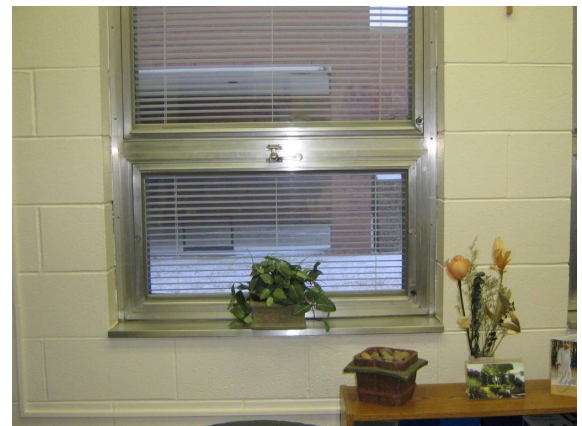
Window has loose weather stripping between window panes.

Replace aluminum windows.

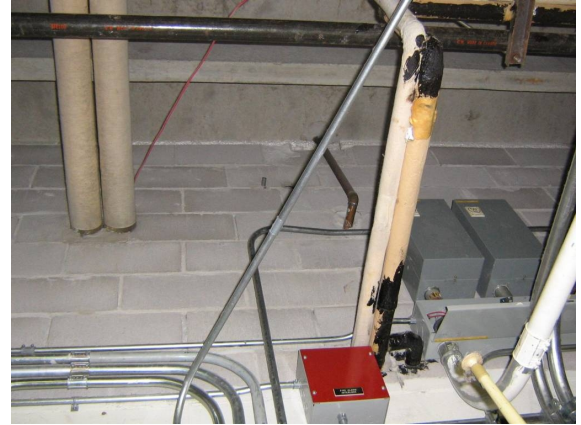
There is missing fire stopping in mechanical rooms and service rooms throughout the school.

Cartier mechanical room, unsealed pipe penetrations

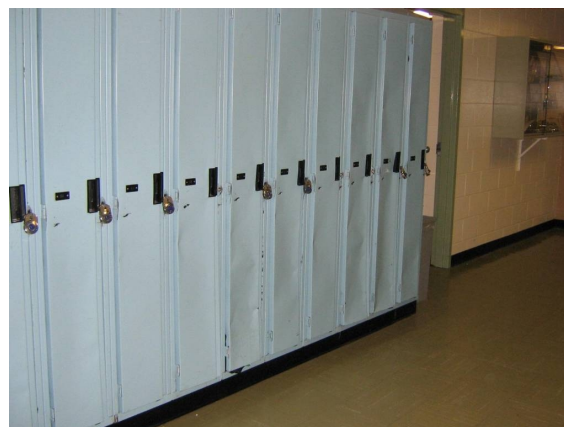
Lockers throughout the school are damaged and unlockable.

Lockers old and badly dented.

Replace damaged lockers.

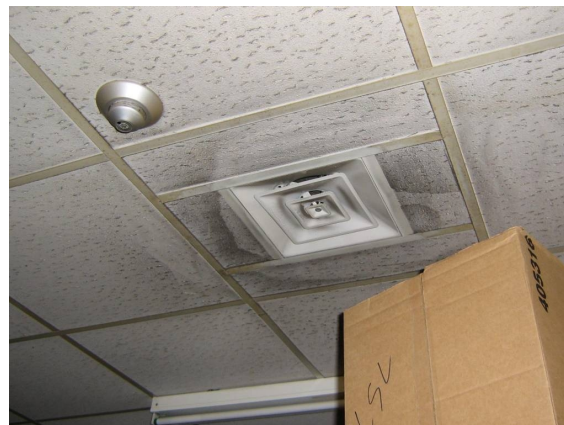
There are areas throughout the school with damaged and marked ceiling tiles.

Dirty ceiling tiles.

Replace damaged ceiling tiles.

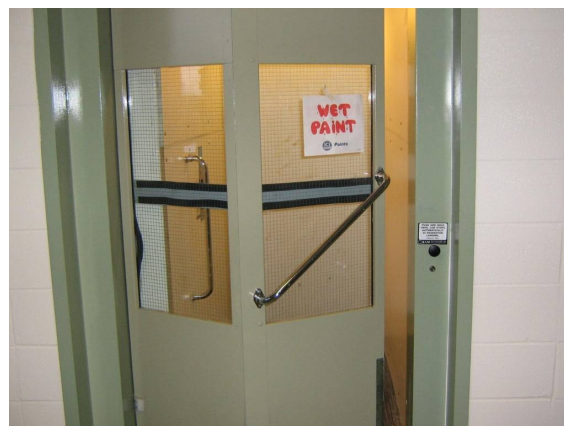
Single passenger elevator

Replace lifts with hydraulic wheel chair lifts.

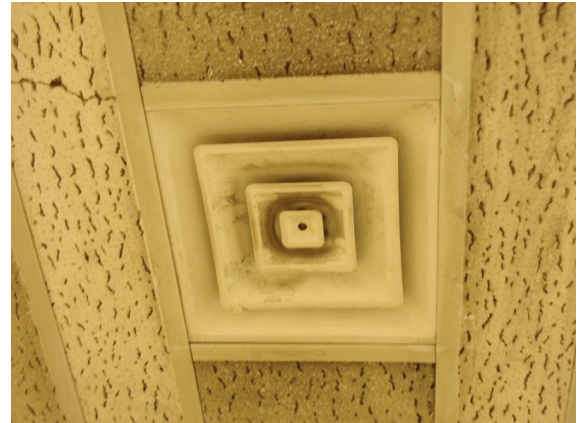
Diffuser Dust Rings.JPG

For the 1968 portion of the school there are dust rings on some of the Classroom diffusers indicating previous dust build-up in the ducting system. There are also some areas of the school where complaints of poor ventilation and insufficient cooling are occurring, possibly due to reheat coils being clogged and improper air balance.
