RECAPP Facility Evaluation Report

Edmonton School District No. 7

Lynnwood Elementary School

B3200A
Edmonton

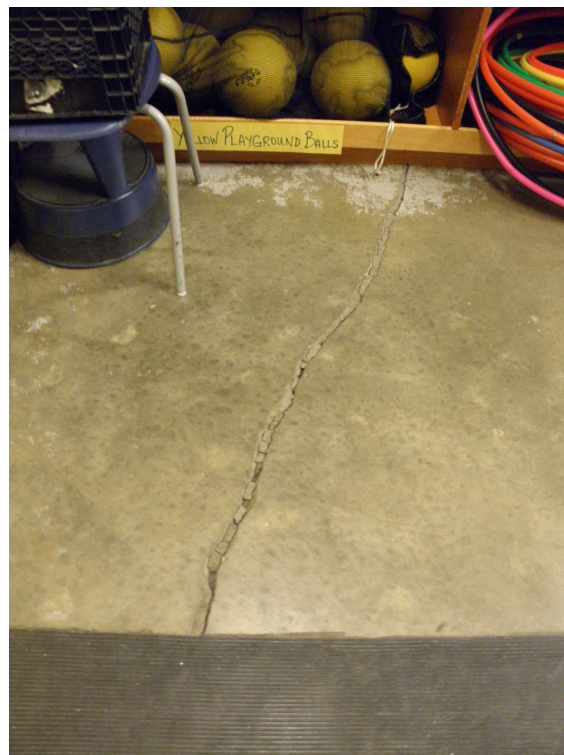
<u>Rating</u>	<u>Installed</u>	<u>Design Life</u>	<u>Updated</u>
3 - Marginal	1960	0	JAN-13

(1960) Original Building (Main Floor - Gym Storage 6) - has cracked concrete slab.

Repair concrete slab - 1960 Section. (approx. 10 square metres)

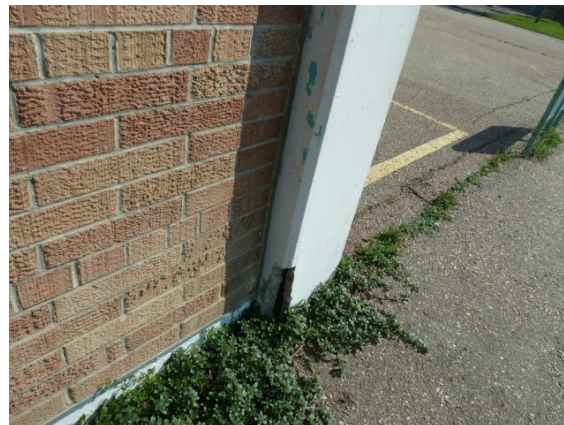
<u>Rating</u>	<u>Installed</u>	<u>Design Life</u>	<u>Updated</u>
3 - Marginal	1960	0	JAN-13

(1960) Original Building (Main Floor - Southeast corner) - has damaged cast in place concrete column.

Repair 1 concrete column.

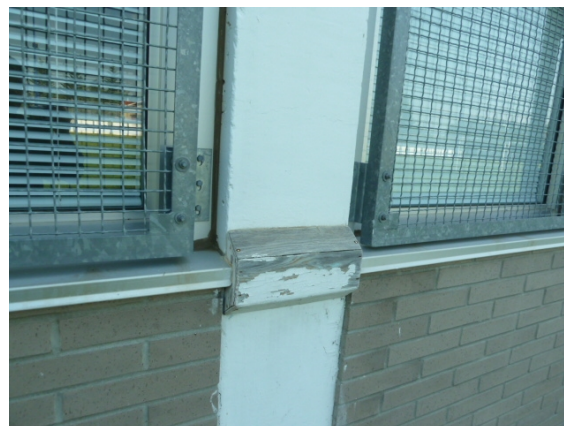
(1960) Original Building - has rotten wood trim and worn out paint.

Replace and repaint 14 wood trims.
