RECAPP Facility Evaluation Report

Mayfield School

B3207A
Edmonton

Evaluation Company: Francis Ng Architect Ltd.
Evaluation Date: August 17 2012
Evaluator Name: Francis Ng

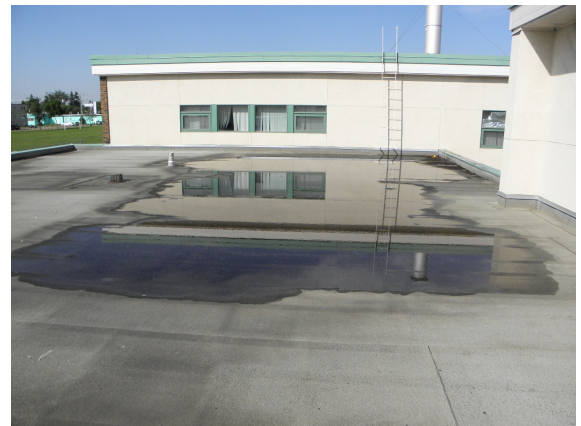
(1962) Addition (Low Roof) - SBS roofing has ponding.

Repair SBS roofing - 1962 Section. (approx. 50 square metres)

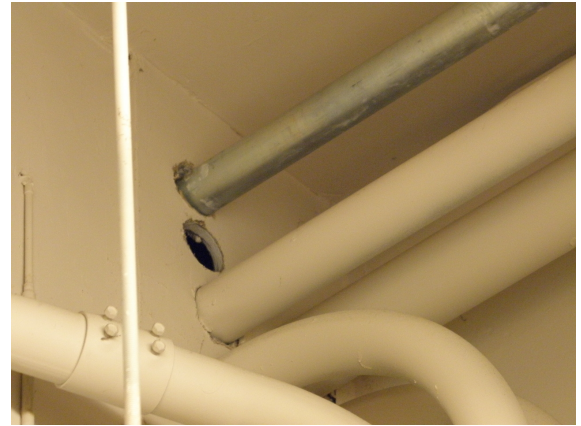
(1958) Original Building (Mechanical Room 35) - conduits penetrating walls need firestopping.

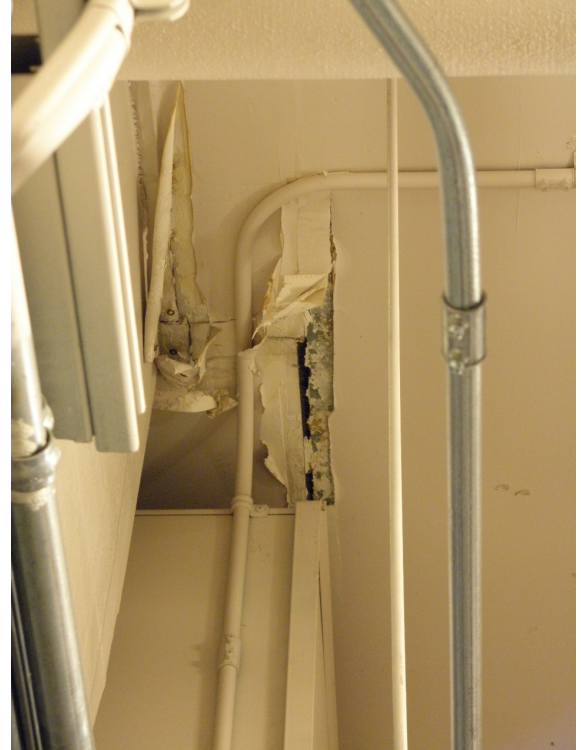
(1958) Original Building (Main Floor - Mechanical Room 35) - has damaged gypsum board ceiling finish.

Repair Mechanical Room 35 ceiling - 1958 Section. (approx. 5 square metres)
