RECAPP Facility Evaluation Report

Edmonton School District No. 7

McKernan Elementary / Junior High School

Evaluation Company: N53 Architecture Inc.
Evaluation Date: December 11 2012
Evaluator Name: Jason Porterfield

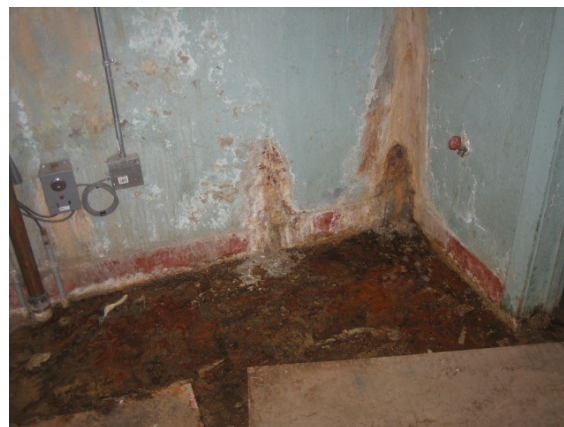
IMG_9828.jpg

Event: Repair Water Infiltration to Basement Spaces--100 m2

Water infiltration into basement spaces causing damage to bottom of doors, frames and some mechanical equipment. Weeping tile installed in 2003 does not appear to have solved the situation.

Review of current water protection systems in place at school including the construction of the 2003 weeping tile and sump pump. Provide new waterproofing concrete wall membrane to the exterior side of the foundations in troubled areas.

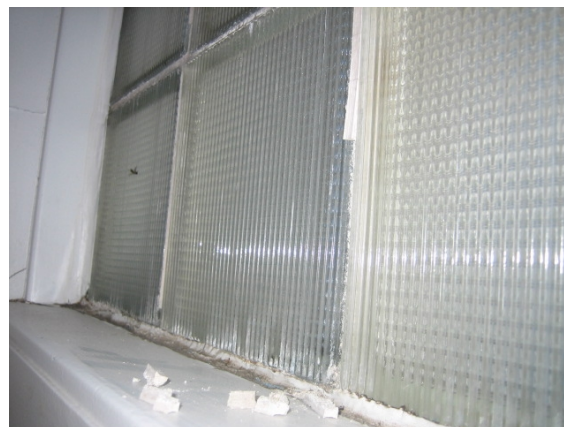
IMG_9725.jpg

Event: Replace glass block with fixed aluminum windows (212m2)

Glass block seals have failed and allows water movement into building.

Recommend removing all glass block and installing new aluminum window units.

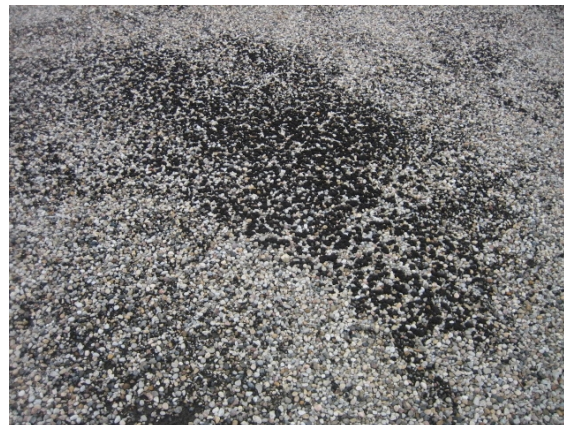
Mckernan 007.jpg

Event: Replace 2,970m2 roofing with new SBS 1952/1952 section

Roofing membrane is showing various signs of failure including membrane bubbling, soft spots, insufficient gravel cover due to high slope. Roof edge flashings are worn and rusted.

Recommend replacing roof with new SBS roofing system.

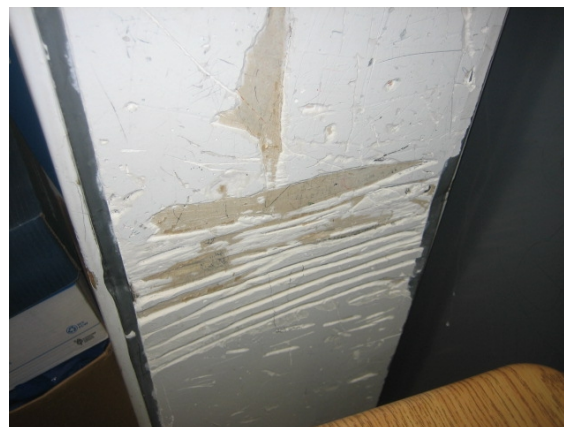
IMG_9735.jpg

Event: Repair damaged walls, 50m2.

Walls along walls in classrooms are damaged from chairs, tables and students.

Recommend repairing the damaged wall finish and install a new wood chair rail.

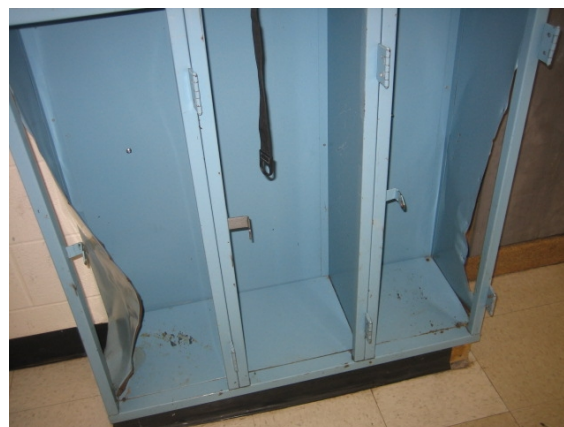
IMG_9774.jpg

Event: Replace 20 lockers in boys change room

Lockers in the boys change room are badly damaged and the doors have previously been removed.

Recommend replacing the lockers in the boys change room.

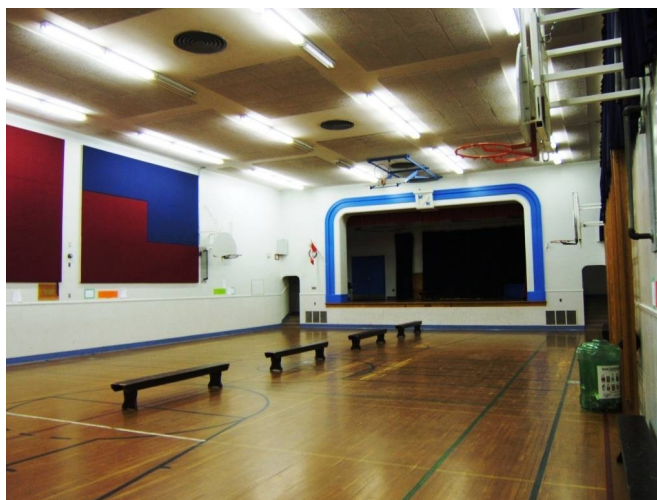
Fabric wrapped acoustic panels installed along the walls of the 1952 gymnasium.

View of South Gymnasium.

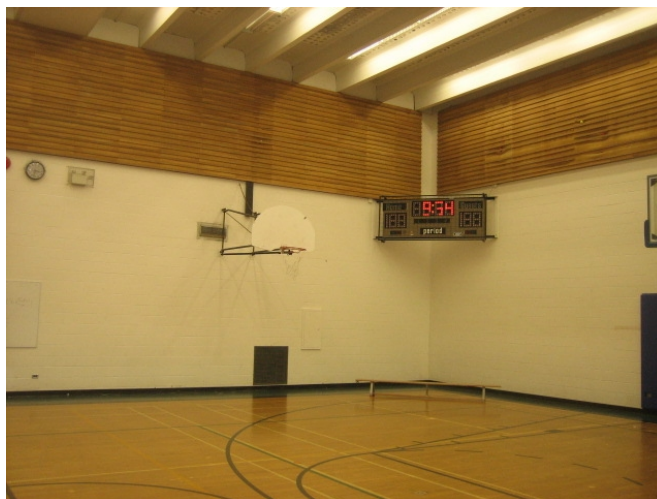
IMG_9769.jpg

Fabric wrapped acoustic panels along top 3m of the north gymnasium in the 1973 section. Wood strips installed over the acoustic panels.

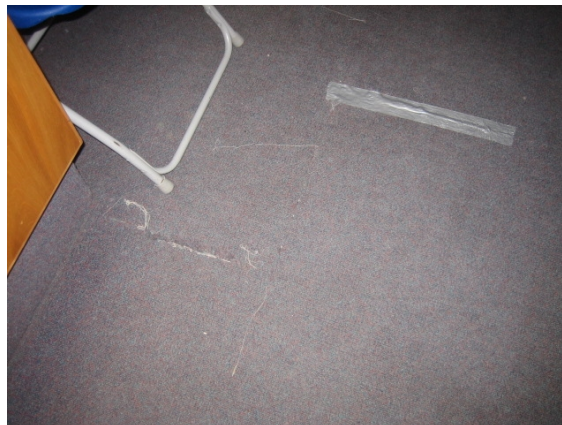
IMG_9703.jpg

Event: Replace 75m2 carpet flooring in 5 classrooms (75m2)

Carpet is worn, stained and ripped. Duct tape used to patch some spots.

Recommended to replace small portion of carpet in classrooms.

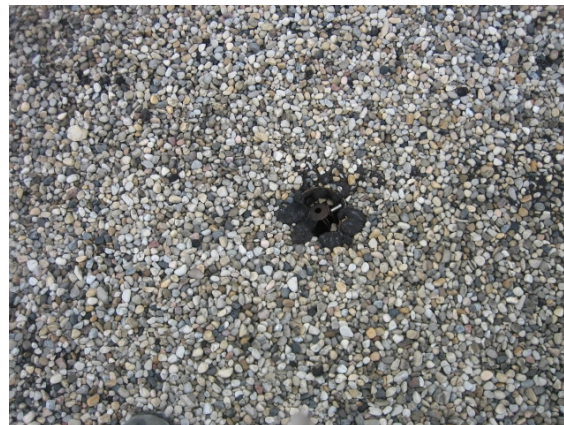
Mckernan 019.jpg

Event: Replace 12 roof drains on the 1952 and 1953 sections

Install new roof drains complete with screens.

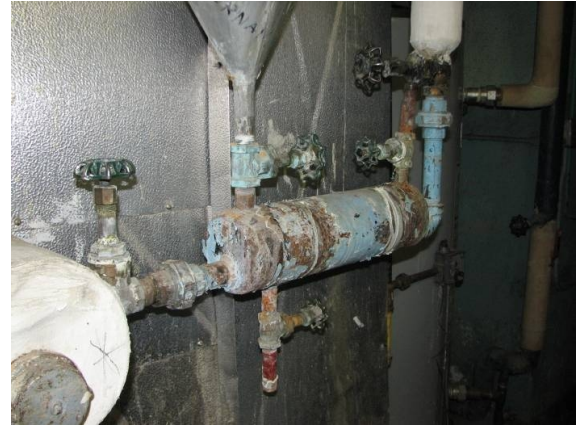
IMG_3547_18_1_1.JPG

Event: Replace 2 Steam Boilers and Entire Heating System

The schools heating system is in poor condition. The present steam boilers have been in operation since 1952, they show signs of corrosion on valves, hot water lines, chemical feeders, all the equipment that is associated with the Heating Boilers. The boilers are often failing, need constant repair and maintenance, costs for maintenance and service are extensive and are incurred often, and operating costs are very high as this steam system is a very inefficient system. The controls on the system are pneumatic and outdated. The condition of this system is poor and failure is imminent.

Replace the whole school's heating system with a new hydronic boiler system, perimeter heating, chimneys and force flow heating system to serve the whole school (North and South) as the North side of the school is only heated through the AHU. The cost estimate in this section includes all perimeter heating, chimneys and force flow heating for the whole school.
