# RECAPP Facility Evaluation Report

Edmonton School District No. 7

**Menisa School**

B3219A  
Edmonton

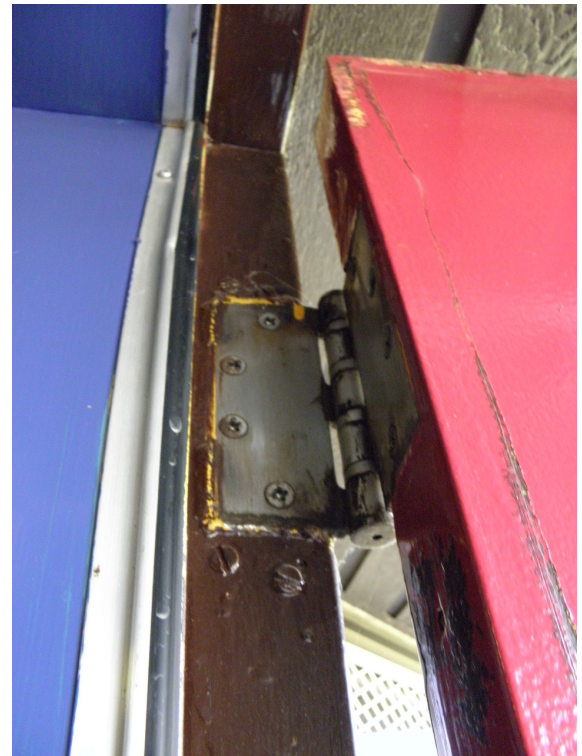
(1981) Original Building (Southwest Exit F2) - metal doors have welded hinges.

**Recommendation:**  
 Replace exterior utility doors. (6 doors)

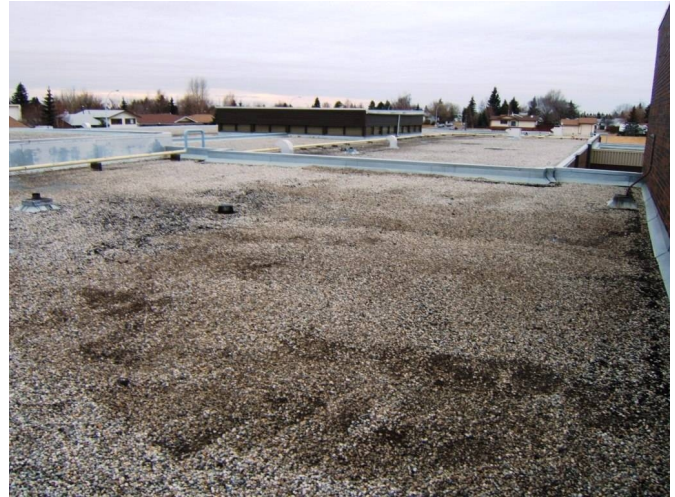
<u>Rating</u>	<u>Installed</u>	<u>Design Life</u>	<u>Updated</u>
3 - Marginal	1981	25	MAR-13

Partial view of built-up roofing.

Replace built-up roofing. (approx. 2610 square metres)

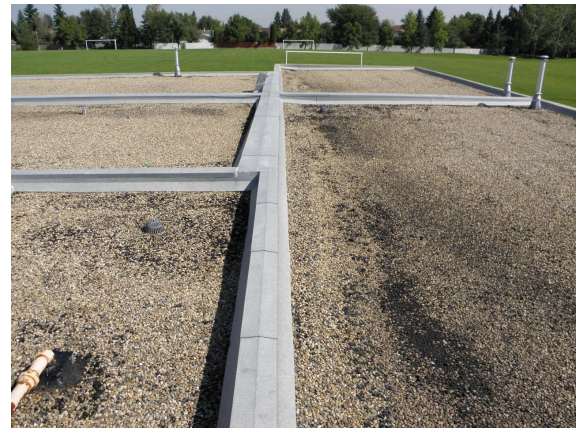
(1982) Addition - built-up roofing has blisters and bubbles. (approx. 410 square metres)

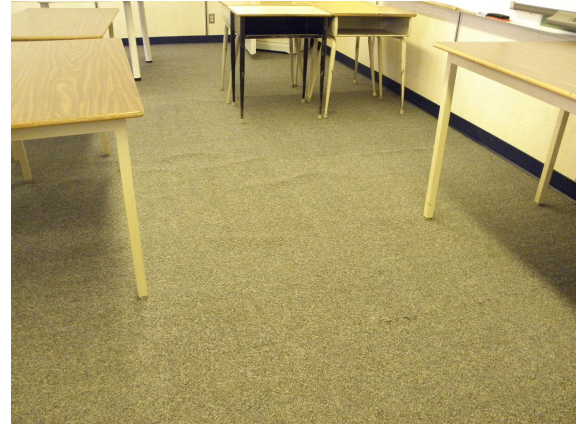
(1982) Addition (partial Classroom 42) - carpet flooring has ripples and open seams.

Replace carpet flooring. (approx. 235 square metres)

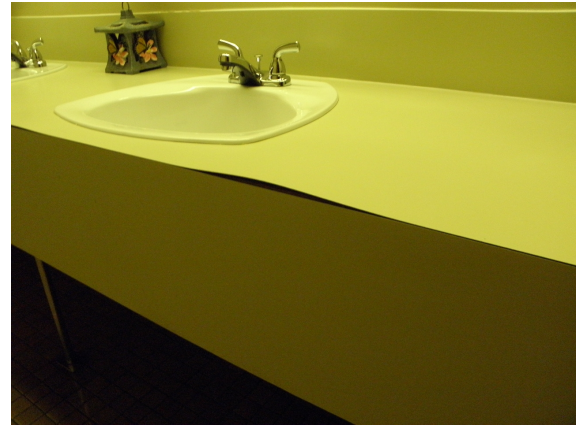
(1981) Original Building (Women's Washroom 26) - has damaged vanity.

Repair millwork. (approx. 2 linear metres)
