RECAPP Facility Evaluation Report

Edmonton School District No. 7

North Edmonton Elementary School

B3232A
Edmonton

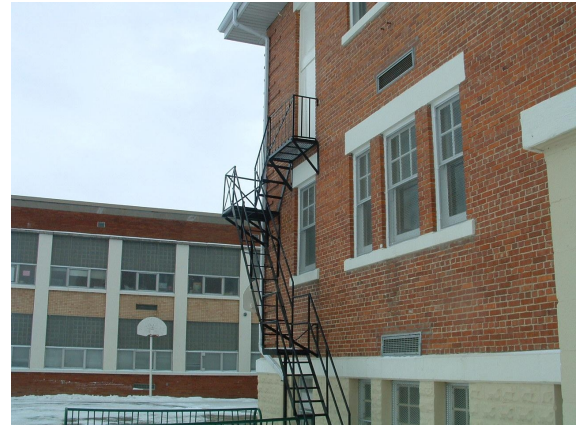
The fire escape has been contributing to vandalism in the building. Police and the Fire department have recommended it's removal.
