RECAPP Facility Evaluation Report

Edmonton School District No. 7

Sherbrooke School

B3253A
Edmonton

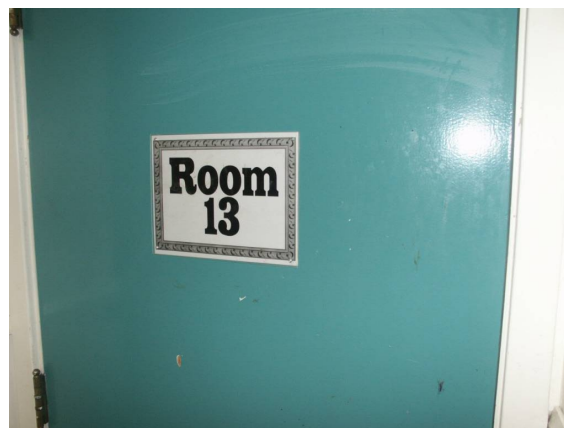
Laminated paper signage.

Replace signage with a single durable and flexible system.
