# **RECAPP Facility Evaluation Report**

**Riverdale Elementary School**

B3263A  
Edmonton

<b>Evaluation Details</b>	
<b>Evaluation Company:</b>	A&E Architectural & Engineering Group Inc.
<b>Evaluation Date:</b>	June 25 2008
<b>Evaluator Name:</b>	Vic Maybroda

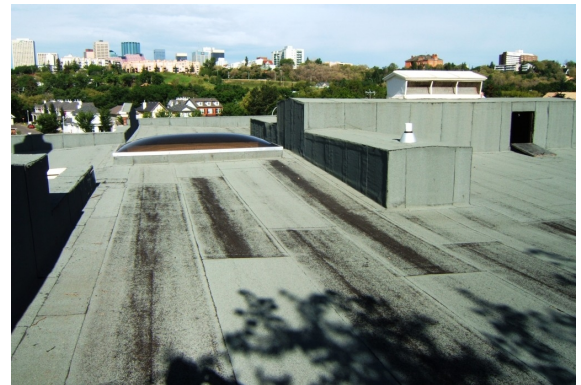
<u>Rating</u>	<u>Installed</u>	<u>Design Life</u>	<u>Updated</u>
3 - Marginal	1988	25	MAR-09

Granular surface worn to expose roof felts leading to potential for roof failure.

View of SBS roof.

Replace SBS membrane roofing.

<u>Type</u>	<u>Year</u>	<u>Cost</u>	<u>Priority</u>
Failure Replacement	2009	\$137,500	Medium
